**Michael A. Woodbury**  
**Consulting Arborist**  
206-659-4288  
pnrc@comcast.net

July 13, 2016

**Re:** Tree Removal Permit 2016-ACP-0015, Review and Recommendations  
**Site Address:** Barnes residence, 18215 Ballinger Way NE, Lake Forest Park, WA 98155

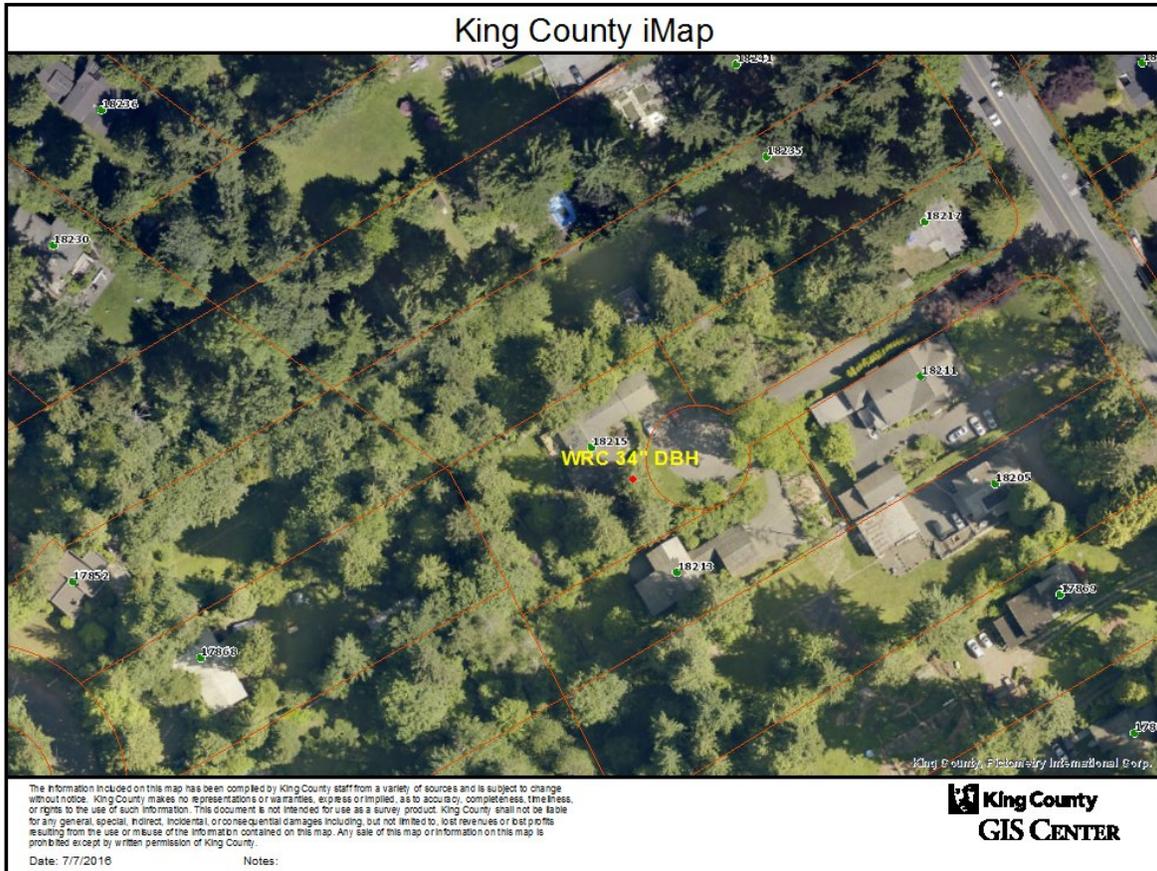
**ATTACHMENT: 2013 AERIAL SITE PHOTO**  
**18215 Ballinger Way NE**  
**Lake Forest Park, WA**

One landmark tree (a tree that is 28 inches in diameter and larger) is proposed for removal. There are plans for some work to the garage foundation that will occur within the critical root zone of the tree. Mr. and Mrs. Barnes are also concerned that the tree has out grown its space and may pose a risk. The location of the proposed tree removal is shown on the *Attachment: 2013 Aerial Site Photo*.

The site is a developed single family residential lot, 20,215 square feet in size. The tree canopy coverage goal for this size lot, pursuant to Chapters 16.14.080, is 58 % (11,725 sq. ft.). The current canopy coverage is approximately 53% (10,705 sq. ft.), as determined either by collected tree data and/or interpretation of high resolution aerial photography, see *Attachment: 2013 Aerial Site Photo*.

Location of the proposed tree removal.
