Re: Arborist Review Tree Permit #2016-ARP-0023, Review and Recommendations
Site: Brentwood Beach LLC property, 17114 Brentwood PL NE, Lake Forest Park, WA 98155

APPENDIX A: 2015 AERIAL SITE PHOTO
Brentwood PL NE
Lake Forest Park, WA

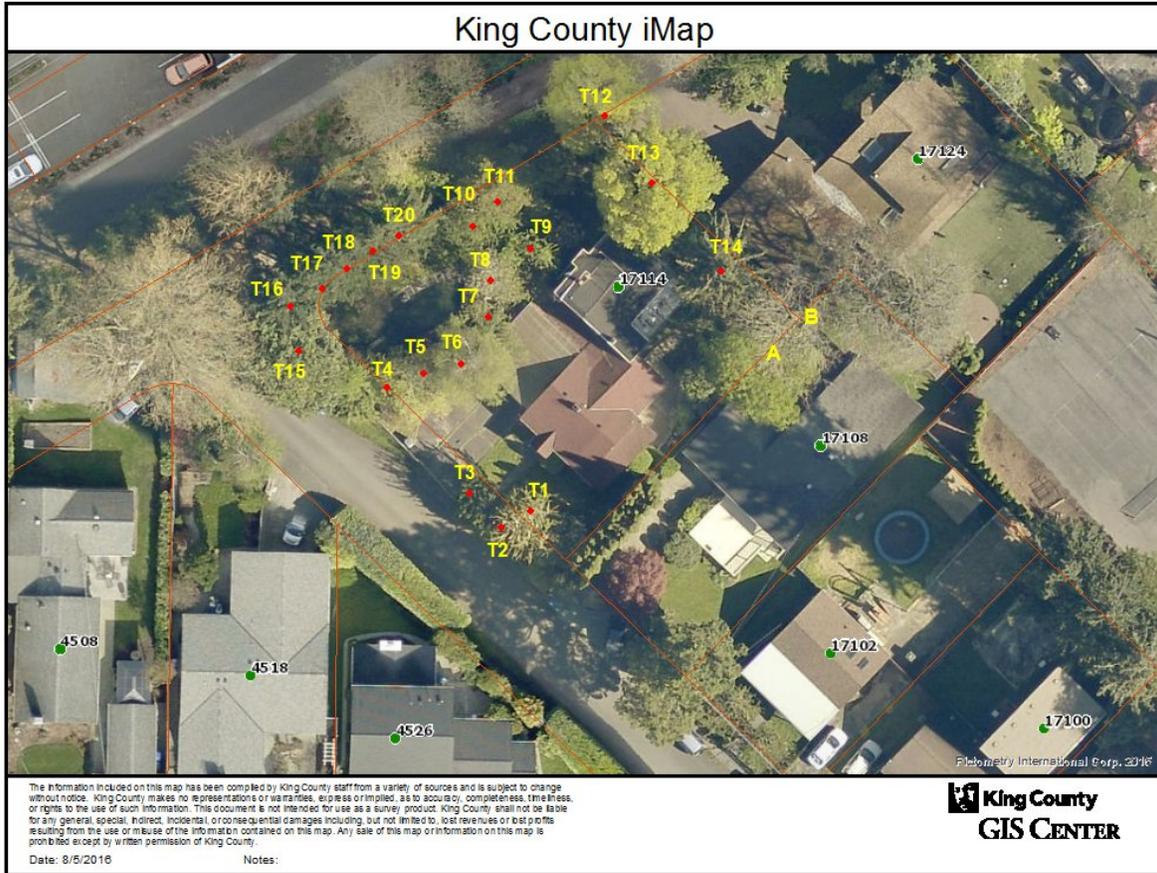
Locations of inventoried trees.

<u>Trees proposed for removal:</u>	<u>Trees to retain:</u>	<u>Offsite trees:</u>
T2	T1	A and B
T3	T4	
T5	T10	
T6	T11	
T7	T16	
T8	T18	
T9	T20	
T12
