June 12, 2015

**Re:** Arborist Review Tree Permit #2015-ARP-0015, Review and Recommendations  
**Site:** Scofield property, 4950 NE 184th St, Lake Forest Park, WA 98155

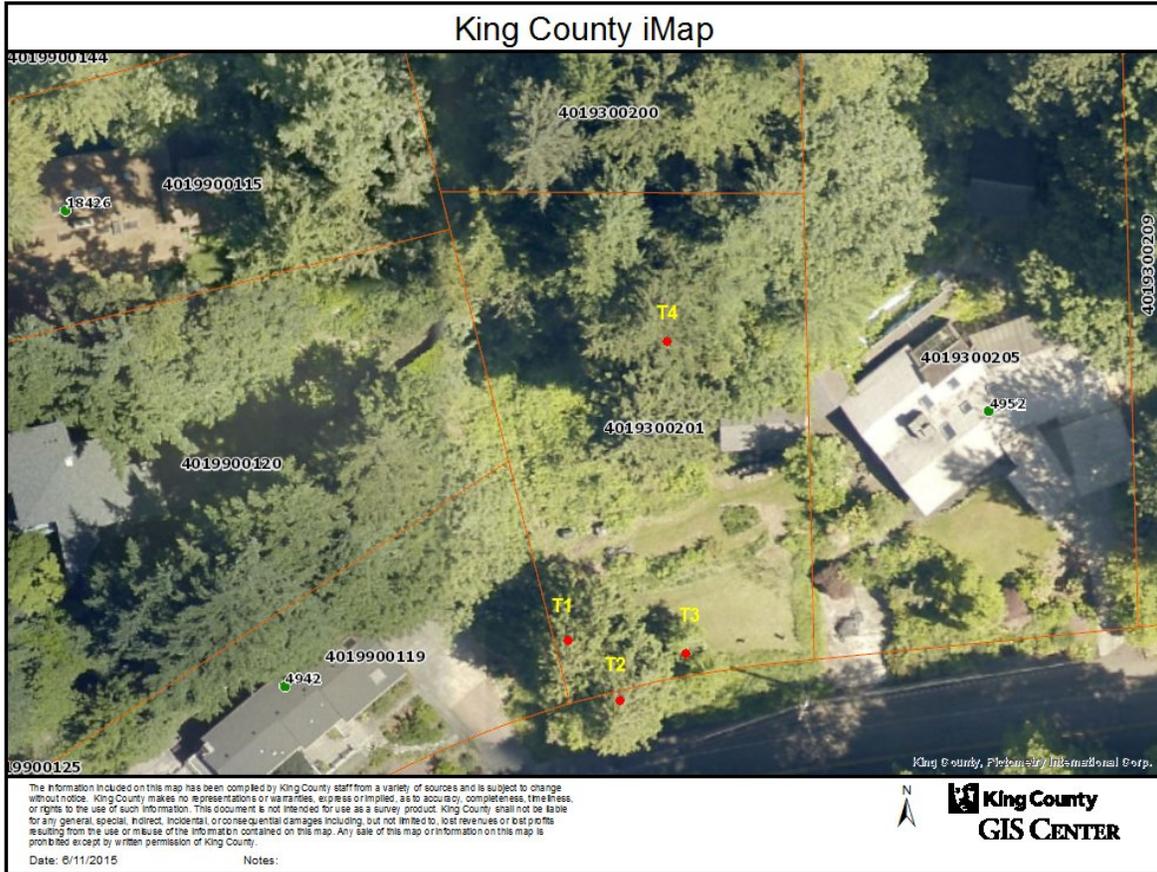
**ATTACHMENT: 2013 AERIAL SITE PHOTO**  
**4950 NE 184th St.**  
**Lake Forest Park, WA**

Locations of inventoried trees.

<u>Trees proposed for removal:</u>	<u>Trees to retain:</u>
T1	T2
T3	T4
