Michael A. Woodbury
Consulting Arborist
206-659-4288
pnrc@comcast.net

Re: Arborist Review Tree Permit #2016-ARP-0003_Baptie, Review and Recommendations
Site: Wellington Hills Construction property, 3580 NE 162 St, Lake Forest Park, WA 98155

**APPENDIX A: 2013 Aerial Site Photo
3580 NE 162nd St
Lake Forest Park, WA**

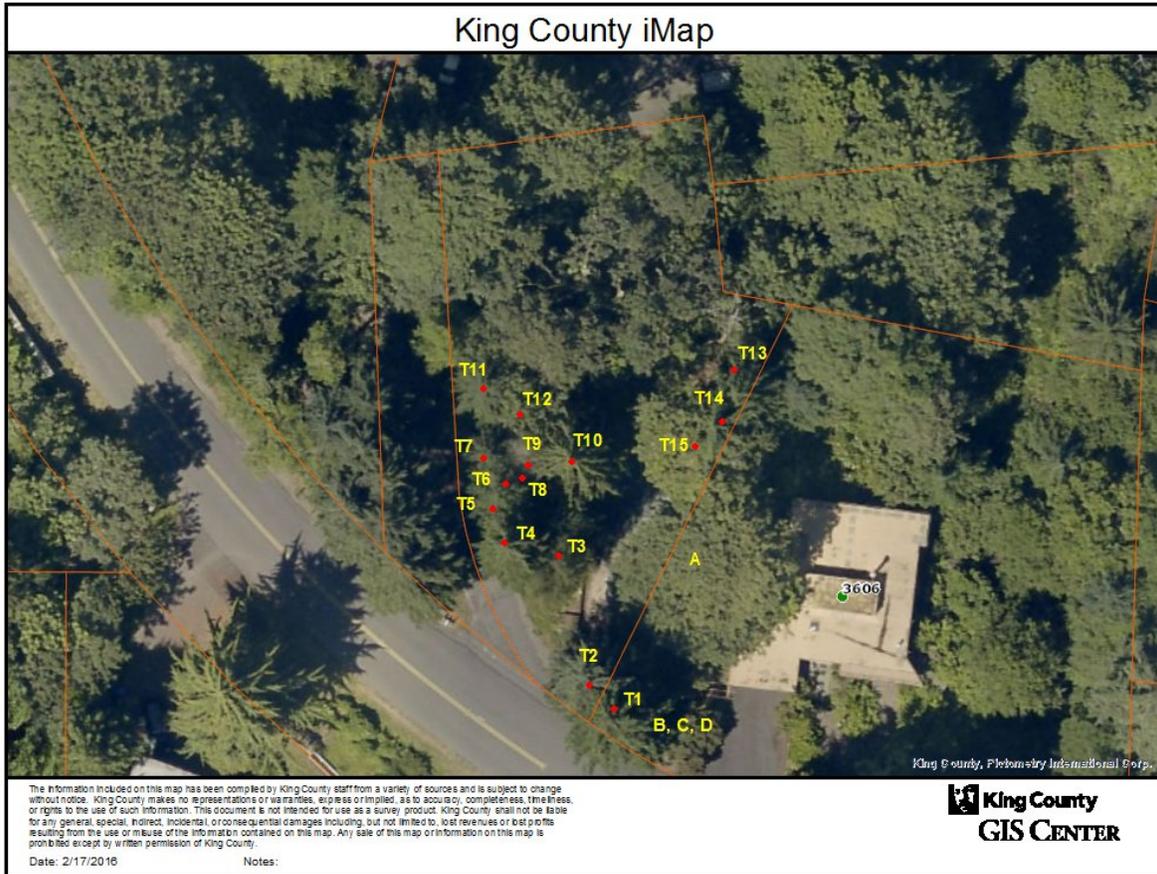
Locations of inventoried trees.

Trees proposed for removal:

- T3
- T5
- T8
- T9
- T10
- T11
- T12
- T15

Trees to retain:

- T1
- T2
- T4
- T6
- T7
- T13
- T14

Offsite Trees:

A, B, C & D
