Michael A. Woodbury
Consulting Arborist
206-659-4288
pnrc@comcast.net

July 19, 2016

Re: Arborist Review Tree Permit #2016-ARP-0012, Review and Recommendations
Site: Home Heroes 7, LLC property, 195XX 53rd Ave NE, Lake Forest Park, WA 98155.

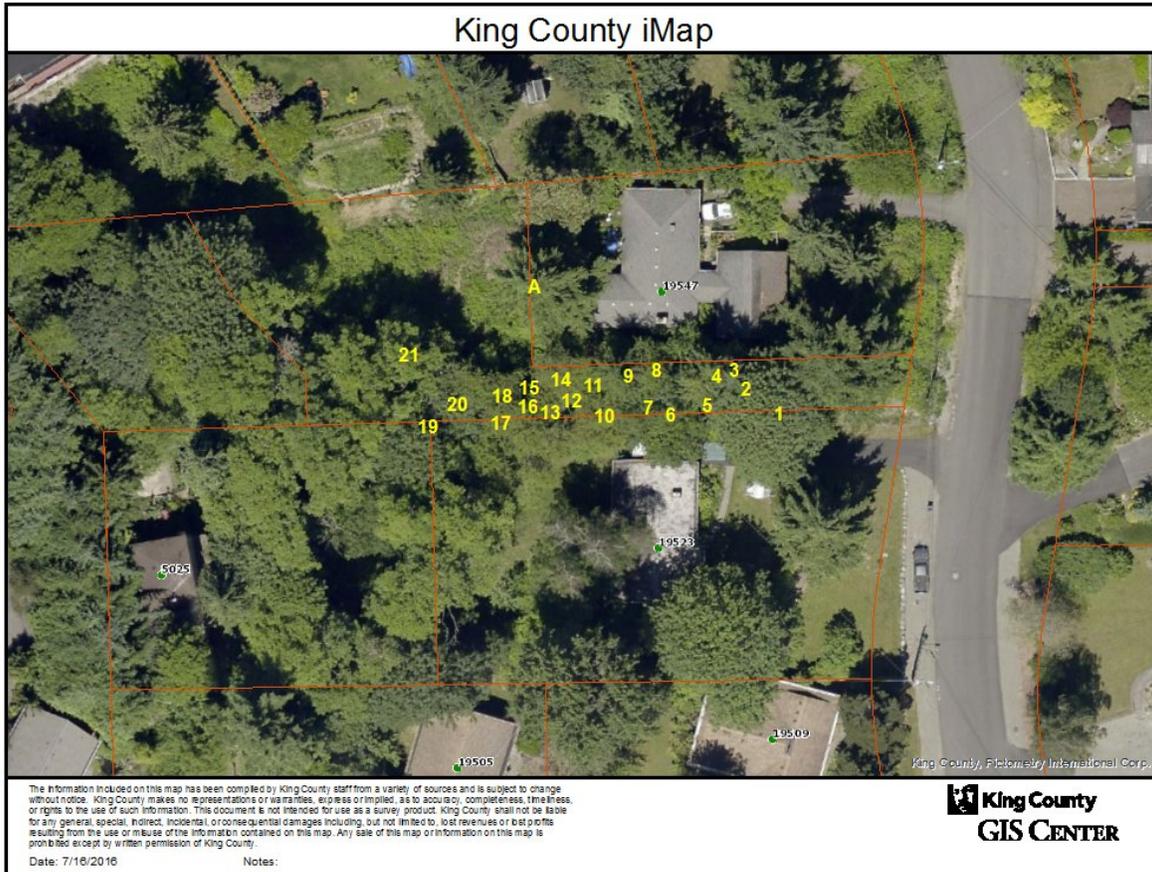
**Appendix A: 2013 AERIAL SITE PHOTO
195XX 53rd Ave NE
Lake Forest Park, WA**

- Trees numbered 17, 18, 19 and 20, and 21 to allow for the construction of the new driveway and house as planned.
- Trees 6 and 7, located north of the existing driveway, along the common property line, are both in poor condition and pose a moderate level of risk to the residence at 19523. Both trees should be removed to avoid near term risk.

Locations of inventoried trees.

Trees to Remove: 6,7, 17,18,19,20,and 21.

Trees to Retain: 1,2,3,4,5,8,9,10,11,12,13,14,15, and 16.
