INSPECTOR'S DAILY REPORT

City of Lake Forest Park - Staunton Cove Short Plat

Subject: Storm Drainage Construction

Location: 40th Place NE, south of the NE 186th Street intersection

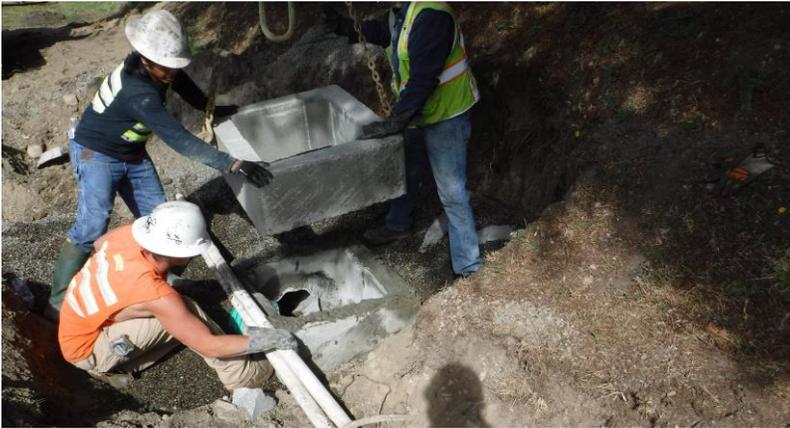
- The base of CB-6 was already in place where the existing storm line was cut. CB-6 is a type-1 structure, as shown on the approved plans.
- Materials on site were observed.
- Foreman reported the following:
 - o The point of connection to the existing storm line has moved approximately 8 feet south due to existing corporation stops located at the approved point of connection. They anticipate to have 0.28' tolerance to provide the slopes depicted on plans.
 - o CB-4 will need to move 2' east of the approved location on plans to avoid the located existing gas line.
 - o CB-8 will need to move 2' west of the approved location on plans to avoid the located existing sewer main line.

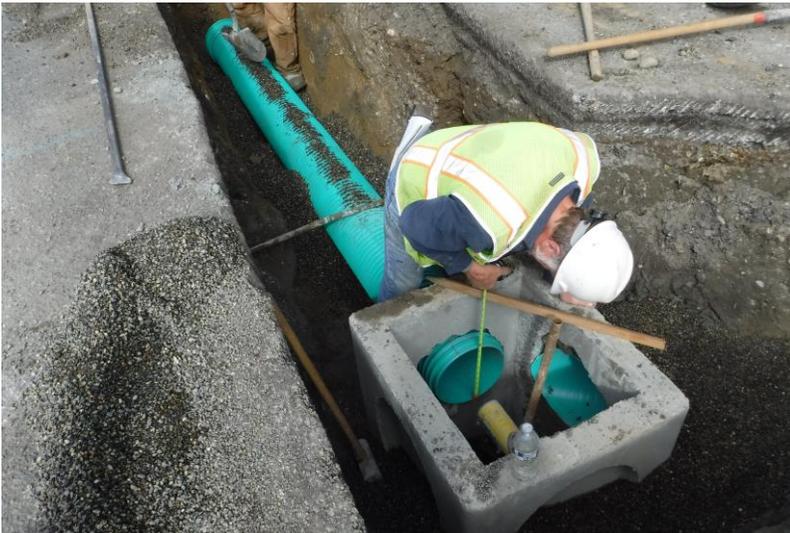
1 PM - CB-5 base structure was placed. CB-5 is a type-1 structure, as shown on the approved plans.
- Bill Smith (contractor, superintendent) was on site, briefly.

1:10 PM - An existing copper water service line was in conflict. The contractor raised the existing service line slightly and shaved a few ribs off the top of the storm pipe that was to be connected to the north of the CB-5 structure. Bedding material was placed after pipe placement and grout work outside CB-5.

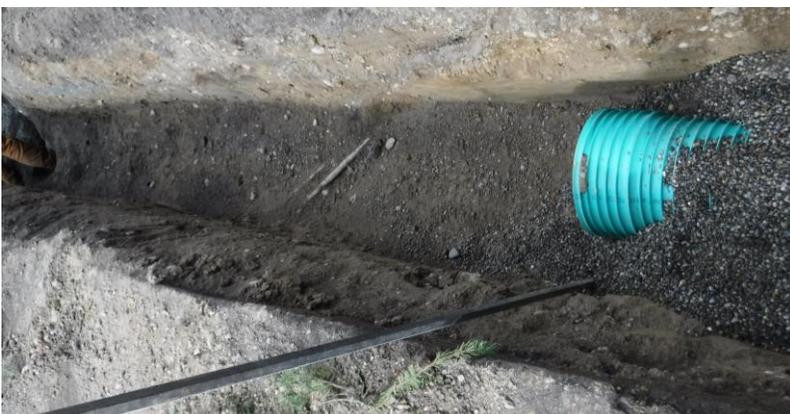
More exposed utilities
