INSPECTOR'S DAILY REPORT

City of Lake Forest Park - Staunton Cove Short Plat

| Daily Information | |
|---|--|
| Description of Work: | Construction of Temporary Erosion and Sedimentation Control (TESC) |

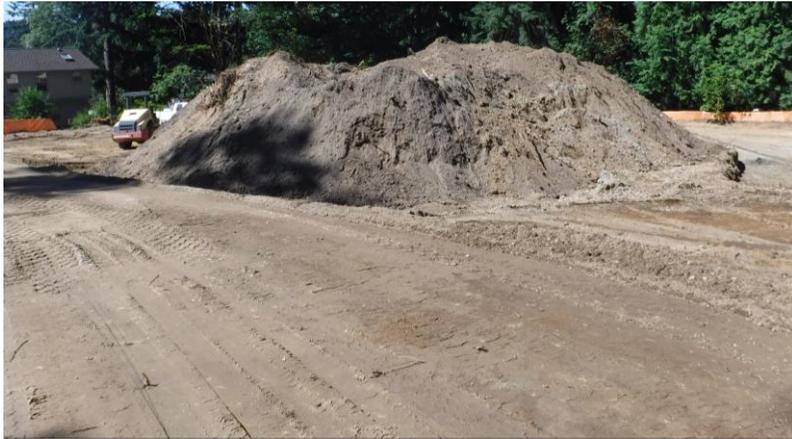
- (1) Unwanted stockpile material next to construction access route.
- (2) Construction ingress on the north end.
- (3) Approved construction ingress/egress on the south end. Rock was barely the minimum approved length of entrance. However, more rock arrived after taking this picture, as shown below.

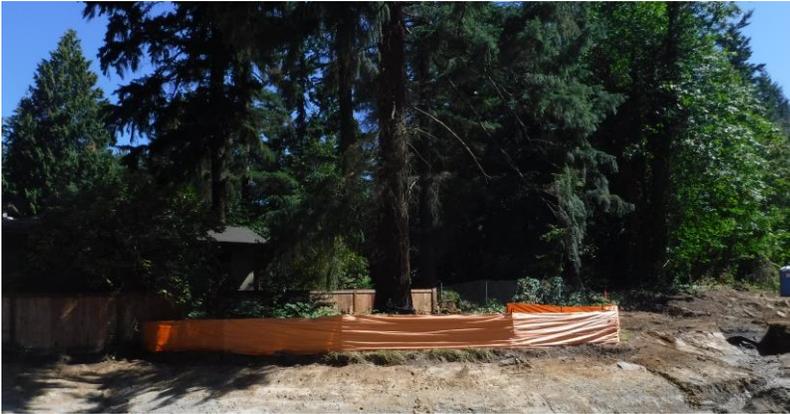
1. There were two wells found on site. The grading foreman reported that they are currently working with Department of Health in taking the steps to properly decommission these wells.
2. Only the 48-inch diameter tree along the northern border was saved where the approved plans had indicated, "Trees To Be Retained If Possible".

- (4) Only the 48-inch diameter tree on the north was saved where the approved plans had indicated, "Trees To Be Retained If Possible".
- (5) The two wells found on site.
