INSPECTOR'S DAILY REPORT

City of Lake Forest Park - Staunton Cove Short Plat

Subject: Temporary Sedimentation and Erosion Control

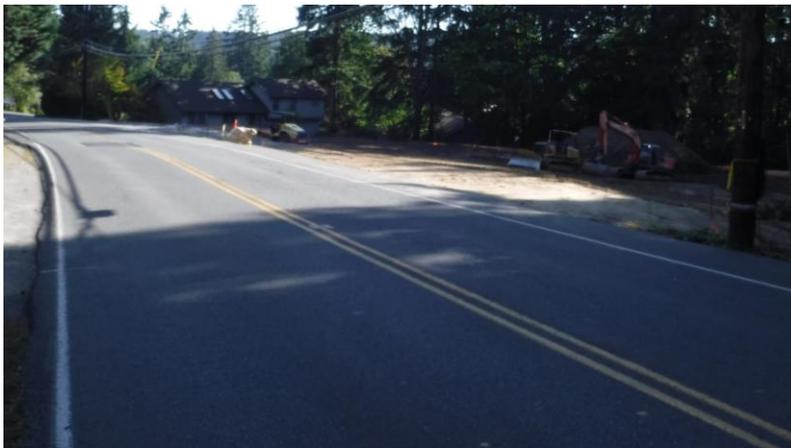
North end, looking south.

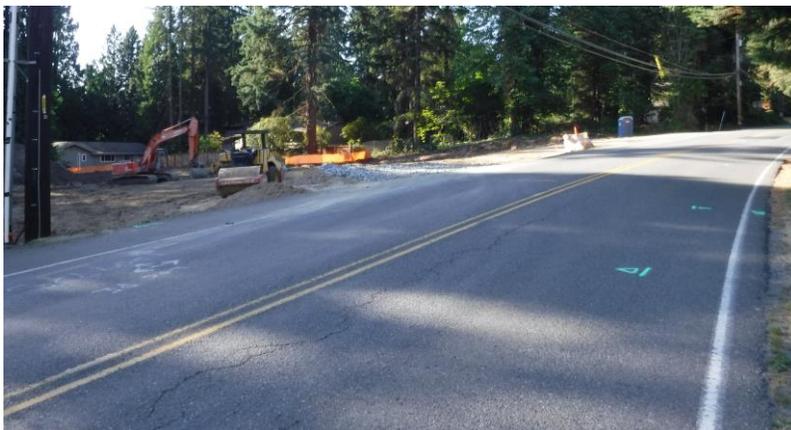
South end, looking north

Minimal dirt tracks
