INSPECTOR'S DAILY REPORT

City of Lake Forest Park - Staunton Cove Short Plat

Daily Information	
Inspector's Name:	Michael Maranan
Inspector's Shift Hours:	8 a.m. to 5 p.m. - Periodic
Weather:	a.m.: 79±°F, sunny p.m.:
Prime Contractor:	Universal Land Construction Company
Representative & Title:	Mike Johnson, Project Manager
Contractor's Work Activity	
Location of Work:	18623 40th Place NE
Description of Work:	Construction of Temporary Erosion and Sedimentation Control (TESC)

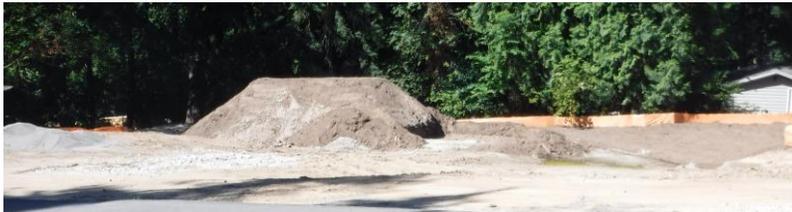
- (1) Stockpile material and exposed areas should have already been covered and/or stabilized at this time.
- (2) Silt fence section should be completed soon.
- (3) Buried and embedded quarry spalls in the north construction entrance. This is also happening in the southern entrance.

<p>7. Stabilization of exposed soils: <u>Exposed areas and stockpiles that have not been worked on for at least 7 days should be covered/stabilized.</u></p> <p>8. Dust control: OK.</p> <p>9. Source control: OK</p> <p>Inspector left at approximately 11:10 AM.</p> <p>Side note: the artesian well on site was observed as no longer flowing.</p>
--	--

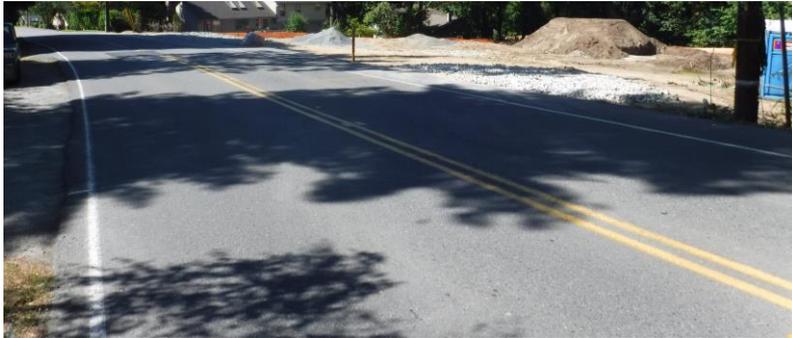
North end, looking south.

Comment:
Minimal dirt tracking.

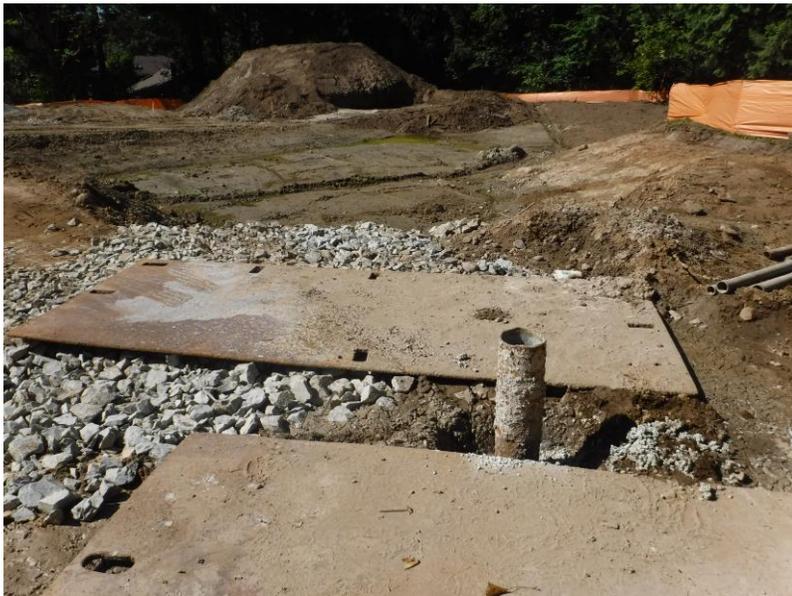
Comment:
Artesian well is no longer flowing, as the 6-inch riser is dry. The downstream properties appear to be drying up as well.
