# INSPECTOR'S DAILY REPORT

City of Lake Forest Park - Staunton Cove Short Plat

Daily Information	
Inspector's Name:	Michael Maranan <span style="float: right;">Date: 9/2/2016</span>
Inspector's Shift Hours:	8 a.m. to 5 p.m. - Periodic
Weather:	a.m.: p.m.: 65±°F, mostly cloudy
Prime Contractor:	Universal Land Construction Company
Representative & Title:	Mike Johnson, Project Manager
Contractor's Work Activity	
Location of Work:	18623 40th Place NE
Description of Work:	Construction of Temporary Erosion and Sedimentation Control (TESC)

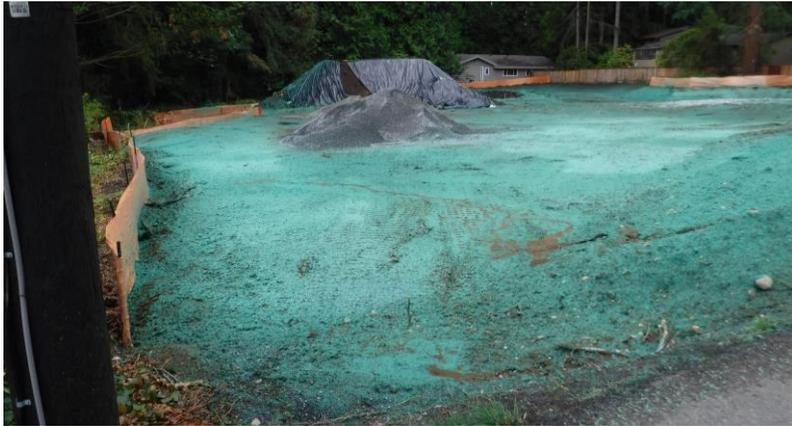
- (1) Stockpile material and exposed areas should have already been covered and/or stabilized at this time. Addressed by the contractor – some maintenance needed on the stockpile cover.
- (2) Silt fence section should be completed soon. Silt fence properly installed in front (north) of stump.
- (3) Construction entrance repair deferred due to no construction activity on site.

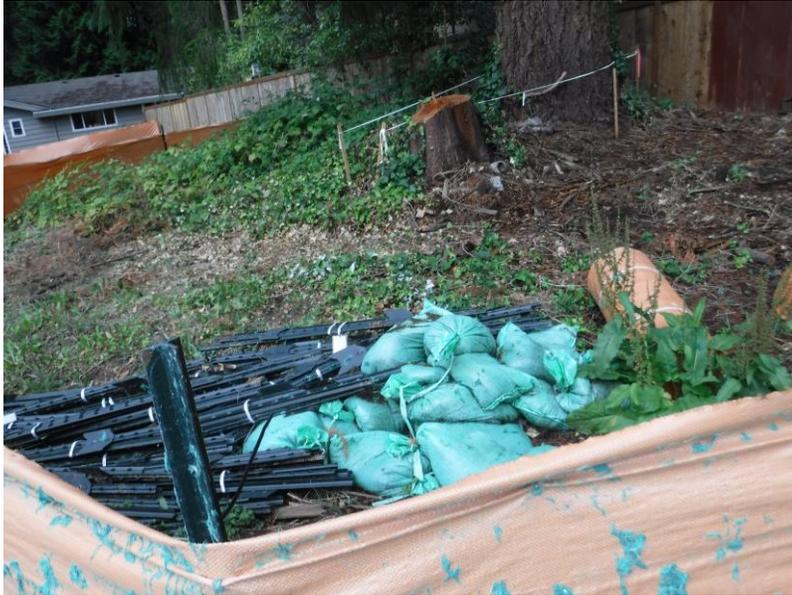
Subject: Others – Removal of Construction Materials within Tree Protection Areas On Site

Location: Northern tree protection area on site

Comment:  
Earlier emails between the city, contractor and developer regarding removal of equipment within the southern tree protection area was followed up on site. The equipment has been removed; however, some construction materials (rolls of filter fabric, steel stakes and sand bags) were found in the northern tree protection area.

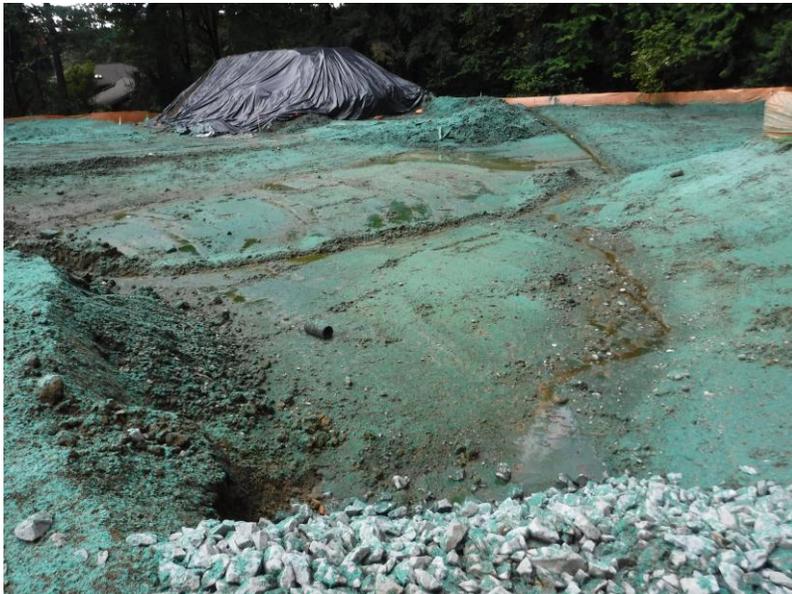
Subject: Others - Artesian Well

Location: Site

Comment:  
Although the 6-inch riser over the artesian well is dry, the downstream properties appear to have standing water. It might be due to the recent rain event.
