INSPECTOR'S DAILY REPORT

City of Lake Forest Park - Staunton Cove Short Plat

City of Lake Forest Park – Staunton Cove Short Plat

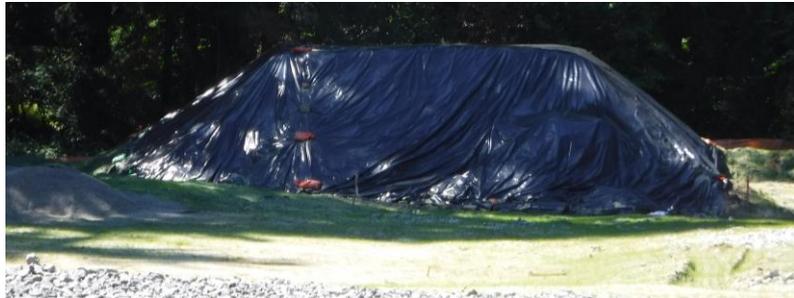
Subject: Temporary Sedimentation and Erosion Control

Location: On site

(1) ~~Stockpile material and exposed areas should have already been covered and/or stabilized at this time. Addressed by the contractor—some maintenance needed on the stockpile cover. Done~~

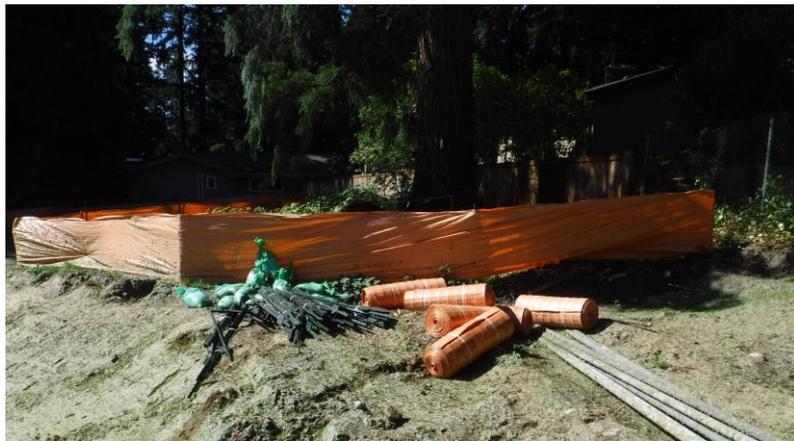
Subject: Others – Removal of Construction Materials within Tree Protection Areas On Site

Location: Northern tree protection area on site

Construction materials have been removed.

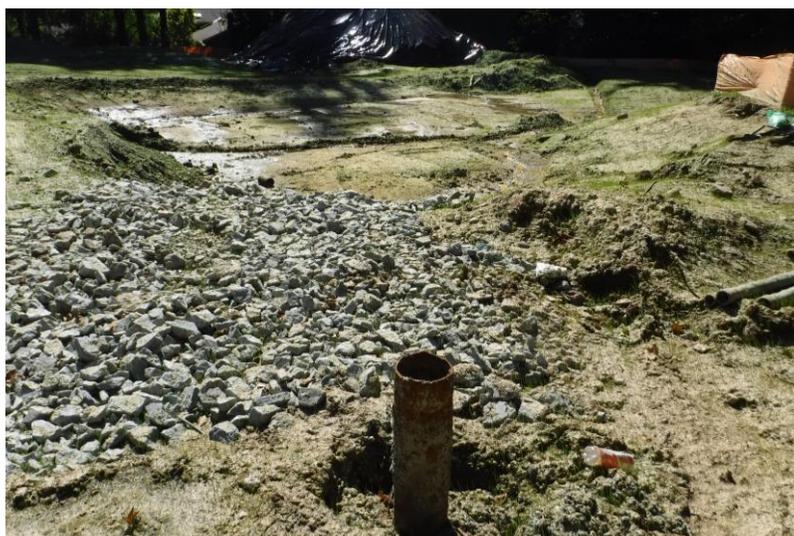
Subject: Others - Artesian Well

Location: Site

Although the 6-inch riser over the artesian well is dry, the downstream properties appear to have standing water.
