# INSPECTOR'S DAILY REPORT

City of Lake Forest Park - Staunton Cove Short Plat

Subject: Storm Drainage Construction

Location: 40<sup>th</sup> Place NE, north of the NE 186<sup>th</sup> Street intersection

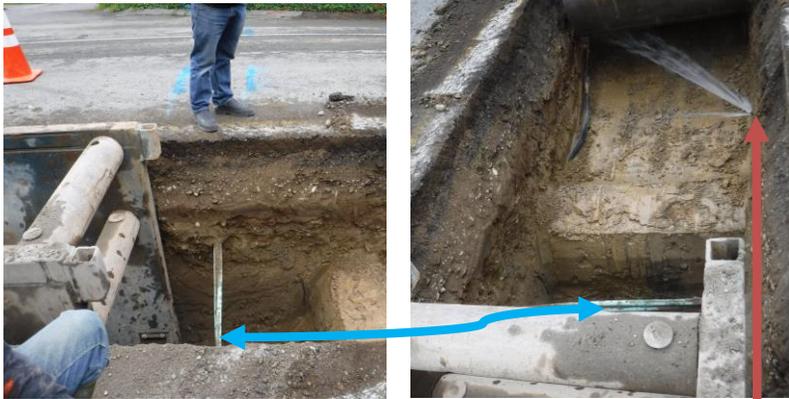
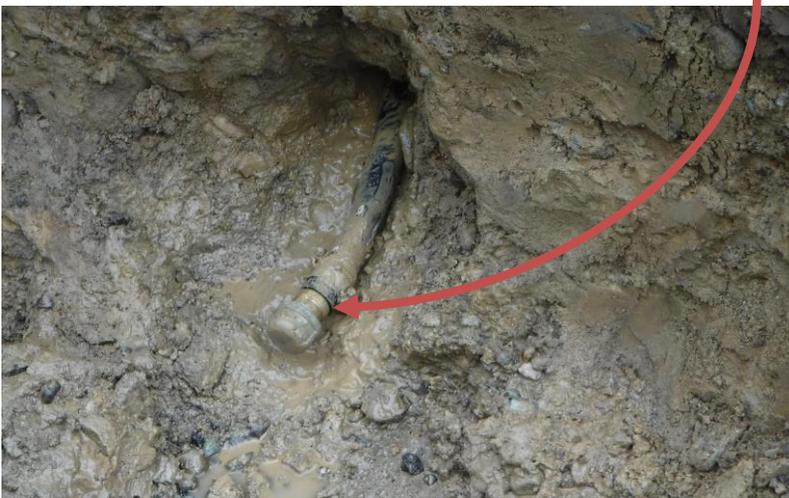
- 10:40 AM - Only one stick of storm pipe had been installed. The trench safety box was used for this construction.
- An existing water service line made of high-density polyethylene pipe was pulled by the excavator. The foreman immediately contacted the general manager for Lake Forest Park Water District. Three water district personnel showed up 10 minutes later, including the general manager. The general manager determined that the pulled pipe was abandoned, and with the source of inflow not known, the service line should be capped.

- 11:10 AM - The existing water service line was capped. The water district staff left the site shortly afterwards.
- 12:00 PM - The second stick was finally placed; backfill and compaction behind the trench safety box commenced.

- (1) The two existing water service lines were already located and exposed when the crew pulled an abandoned service line a few feet farther north. The general manager for the Lake Forest Park Water District was on site to assist in properly capping the abandoned line.
- (2) Steel plates were included in today's temporary patching over the installed storm drainage line.

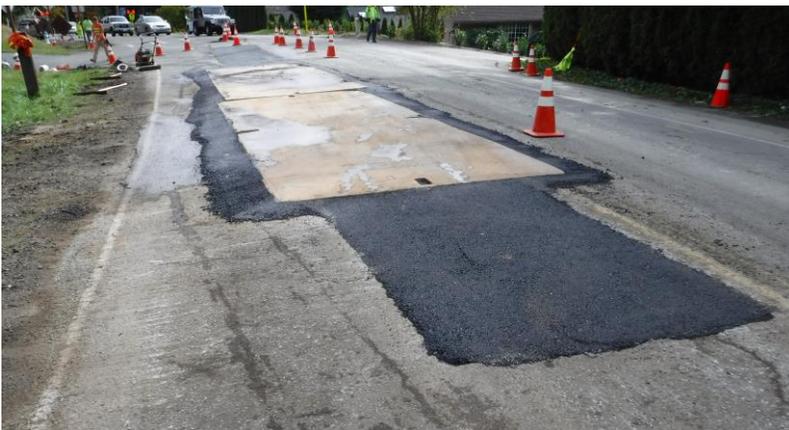
- 1:00 PM - Two more sticks of pipe were placed and bedded. The geotech arrived at this time.
- Sweeper truck arrived and cleaned the street.
- 1:40 PM - Foreman proposed to temporarily cover the street excavation with steel plates. Inspector coordinated with PACE's acceptance and conditions of having the plates over the weekend.

- 4:00 PM - Temporary steel plate placement and asphalt patch work were done. Although the workers did their best to get the (2) steel plates flush to the existing pavement and provided the surrounding area with temporary asphalt for support and transition, the temporary setup still made a little bit of noise, which was a concern.
