# INSPECTOR'S DAILY REPORT

City of Lake Forest Park - Staunton Cove Short Plat

Subject: Storm Drainage Construction

Location: 40<sup>th</sup> Place NE, north of the NE 186<sup>th</sup> Street intersection

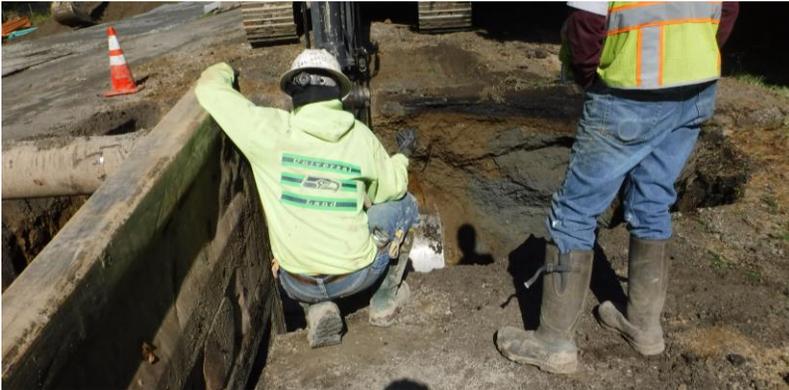
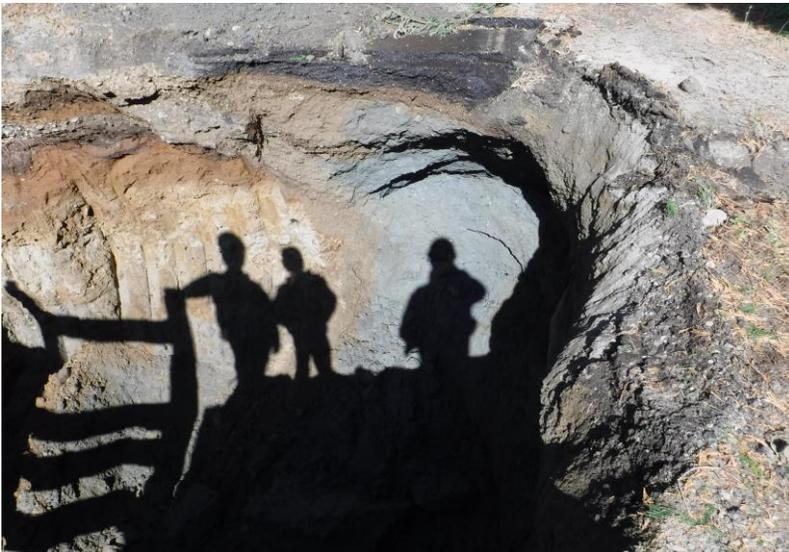
12:30 PM - East wall observed sloughing off of the CB-8 excavation.

2:00 PM - The base structure for CB-8 was finally placed - continued slough-off was the problem. The slough-off extended past the pavement and up to the top of roadside ditch. The existing water main nearby was exposed because of this.

- (1) The sloughed-off wall east of the CB-8 excavation extended past the pavement.
- (2) Besides the pick holes and around the connecting pipe ends, grout was applied over the cracked midsection of CB-8.

5:00 PM - Backfill was typically crushed rock over the existing pavement. For the roadside where the slough-off occurred, a mixture of pea gravel and crushed rock was applied, which is acceptable.

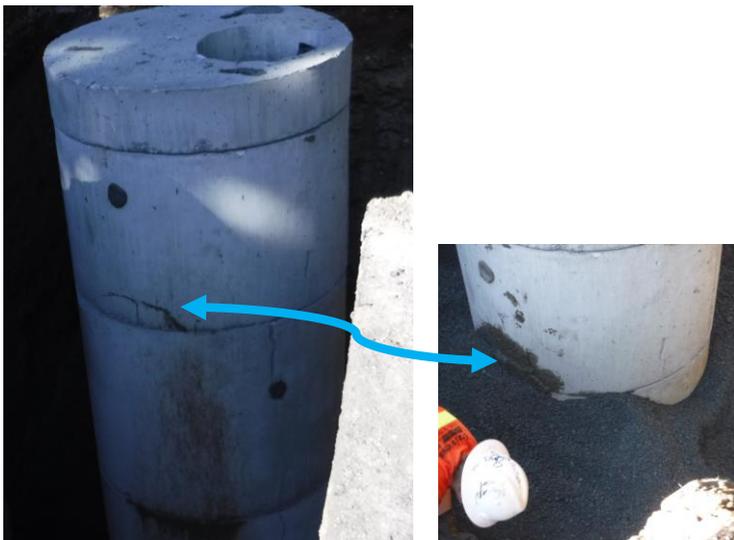
(2)

- The top midsection of the structure had an exterior crack located on the bottom south surface - grout was applied.

- Grading rings were not grouted over the top of structure. Grout work shall be done on the inside wall.
