Michael A. Woodbury
Consulting Arborist
206-659-4288
pnrc@comcast.net

Re: Arborist Review Tree Permit #2016-ARP-0009, Review and Recommendations
Site: Scofield property, parcel 401930-1319, Lake Forest Park, WA 98155.

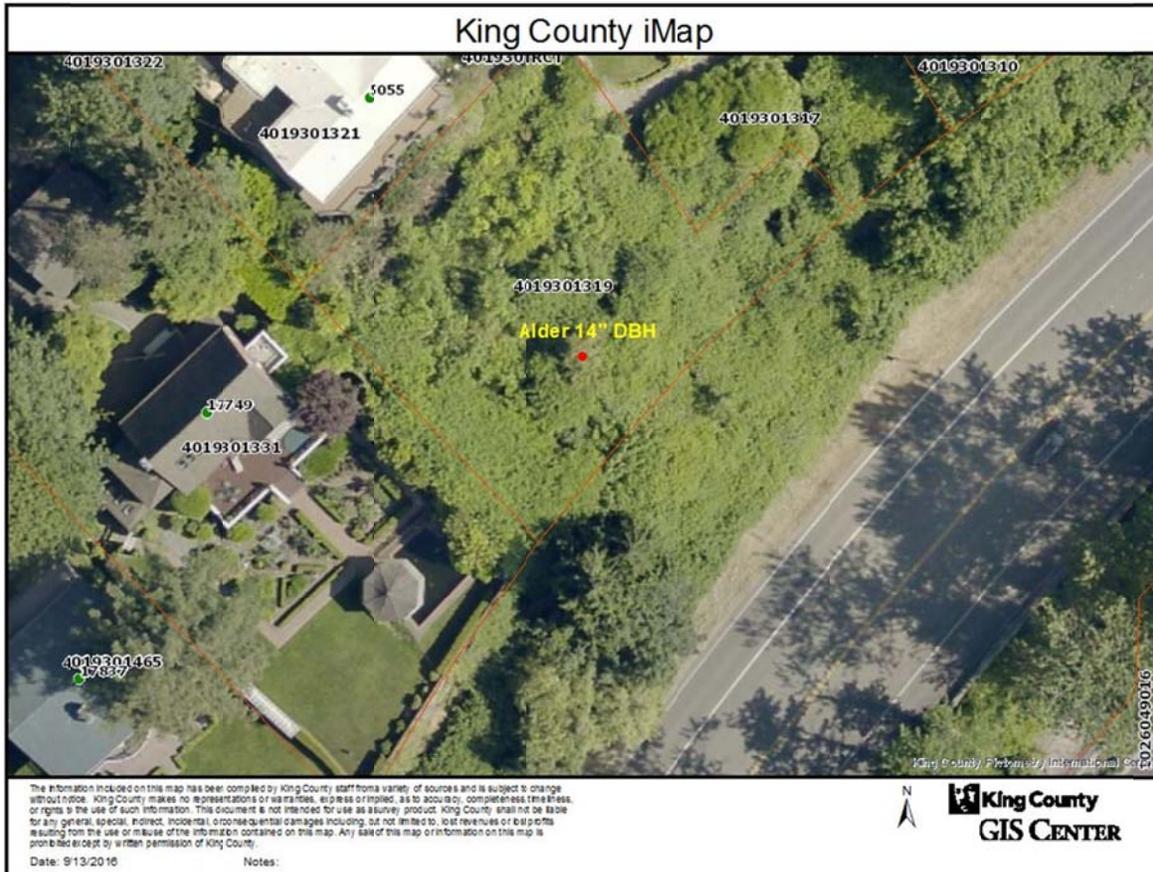
Appendix: 2013 AERIAL SITE PHOTO
Parcel 401930-1319
Lake Forest Park, WA

This is an undeveloped single-family residential lot, 12,026 square feet in size, on sloped terrain. The tree canopy coverage goal for this size lot, pursuant to Chapters 16.14.080, is 39% (4,690 sq. ft.). The current canopy coverage is approximately 4% (450 sq. ft.), as determined either by collected tree data and/or interpretation of high resolution aerial photography, see Appendix: *2013 Aerial Site Photo*.

Location of the proposed tree removal.
