INSPECTOR'S DAILY REPORT

City of Lake Forest Park - Staunton Cove Short Plat

Subject: Storm Drainage Construction

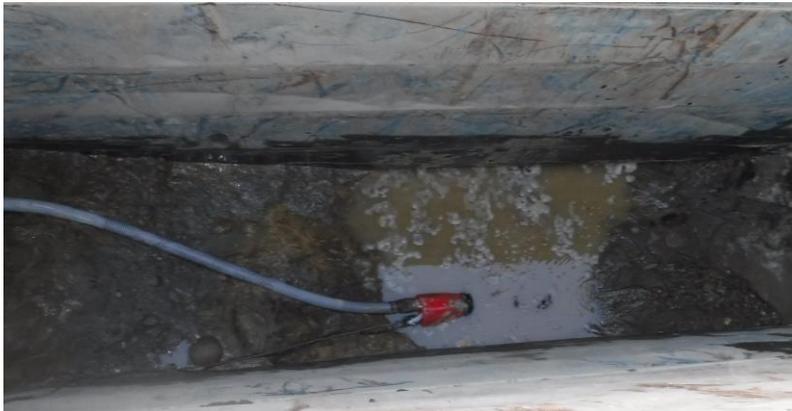
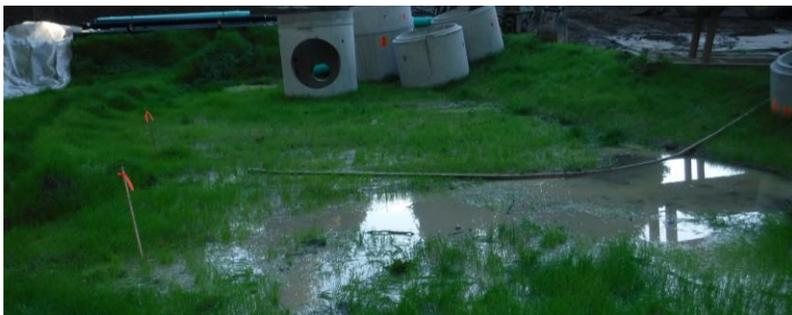
- (1) Water in the trench was too turbid to be pumped into the already installed storm line. The temporary pond was used to contain the trench water.
- (2) From left: A temporary 12-inch PVC riser was installed for future dewatering purposes; small crack outside the CB-3 section (red arrow), and; base of CB-2A placed as close to CB-3 as possible (inside the trench safety box).

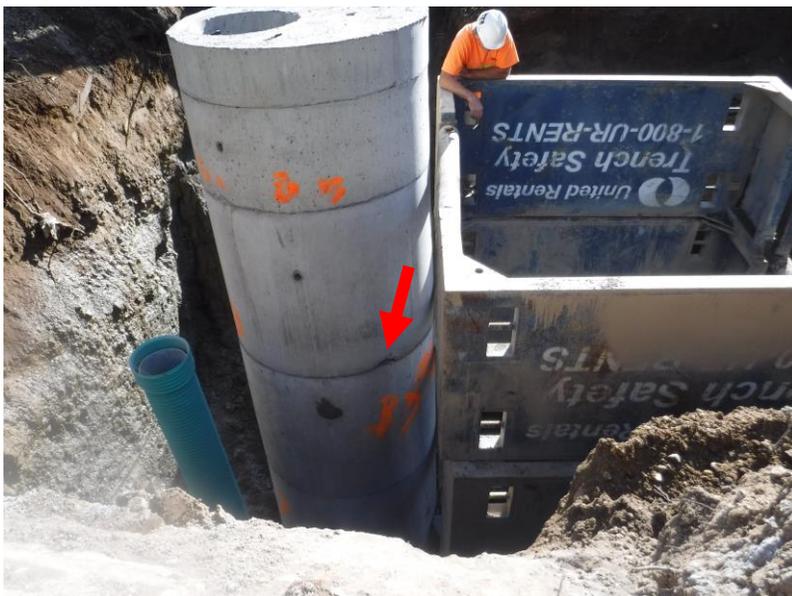
(2)

- A temporary 12-inch riser was placed a few feet northeast of CB-3 for future trench dewatering demands.
 - A crack/spall was located at the northwest bottom of the uppermost 4-foot midsection. **10/13/16 update: cracked area and pickholes were grouted.**

- Contractor proposed placing CB-2A closer to CB-3 to avoid additional placement and connection of an approximately less than 0.5 feet length of PVC spool between the two structures. CB-2A is a 48-inch diameter type-2 StormFilter structure, as depicted on the approved plans. It already has a built-in stub provided for by the manufacturer. The pipe crew will only need to cut the "funneled section" as appropriate to provide the required 12-inch diameter outlet. Inspector coordinated with PACE and the developer's engineer, LDC (Mark Vilwock, P.E.), if this was acceptable. **10/13/16 update: Both PACE and LDC accepted the proposed field modification with no exceptions taken.**
