INSPECTOR'S DAILY REPORT

City of Lake Forest Park - Staunton Cove Short Plat

Subject: Storm Drainage Construction

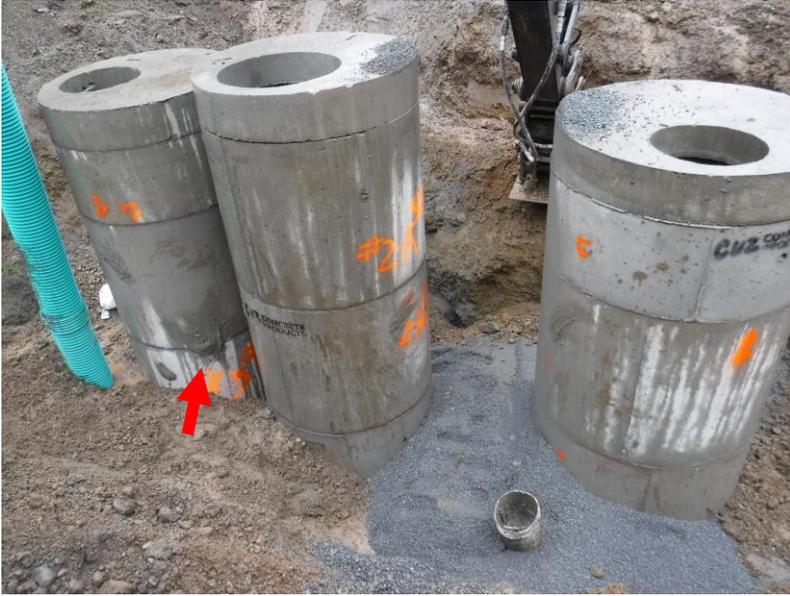
10:50 AM - The crack/spall located at the northwest bottom of the uppermost 4-foot midsection, as noted in yesterday's report, had been grouted.

- (1) From left to right: 12-inch PVC riser for dewatering; CB-3; CB-2A, and CB-2. Most, if not all, holes were grouted from the inside. The exterior crack on CB-3 noted yesterday (red arrow) was grouted.
- (2) The structures were then backfilled with native material. In preparation for the weekend storm, the exposed areas will be covered in either mulch or plastic held down by sandbags.
