**Michael A. Woodbury
Consulting Arborist**

Re: Arborist Review Tree Permit #2016-ARP-0047, Review and Recommendations
Site: Kuppens property 17804 28th Ave NE, Lake Forest Park, WA 98155

APPENDIX A: 2015 AERIAL SITE PHOTO
17804 28th Ave NE
Lake Forest Park, WA

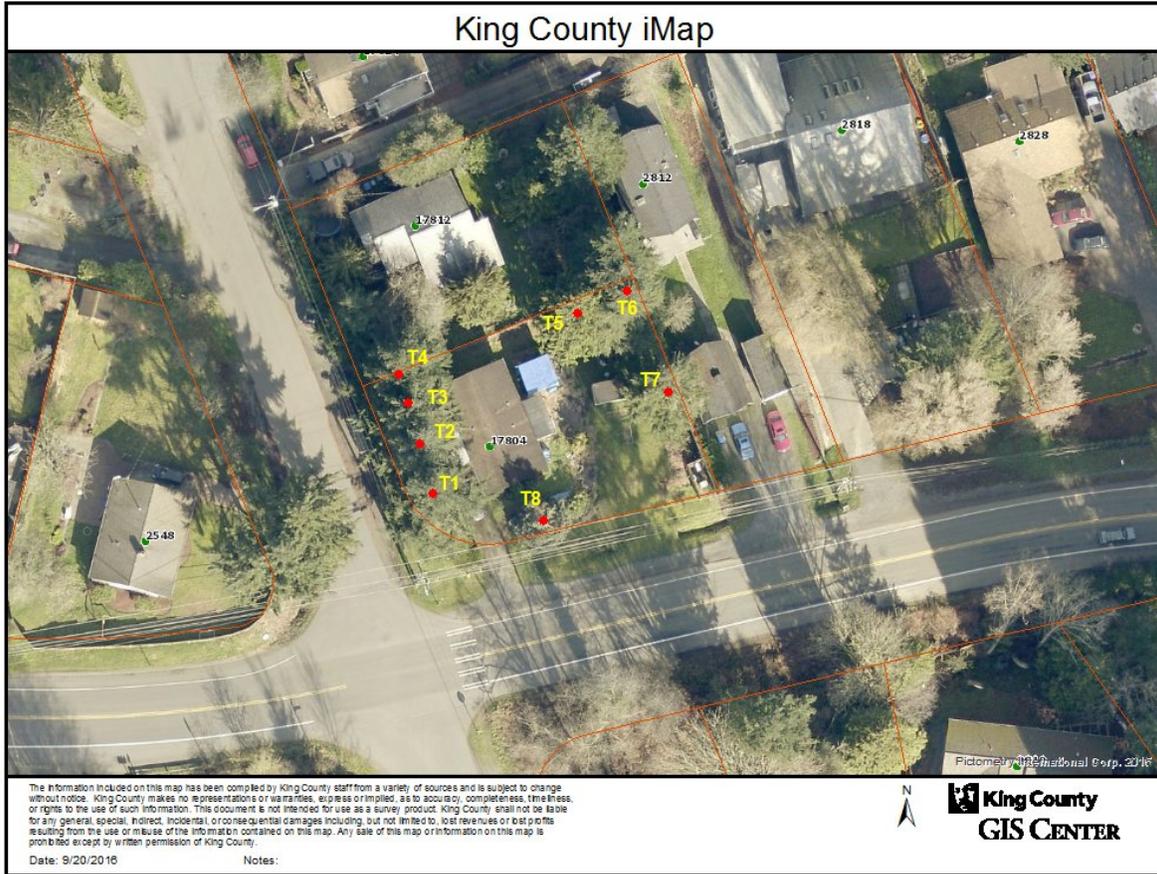
Tree 4 and Tree 5 are proposed to remove to allow for the construction of the new driveway. Removal of the 2 trees will reduce the total tree canopy coverage by approximately 1,712 sq. ft. (19%)

There are six trees that have potential to be retained, Trees 1, 2, 3, 6, 7 and 8. They are generally in good overall health and condition and would pose low risk to the new residence. They are suitable to tolerate the proposed construction activities, provided the recommended tree protection measures are followed, see Appendix B: *Tree Protection Measures*. The retained canopy coverage will be approximately 1,888 sq. ft. (21%).

Locations of the inventoried trees.

Trees proposed for removal: Trees to retain:

T4
T5

T1
T2
T3
T6
T7
T8
