Title: **2016-ARP-0046 DeLap (Mason) Tree Report**
194XX 46th Ave NE, Lake Forest Park, WA
Site Plan Review and Level 2 Basic Tree Assessment

Prepared for: Scott DeLap Construction

Prepared by: Urban Forestry Services, Inc.
Christina Pfeiffer
ISA Certified Arborist® #PN-0124A
ISA Tree Risk Assessment Qualified

Date: October 24, 2016

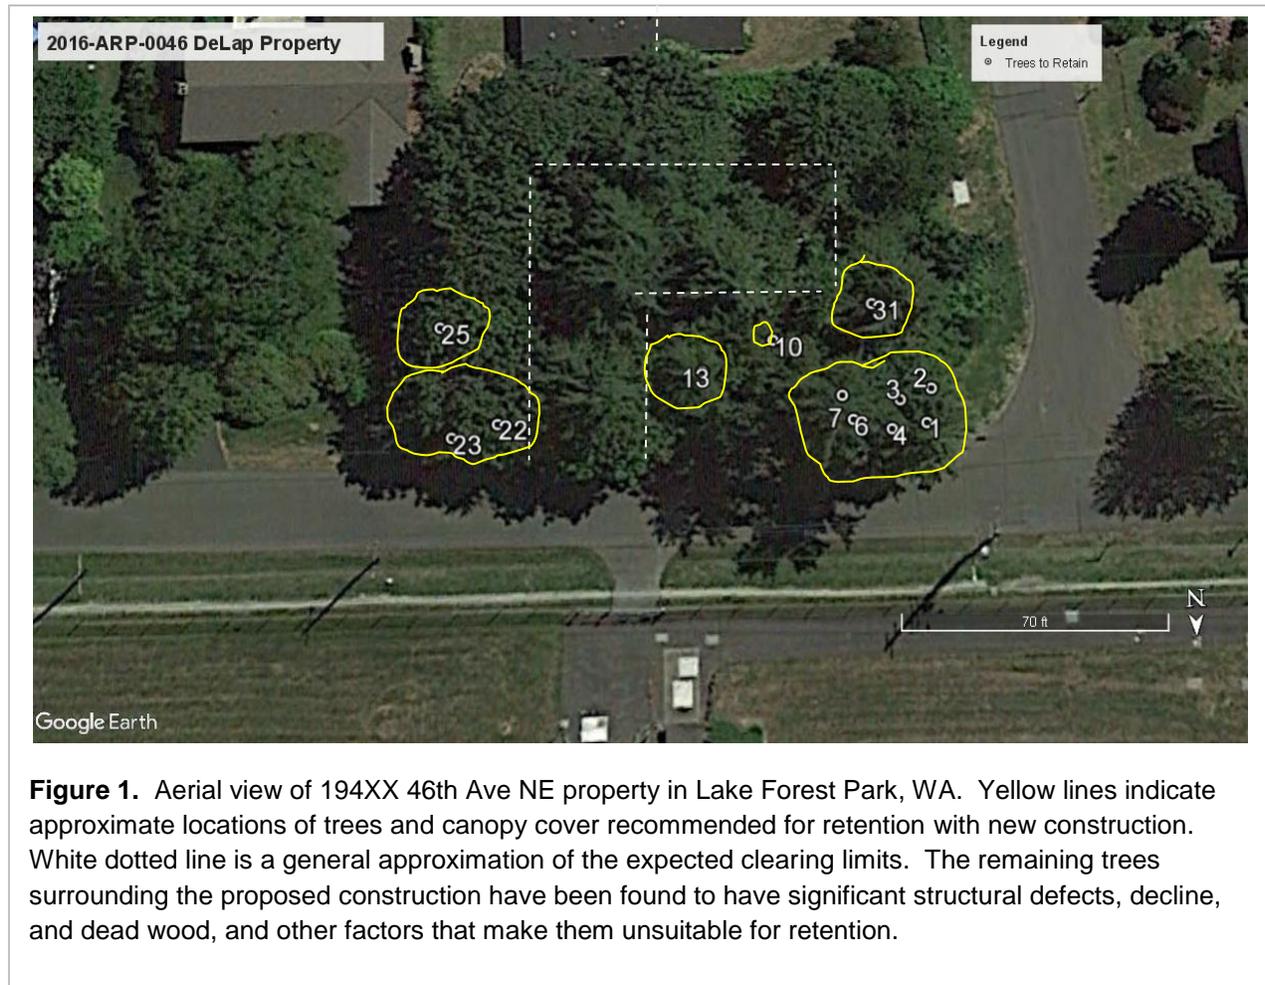
Eleven trees have been marked for retention, with an estimated canopy cover of 5,726 square feet. This area included trees within and overhanging the right-of-way to the north, and the northeast corner of the property. See Figure 1 and the attached Tree Site Plan.

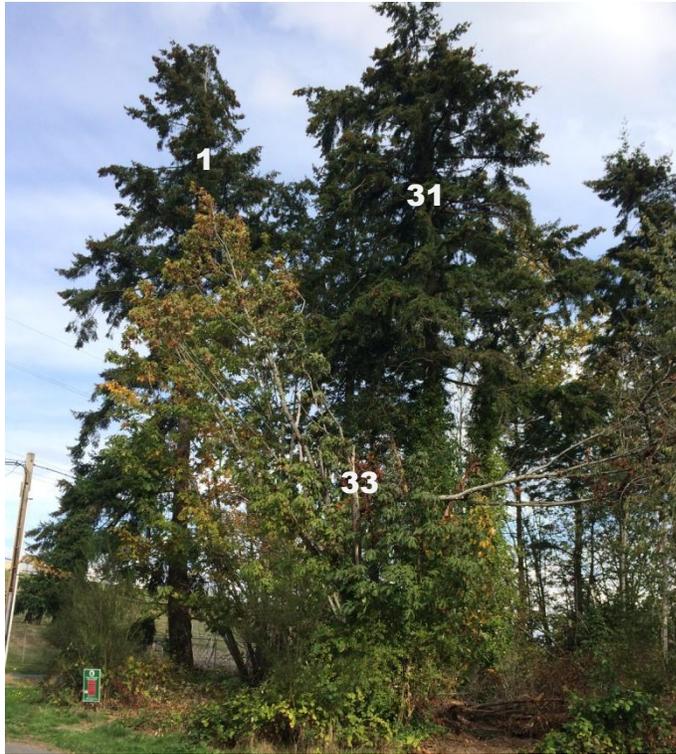
Photo 1. View of the northwest corner of the site, looking north. Douglas fir tree #1 is a Landmark tree located in the ROW. Though it is located near the clearing limits, tree #31 has good potential for retention with appropriate provisions for root protection and construction methods near the CRZ. Bigleaf maple #33 is in advance decline, and breaking apart.

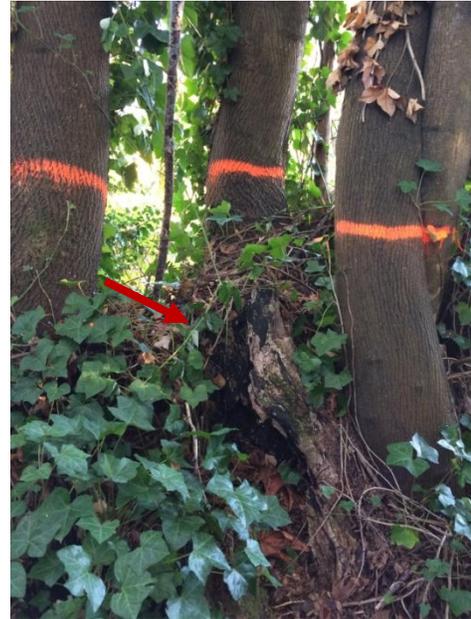
Photo 2. Big leaf maple #48. The multiple trunks have grown from an old stump with advancing decay (arrow). With this poor basal structure, this specimen should be removed.

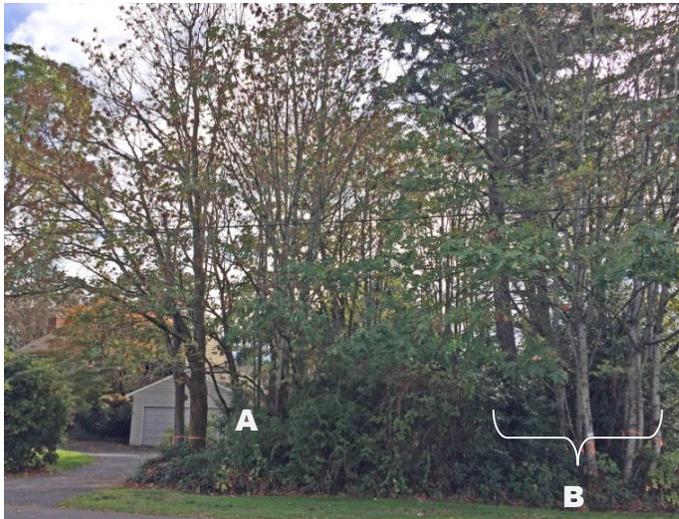
Photo 3. View of the northeast corner of the site, looking south. Two maples can be retained (A). Clump of trees to be removed for driveway construction (B).
