Urban Forestry Services, Inc.

Title: Permit Number 2016-ARP-0040, Nor Wes Property
Site Plan Review, Lake Forest Park, WA

Date: October 26, 2016

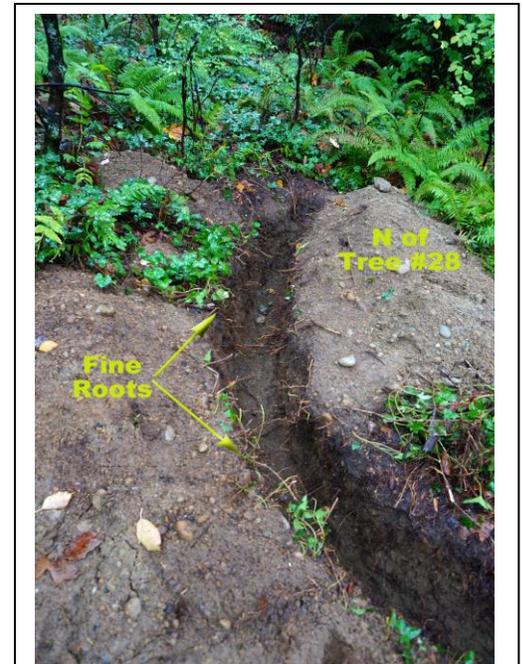
1. I observed no signs that significant root damage or exposure occurred during this work. Specifically:
 - Excavation exposed fine roots north of the tree in the trench 10-feet from the trunk. (Photo-2).
 - Excavation exposed three significant roots from 2-inch to 3-inch diameter in three locations west of the tree in the trench 7.5-feet from the trunk. (Photo-3, Photo-4).
 - Tree #25, the big leaf maple (*Acer macrophyllum*) appears to have structural roots traveling upslope under the driveway location.
 - The proposed relocation of the driveway would significantly impact tree #25, the big leaf maple.

Photo 2. Tree #28 with fine roots north of trunk.

3. Soil or other material above grade and within tree protection fencing should be removed.
4. Due to the presence of fine roots north of the tree #28 trunk, a new driveway shall be installed no closer than 10-foot north of the trunk.

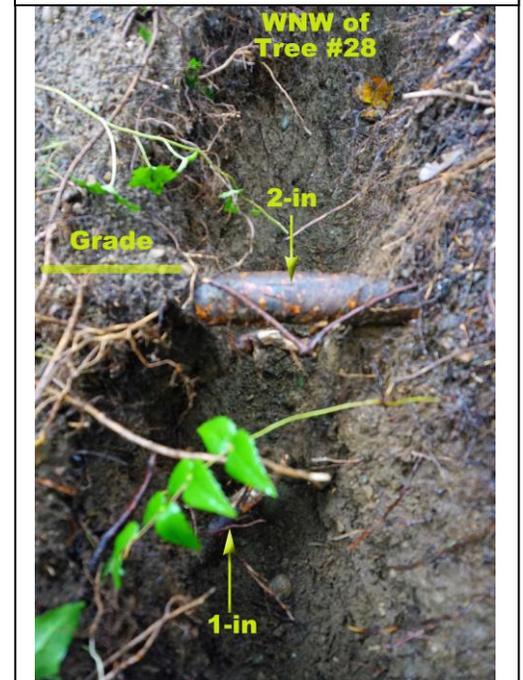
Photo 3. Tree #28 with exposed root WNW of tree.

- Cut the 2-inch diameter root just below grade and WNW of the tree (Photo-3). The root should be cut with a hand or reciprocating saw.
 - Level soil surface.
