# INSPECTOR'S DAILY REPORT

City of Lake Forest Park - Staunton Cove Short Plat

Daily Information	
Inspector's Name:	Michael Maranan <span style="float: right;">Date: 11/1/2016</span>
Inspector's Shift Hours:	8 a.m. to 5 p.m. - Periodic
Weather:	a.m.: 51±°F, rain p.m.:
Prime Contractor:	Universal Land Construction Company
Representative & Title:	Mike Johnson, Project Manager
Contractor's Work Activity	
Location of Work:	Site (18623 40th Place NE)
Description of Work:	Construction of On-Site Storm Drainage Detention System

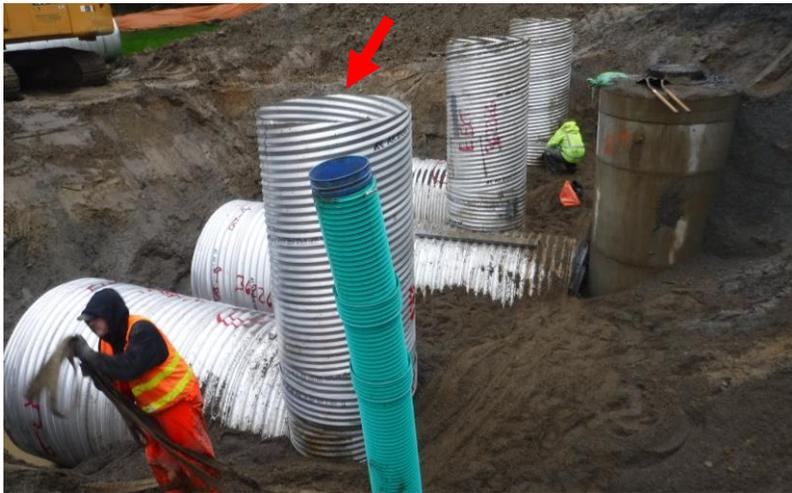
Subject: Storm Detention System

Extensions to the built-in access risers were installed at the east end of the detention system. Initial observation indicates the extension could be higher than the anticipated road grade, and so might need to be cut in the future.
