# INSPECTOR'S DAILY REPORT

City of Lake Forest Park - Staunton Cove Short Plat

Subject: Storm Detention System

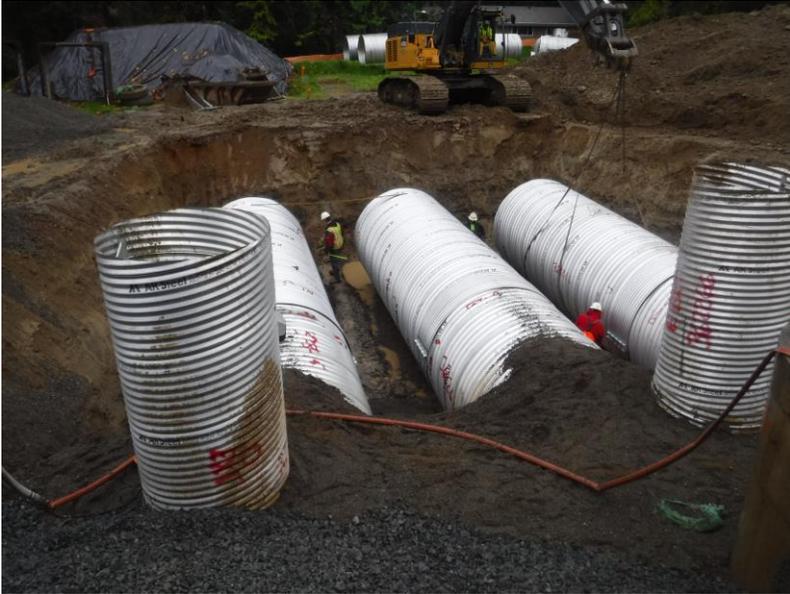
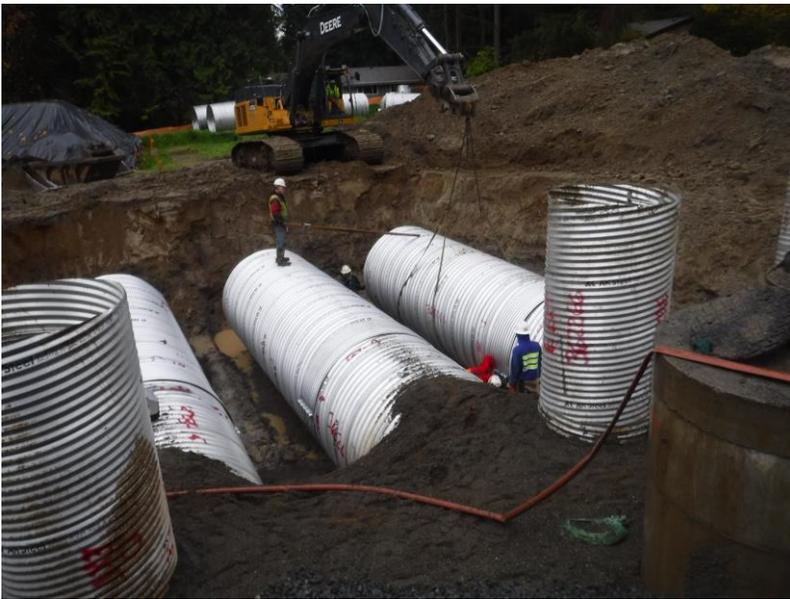
(1) Three 20-footlong sections were installed today for the construction of the storm drainage detention system.
