# INSPECTOR'S DAILY REPORT

City of Lake Forest Park - Staunton Cove Short Plat

Daily Information	
Inspector's Name:	Michael Maranan <span style="float: right;">Date: 11/7/2016</span>
Inspector's Shift Hours:	8 a.m. to 5 p.m. - Periodic
Weather:	a.m.: 58±°F, overcast p.m.: 65±°F, mostly cloudy
Prime Contractor:	Universal Land Construction Company
Representative & Title:	Mike Johnson, Project Manager
Contractor's Work Activity	
Location of Work:	Site (18623 40th Place NE)
Description of Work:	Construction of On-Site Storm Drainage Detention System

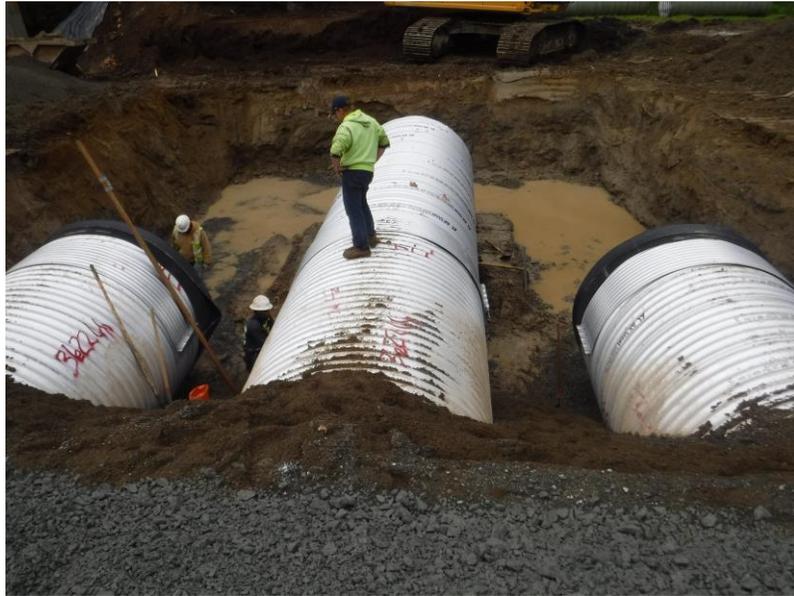
- (1) Three 20-footlong sections were installed side-by-side last Friday for the construction of the storm drainage detention system. Another 20-footlong section was added today prior to installing the end sections.
- (2) The pipe clearance between rows were carefully observed – however, the built-in 3-foot diameter stubs in for the middle west end section were shorter than the ones in the middle east end section. The gap was observed to be somewhere between 8 inches to a little over a foot. Final adjustments will be made tomorrow.

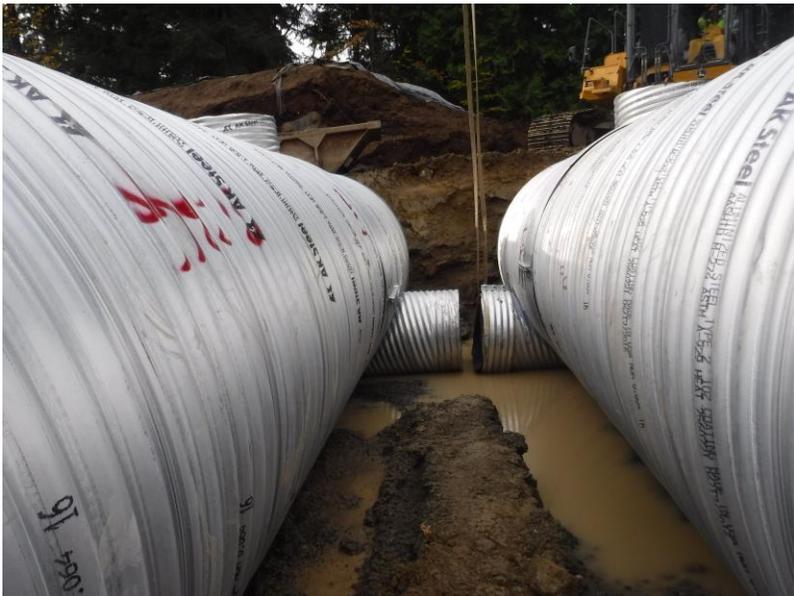
(2)

- Water being pumped from the well casing appears clear.
- 12:40 PM - The middle end section was in place.
- 1:10 PM - The southern end section was in place. It was observed that built-in 36-inch stubouts to connect the middle end section to the outer rows was shorter. Foreman later called the supplier to provide spool(s) and additional banding materials to complete the connection. These additional items were planned to be delivered and installed first thing tomorrow morning.

- 1:50 PM - The northern end section was in place.
- 2:00 PM - Sweeper truck was seen cleaning the street frontage.
- All the endpipes were slightly adjusted so that the stubouts align better (both horizontally and vertically) in preparation for tomorrow's final connection.
