TECHNICAL INFORMATION REPORT

Lakeview 34
3803 NE 155th Street
Lake Forest Park, WA 98155

Original submittal: September 17, 2015
Revised Submittal: November 3, 2016

Encompass Engineering Job No. 15620

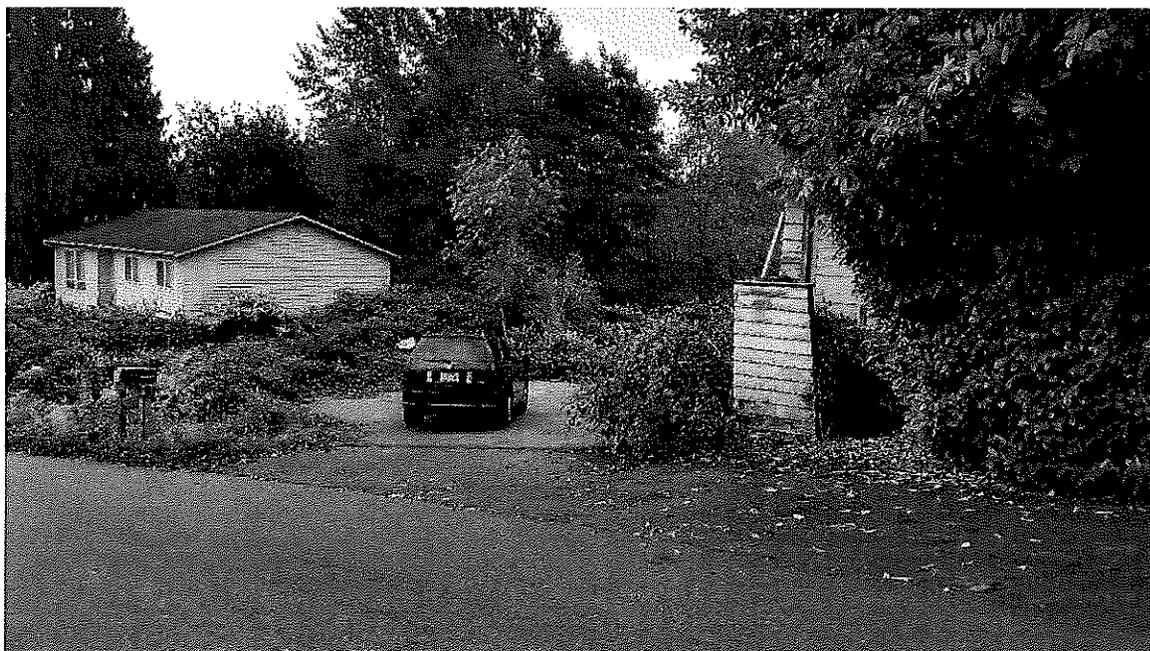
In Photo 1 above, the road clearly slopes down to the left (east) and the far portion of the property in front of the car slopes down to the southeast (Photo 2 below). A ditch starts near the mailboxes and flows down to the left (east). No significant drainage enters the property from the west. A small market is located on the corner and runoff flows to the south and east into Bsche'tla Creek.

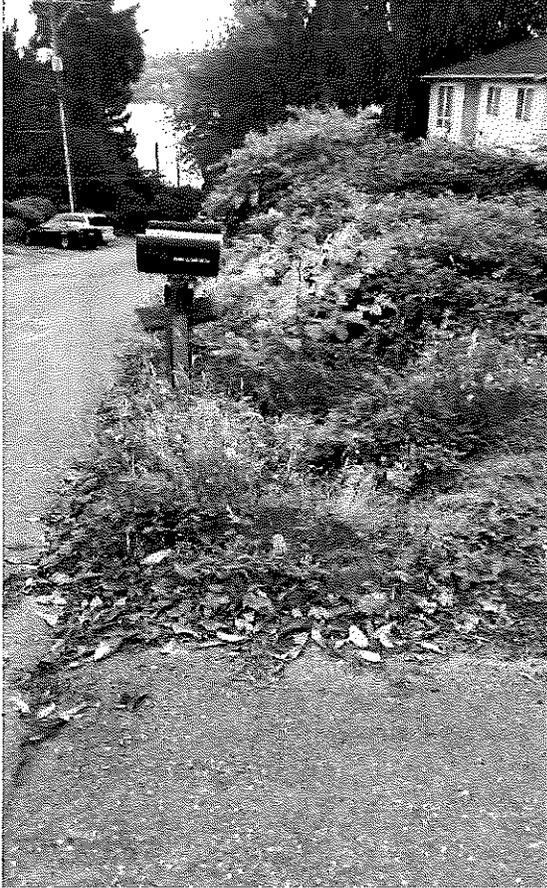
Photo 3

In Photo 3, we see a view down NE 155th Street with Lake Washington in the distance.

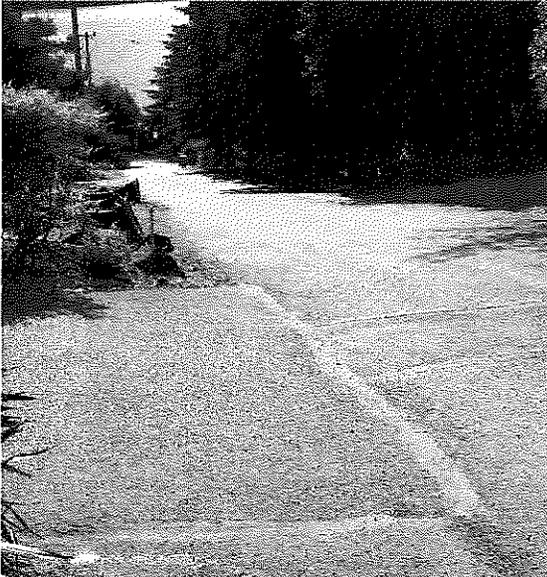
Photo 4

In photo 4, we see NE 155th Street which conveys drainage toward Lake Washington through a series of ditches, culverts & catch basins/storm sewer pipe.

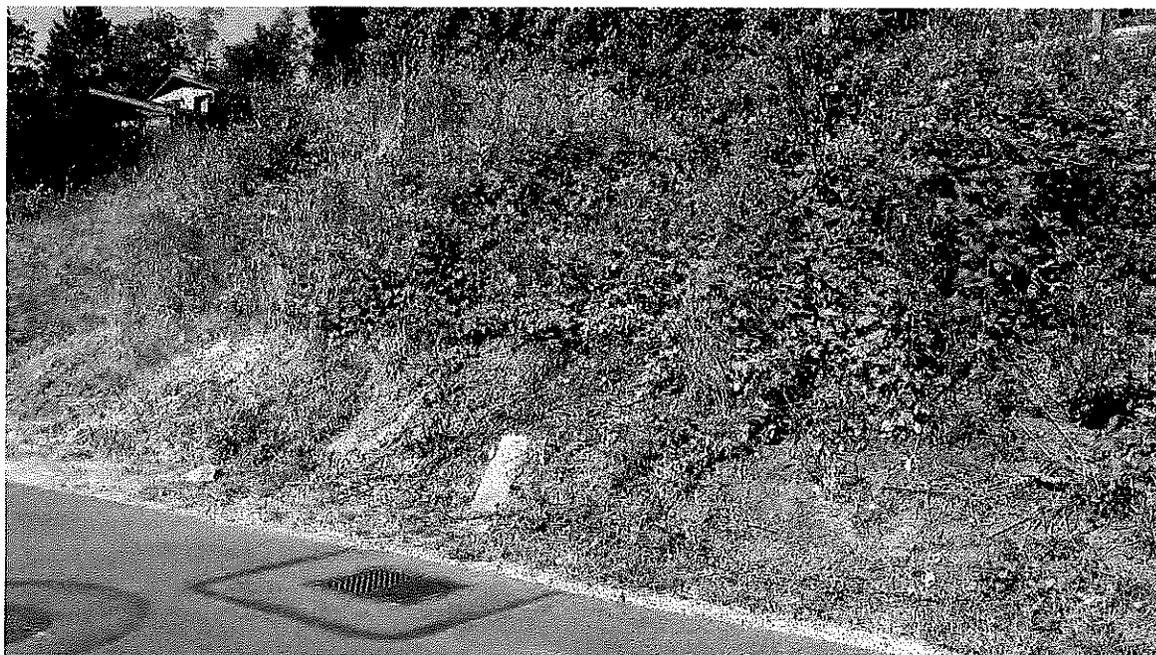
Photo 5

In photo 5, we see a catch basin located in the Burke Gilman trail which is part of the storm water conveyance system that drains the flow from NE 155th Street to Lake Washington.

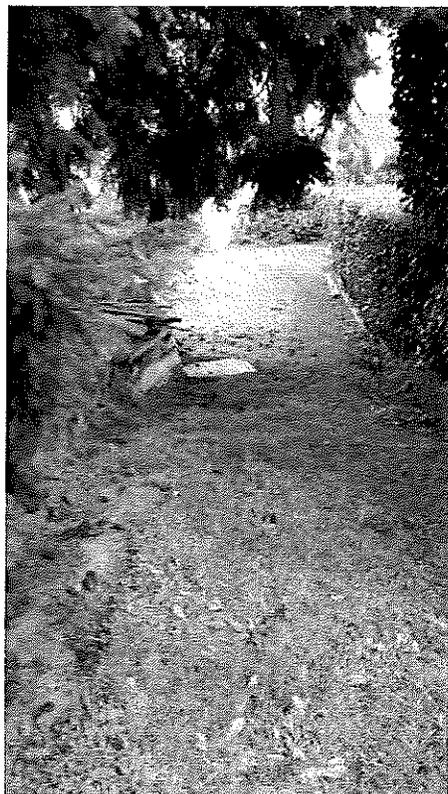
Photo 6 shows a public tract of land located between two residences (15502 Beach Dr NE & 15348 Beach Dr NE). The flow from NE 155th Street is conveyed to Lake Washington via an underground storm sewer running beneath this tract and discharges into the lake near the shoreline.

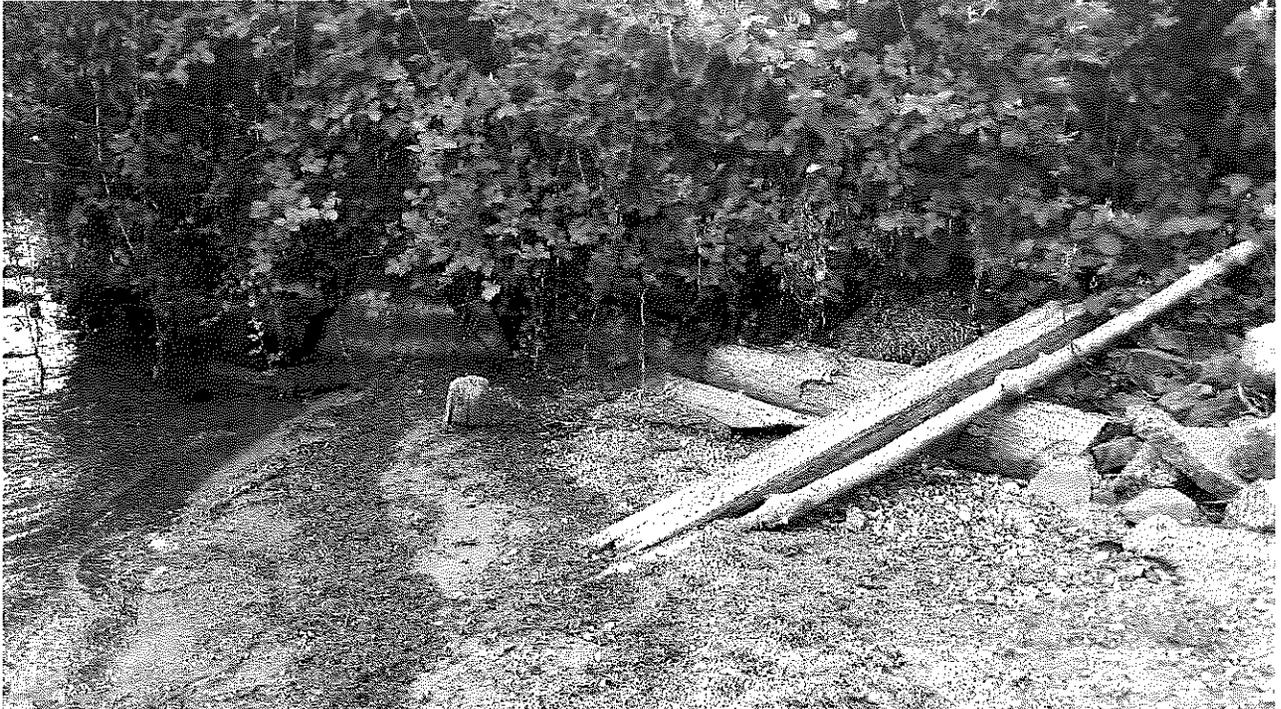
Photo 7

The outlet is hidden under overhanging vegetation and Lake Washington is on the left

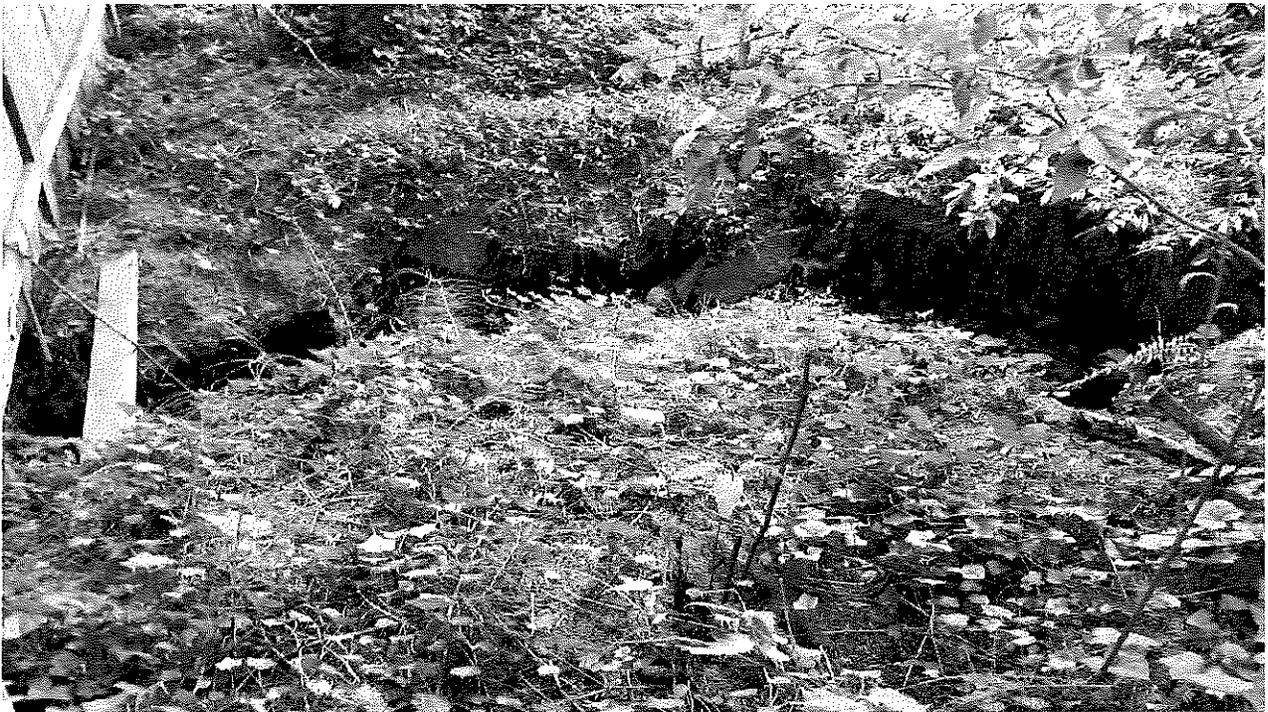
Photo 8

Bsche'tla Creek near NE 153rd Street.

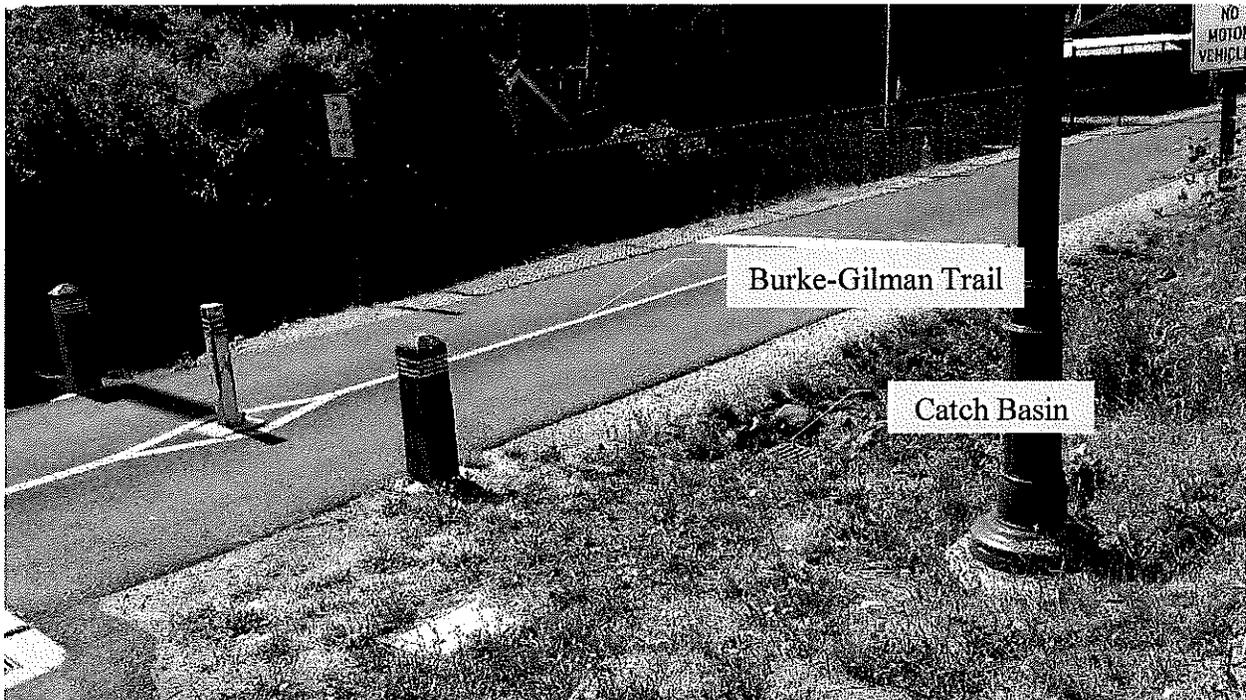
Photo 9

Bsche'tla Creek drains into the Catch Basin shown above via a 24" CMP pipe and drains east to Lake Washington via a 24" CMP pipe.

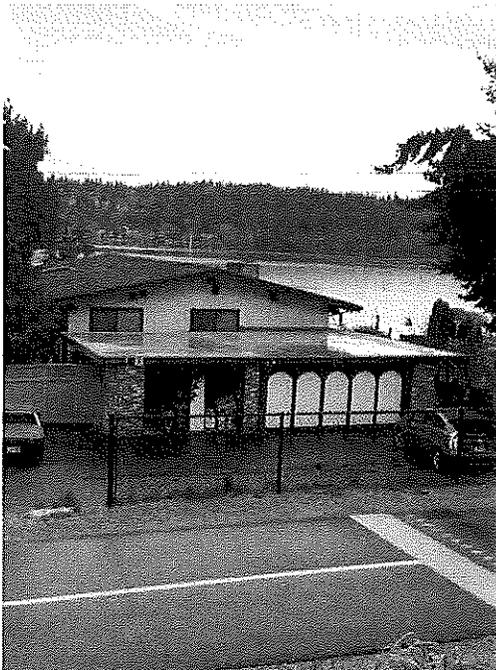
Photo 10 shows the house located at 15502 Beach Dr NE 98155 where an existing drainage problem exists. This drainage issue is along the flow path for NE 155th Street (Flow Path #1)

155th Street and the drainage problem for the home located at 15502 Beach Dr. NE, Level III flow control was used for the design of the stormwater detention vault. Level III flow control requires matching the developed discharge durations to predeveloped durations for the range of predeveloped discharge rates from 50% of the 2-year peak flow up to the full 50-year peak flow and also matching developed peak discharge rates to predeveloped peak discharge rates for the 2-year, 10-year 100-year return periods. Historic site conditions were assumed as the predeveloped condition.
