Tree Assessment and Landscape Tree Appraisal Matrix
LFP 2018-TREE-0007, 46XX 178th St. NE, LFP, WA 98155

Inspector: Thompson
ISA Certified Arborist
ISA Tree Risk Assessment Qualified

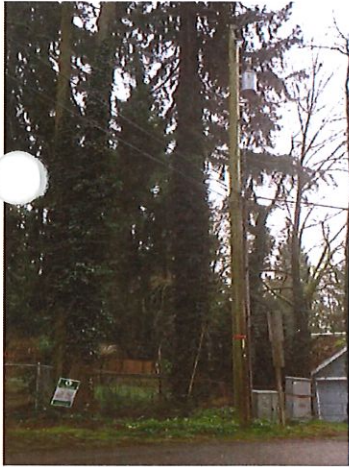
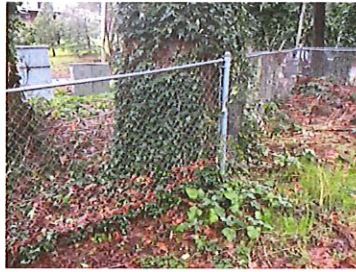
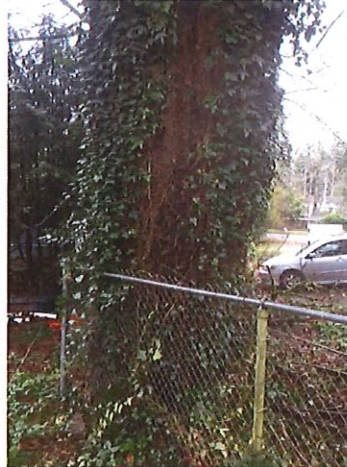
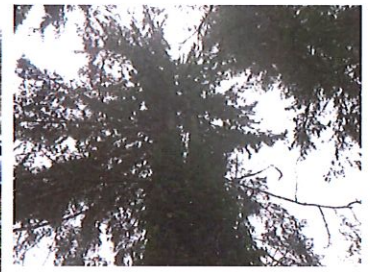
Tree	Species	DBH (in)	Dripline (ft)	CRZ (ft)	Vigor	Structure	Risk	Pres. Value	Recommendations
6	Douglas fir <i>Pseudotsuga menziesii</i>	51.7, (51.7)	20.5	51.7	Fair to Good	Fair	Medium	Low	
Notes / Defects	Notes and recommendations excluded.

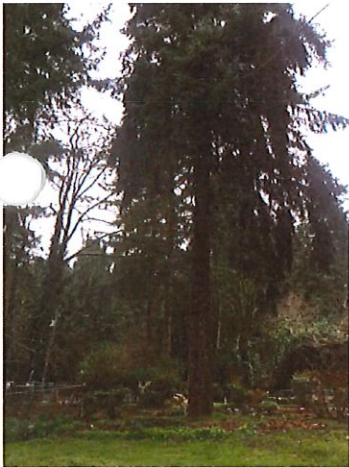
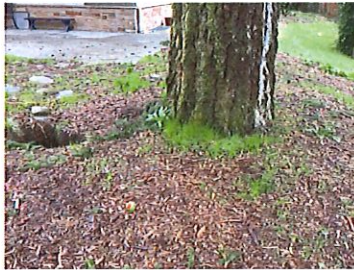
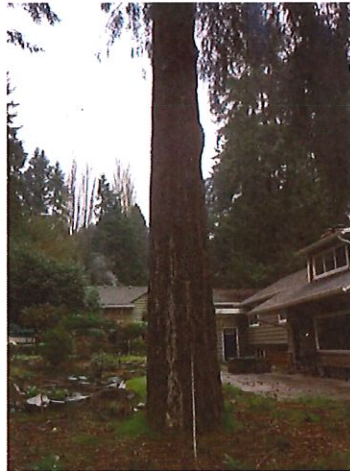
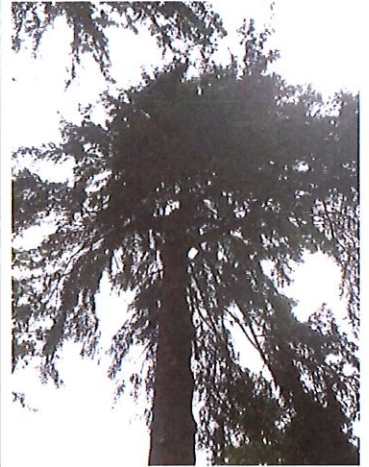
Tree	Species	DBH (in)	Dripline (ft)	CRZ (ft)	Vigor	Structure	Risk	Pres. Value	Recommendations
10	Douglas fir <i>Pseudotsuga menziesii</i>	41.8, (41.8)	20.1	41.8	Fair to Good	Fair	Medium	Low	
Notes / Defects	Notes and recommendations excluded.
