INSPECTOR'S DAILY REPORT

City of Lake Forest Park - Staunton Cove Short Plat

| Daily Information | |
|---|--|
| Description of Work: | Construction of Temporary Erosion and Sedimentation Control (TESC) |

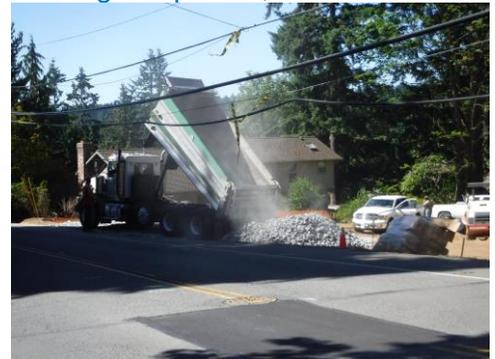
- (1) Unwanted stockpile material next to construction access route.
- (2) Construction ingress on the north end.
- (3) Approved construction ingress/egress on the south end. Rock was barely the minimum approved length of entrance. However, more rock arrived after taking this picture, as shown below.
