# INSPECTOR'S DAILY REPORT

City of Lake Forest Park - Staunton Cove Short Plat

Daily Information	
Inspector's Name:	Michael Maranan <span style="float: right;">Date: 9/2/2016</span>
Inspector's Shift Hours:	8 a.m. to 5 p.m. - Periodic
Weather:	a.m.: p.m.: 65±°F, mostly cloudy
Prime Contractor:	Universal Land Construction Company
Representative & Title:	Mike Johnson, Project Manager
Contractor's Work Activity	
Location of Work:	18623 40th Place NE
Description of Work:	Construction of Temporary Erosion and Sedimentation Control (TESC)

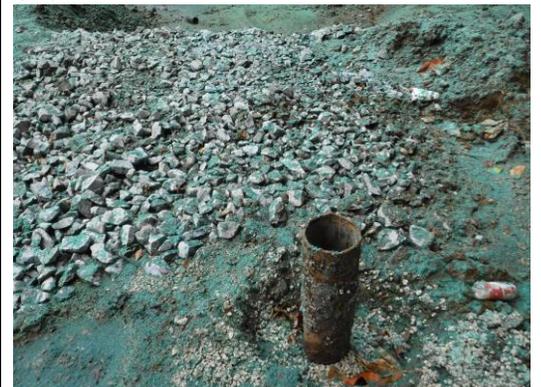
Location: Site

Comment:  
Although the 6-inch riser over the artesian well is dry, the downstream properties appear to have standing water. It might be due to the recent rain event.
