SILVER SHORT PLAT

Technical Information Report

Job No: 14-181

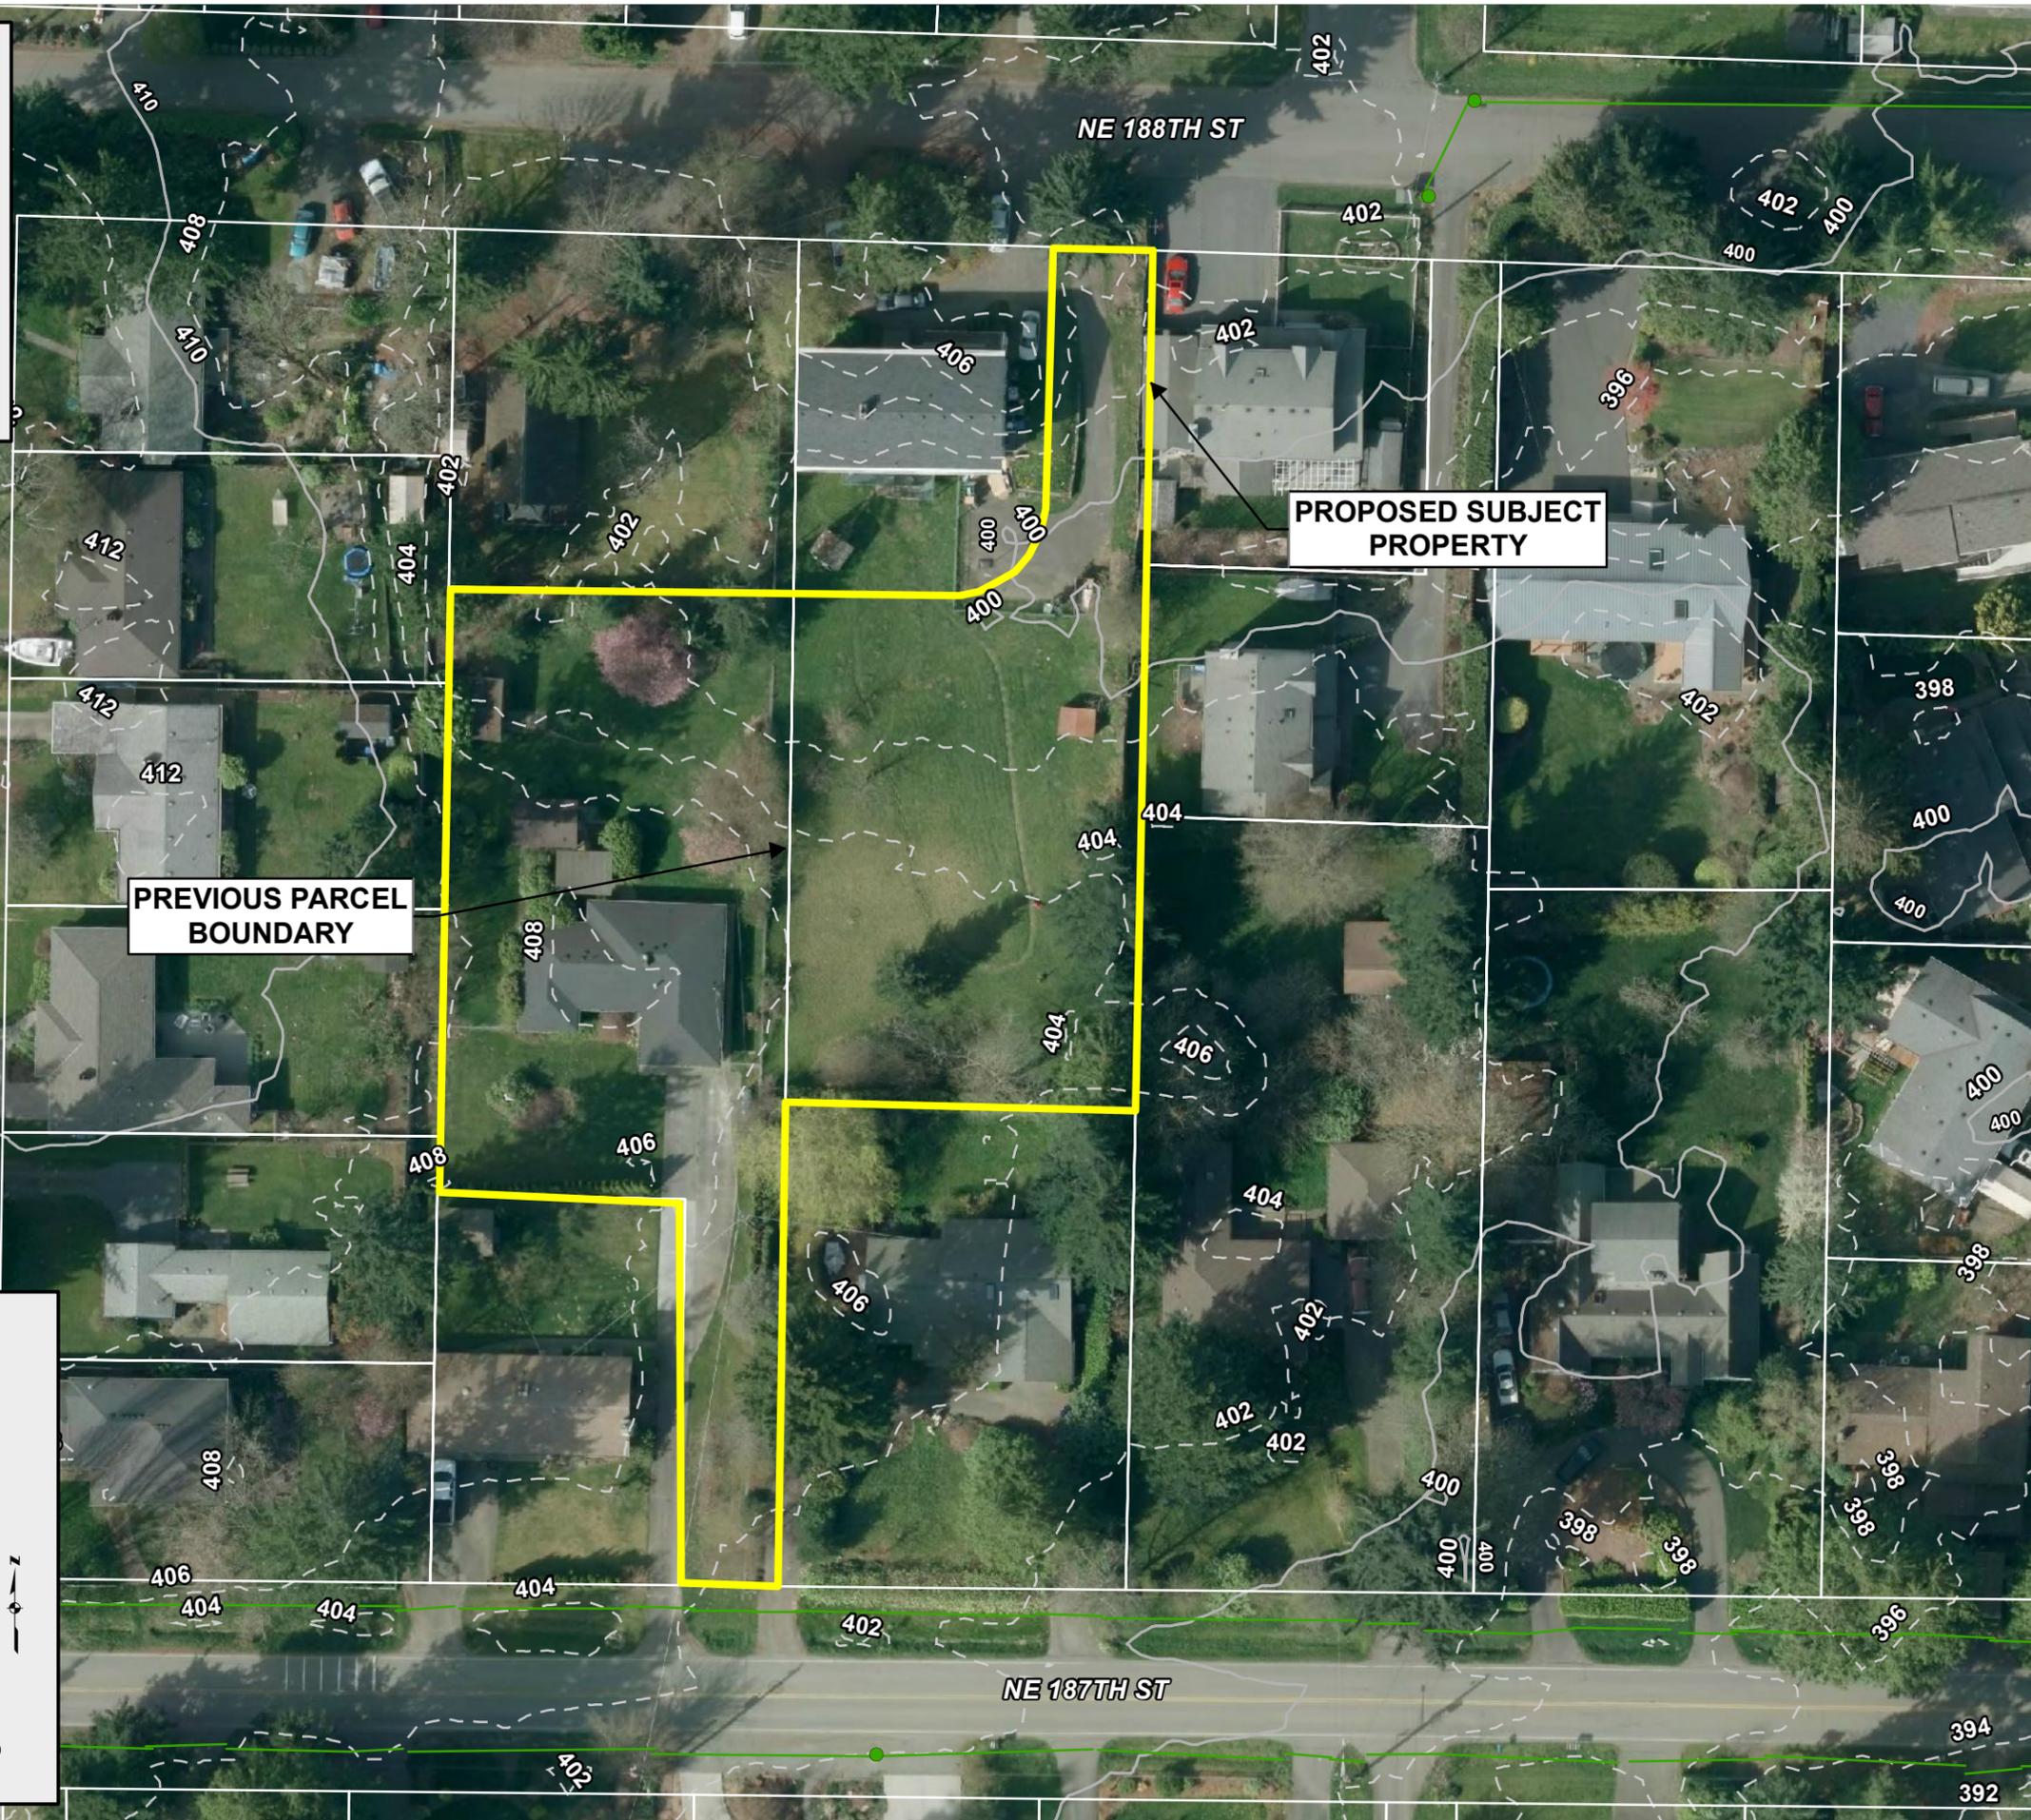
SILVER SHORT PLAT
EXISTING CONDITIONS MAP

In the existing condition, runoff from the site travels overland generally to the east and discharges the site at one of three natural discharge locations. All three downstream flowpaths converge within 1/4 mile of the subject property and therefore the subject property represents one threshold discharge area (TDA). The downstream flow paths are described in further detail in section 3.0, Offsite Analysis. The subject property is tributary to the Cedar River and Lake Washington in respective sequence.

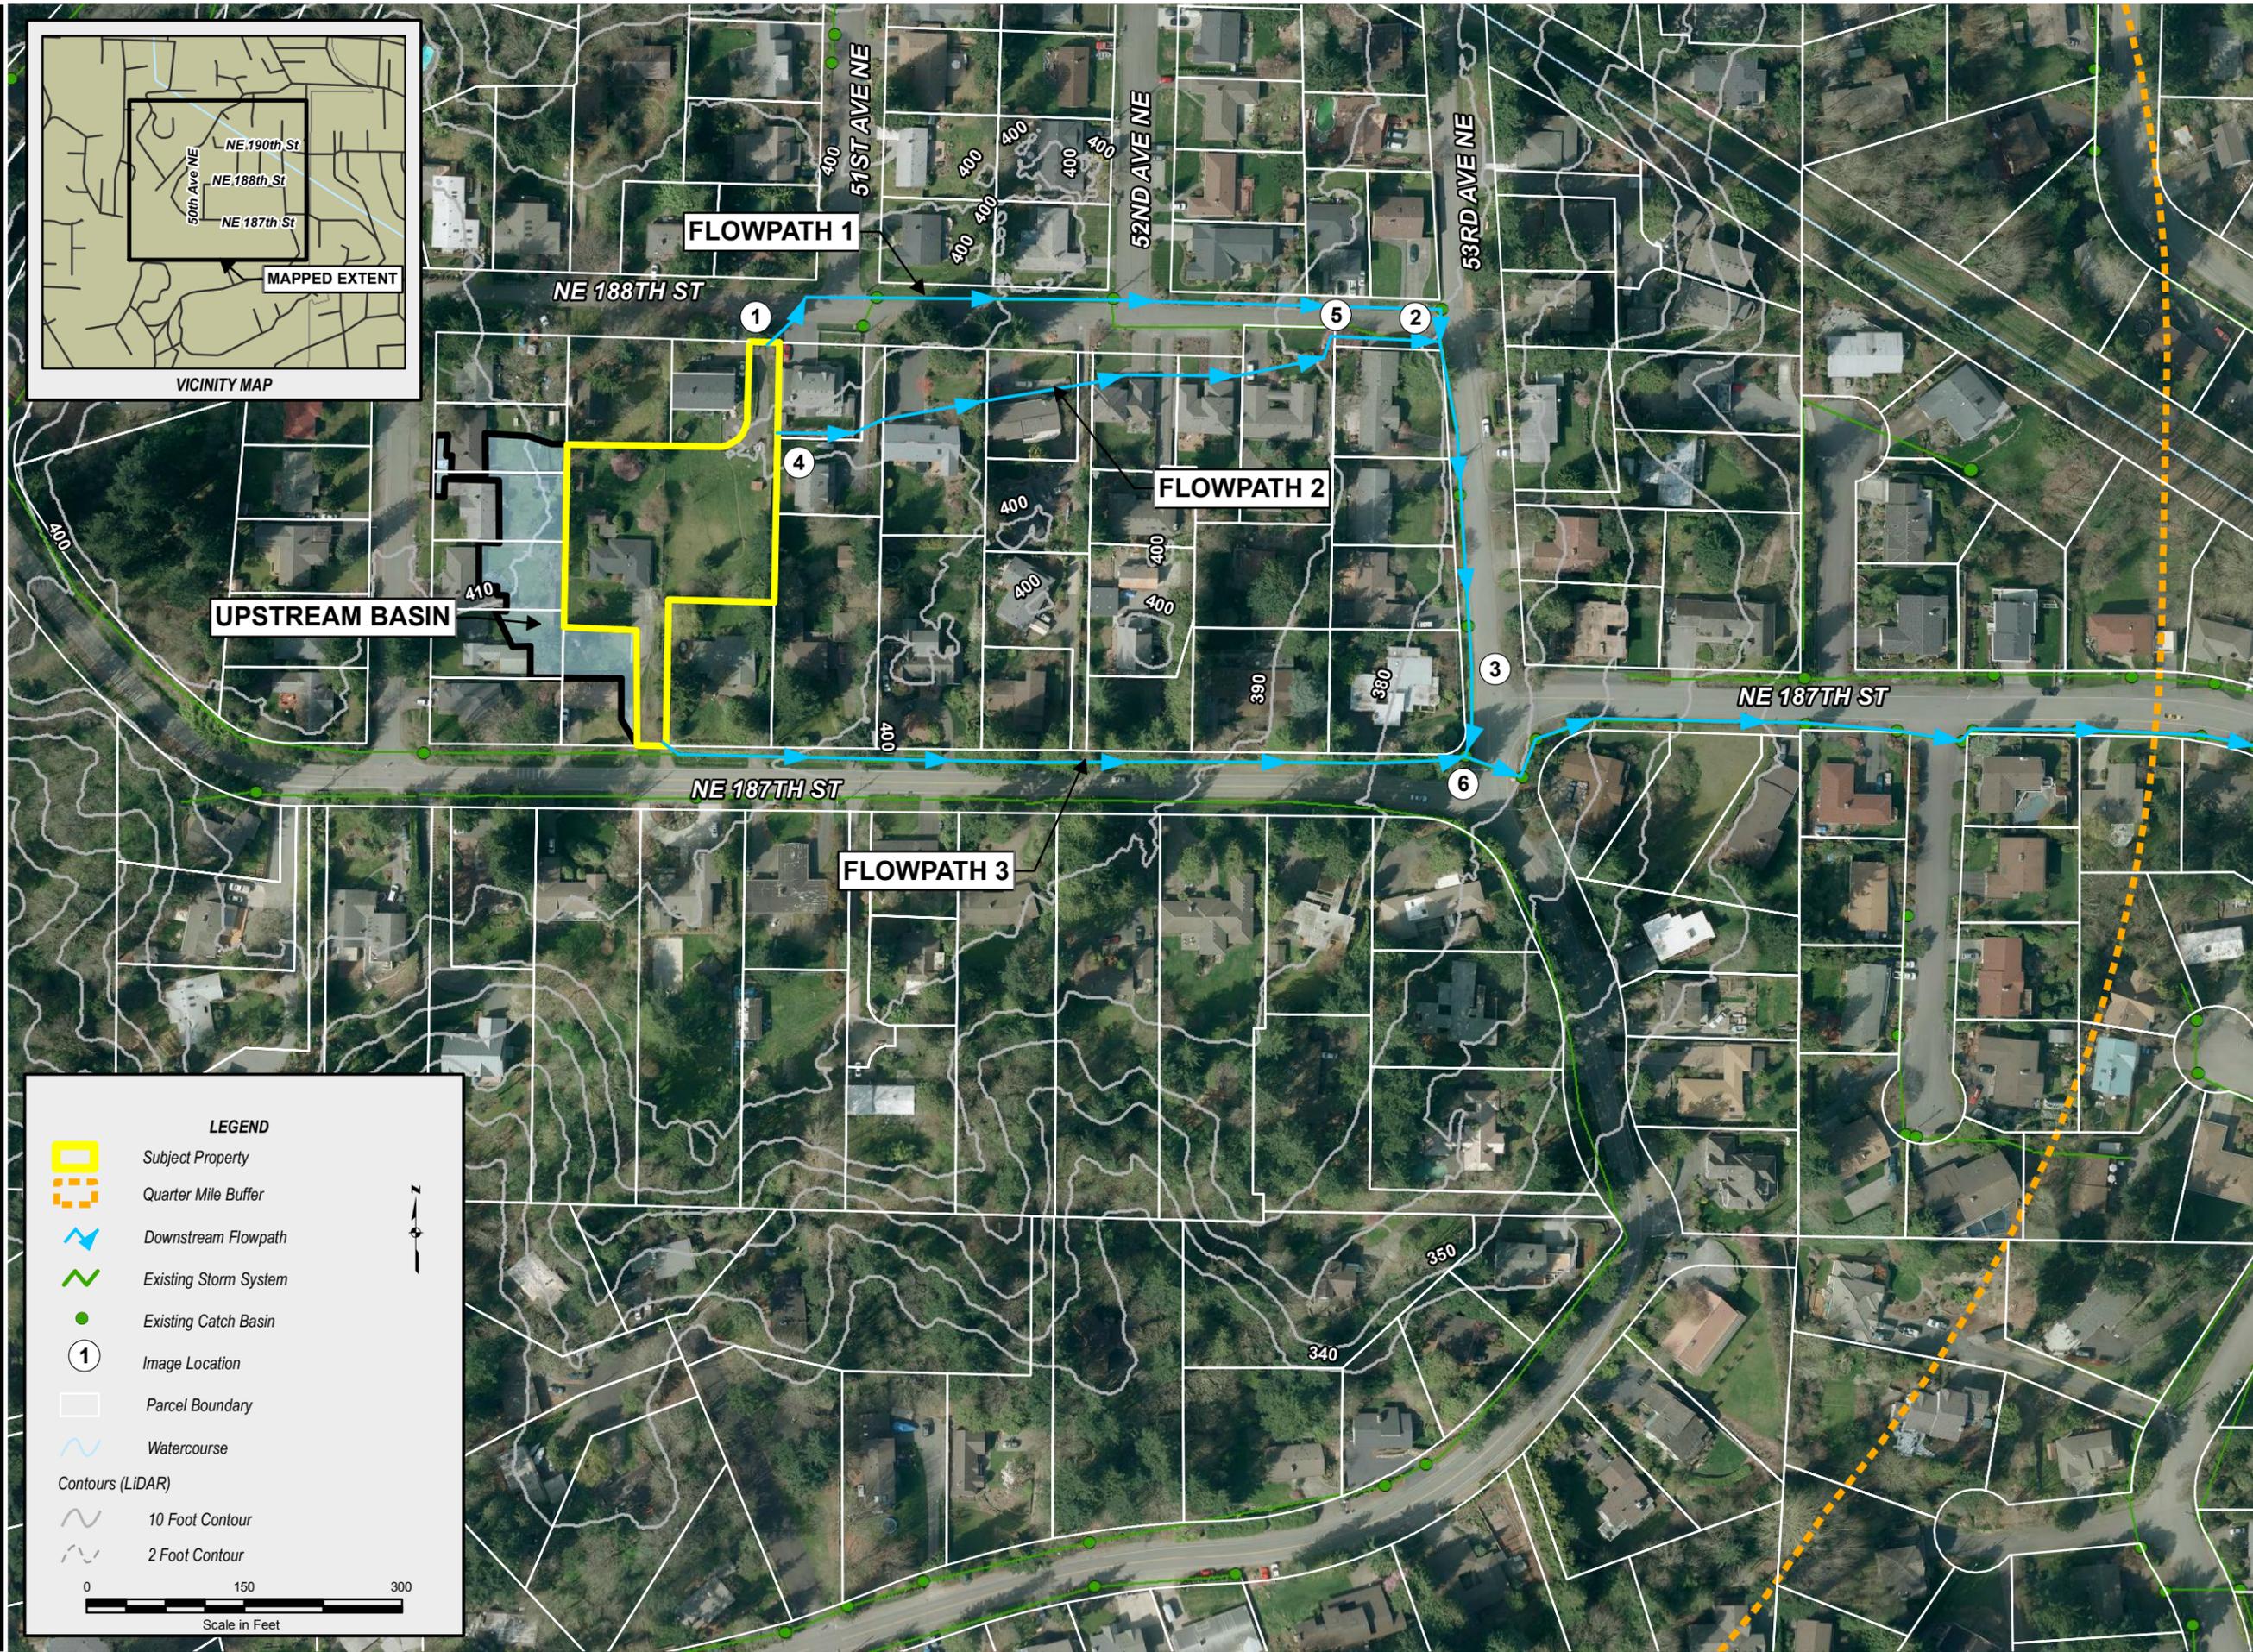
FIGURE:
5.0

UPSTREAM AND DOWNSTREAM ANALYSIS PHOTO RECORD (SEE FIGURE 5.0 FOR
DOWNSTREAM ANALYSIS MAP)

King County LiDAR, onsite engineering survey, and 2012 aerial photography were the best topographical references available for the area containing the site. The limits of downstream analysis extended roughly 0.25 miles beyond the subject property (See figure 5.0, Offsite Analysis Map). The project site is tributary to the Cedar River and Lake Washington in respective sequence.

On May 18th 2015, upstream and downstream analyses were performed at the site. The weather was mostly sunny and approximately 70°F. The ground was dry, and no overland flow was observed in the downstream flow paths. The following observations were verified during this site visit. Please refer to figure 5.0, Downstream Analysis Map, for reference locations.

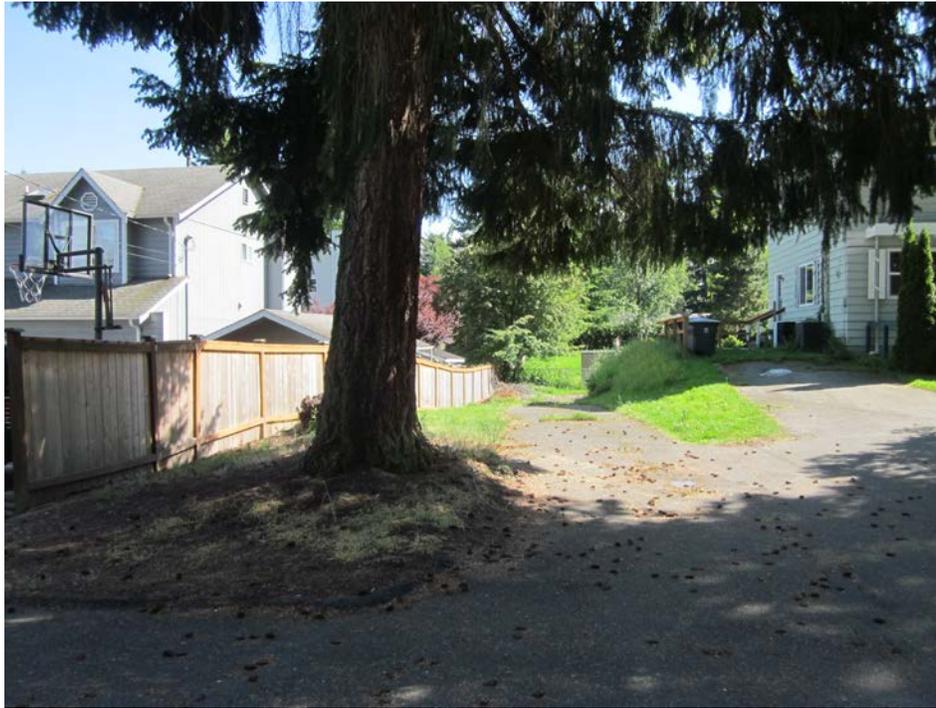
Image ①: Flow path 1 discharges from the northern property line and enters NE188th St. ROW

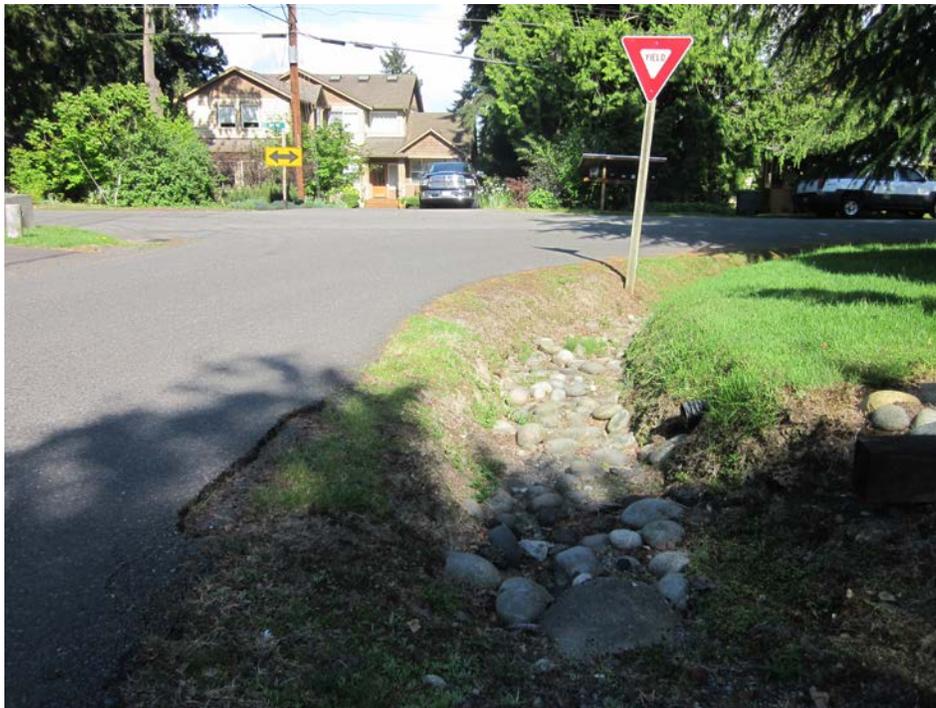
Image ②: Flow paths 1 and 2 merge in roadside ditch located on the southwest corner at intersection of NE188th St. & 53rd Ave NE

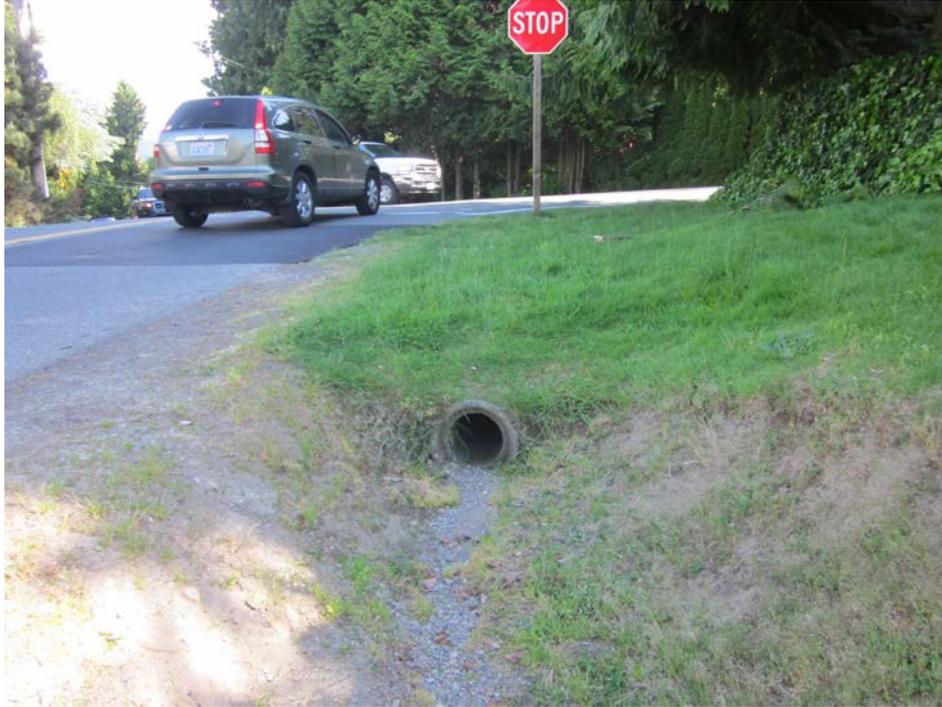
Image ③: Flow paths 1 and 2 flow through a series of roadside ditch and 12" concrete driveway culverts along NE 188th St.

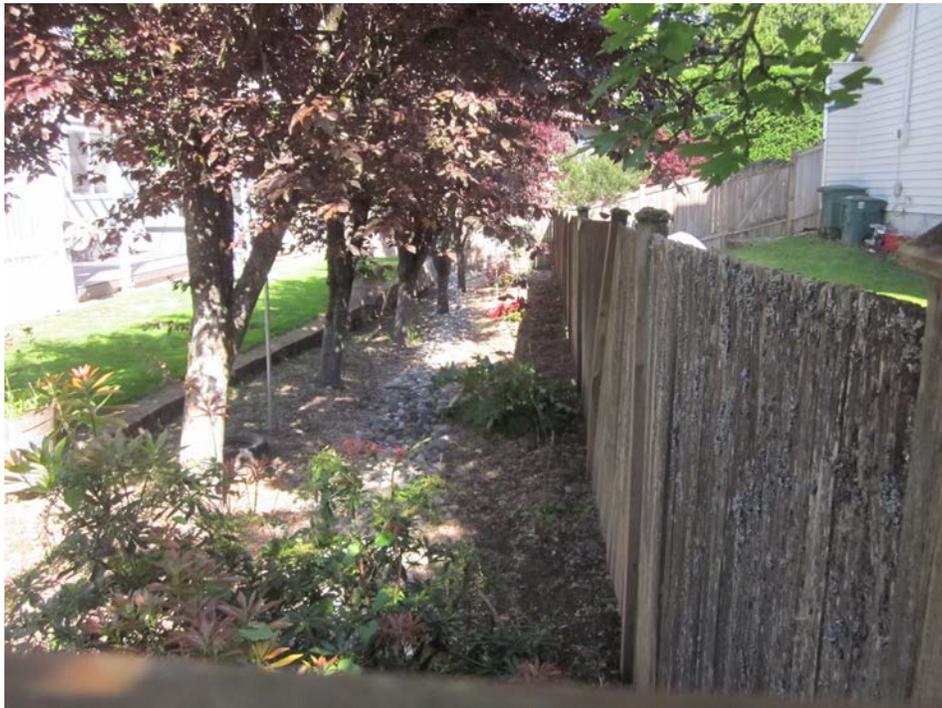
Image ④: Flow path 2 discharges the subject property and is conveyed overland and via underground pipe through adjacent private properties

Flow path 2 is the primary discharge location in the existing condition and is located along the eastern property boundary at a low point on the site. These flows discharge the site ④ and are conveyed as surface flow through adjacent parcels through a series of private storm drain pipes, yard drains, and swales. No drainage easement exists for flow path 2 where it exists over private property. These flows eventually outlet from private property and discharge into a public roadside ditch on the south side of NE 188th St. just west of intersection NE 188th St & 53rd Ave NE ⑤. At this location flows converge with the flow path 1 and continue on in the same course as described under flow path 1.

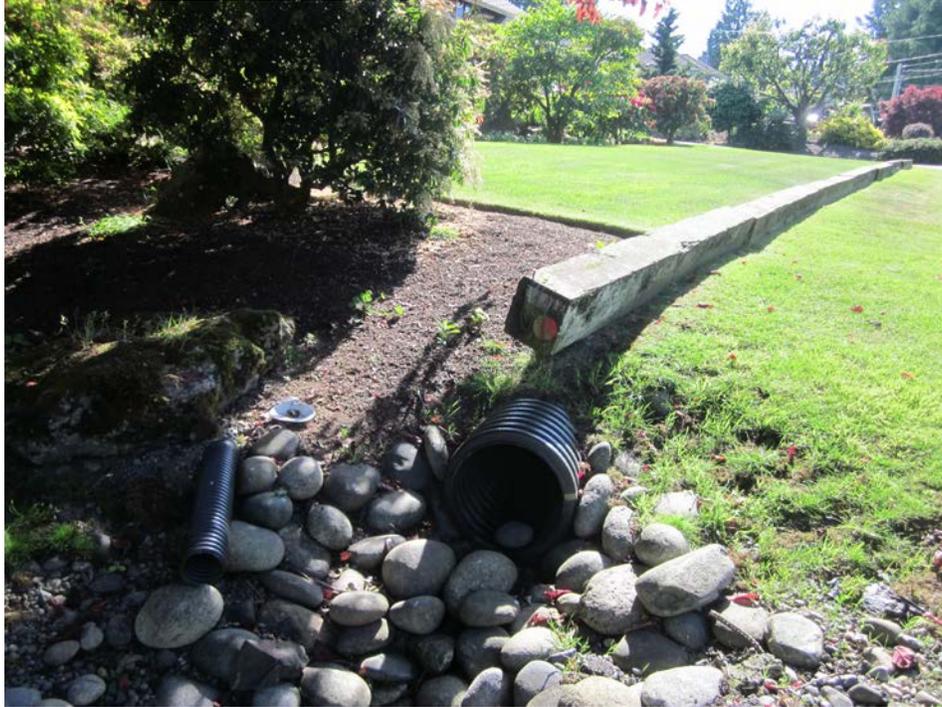
Image ⑤: Flow path 2 outlets from private property and is discharged into NE 188th St. ROW roadside ditch

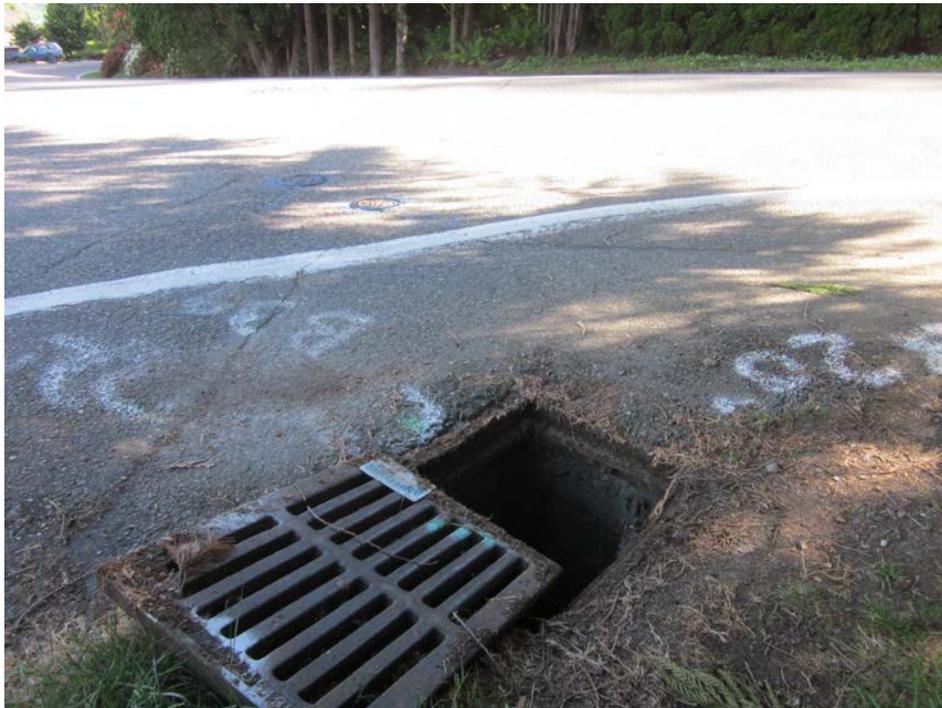
Image ⑥: Flow paths 1 and 2 merge with flow path 3 and are routed to the east along NE 187th St.

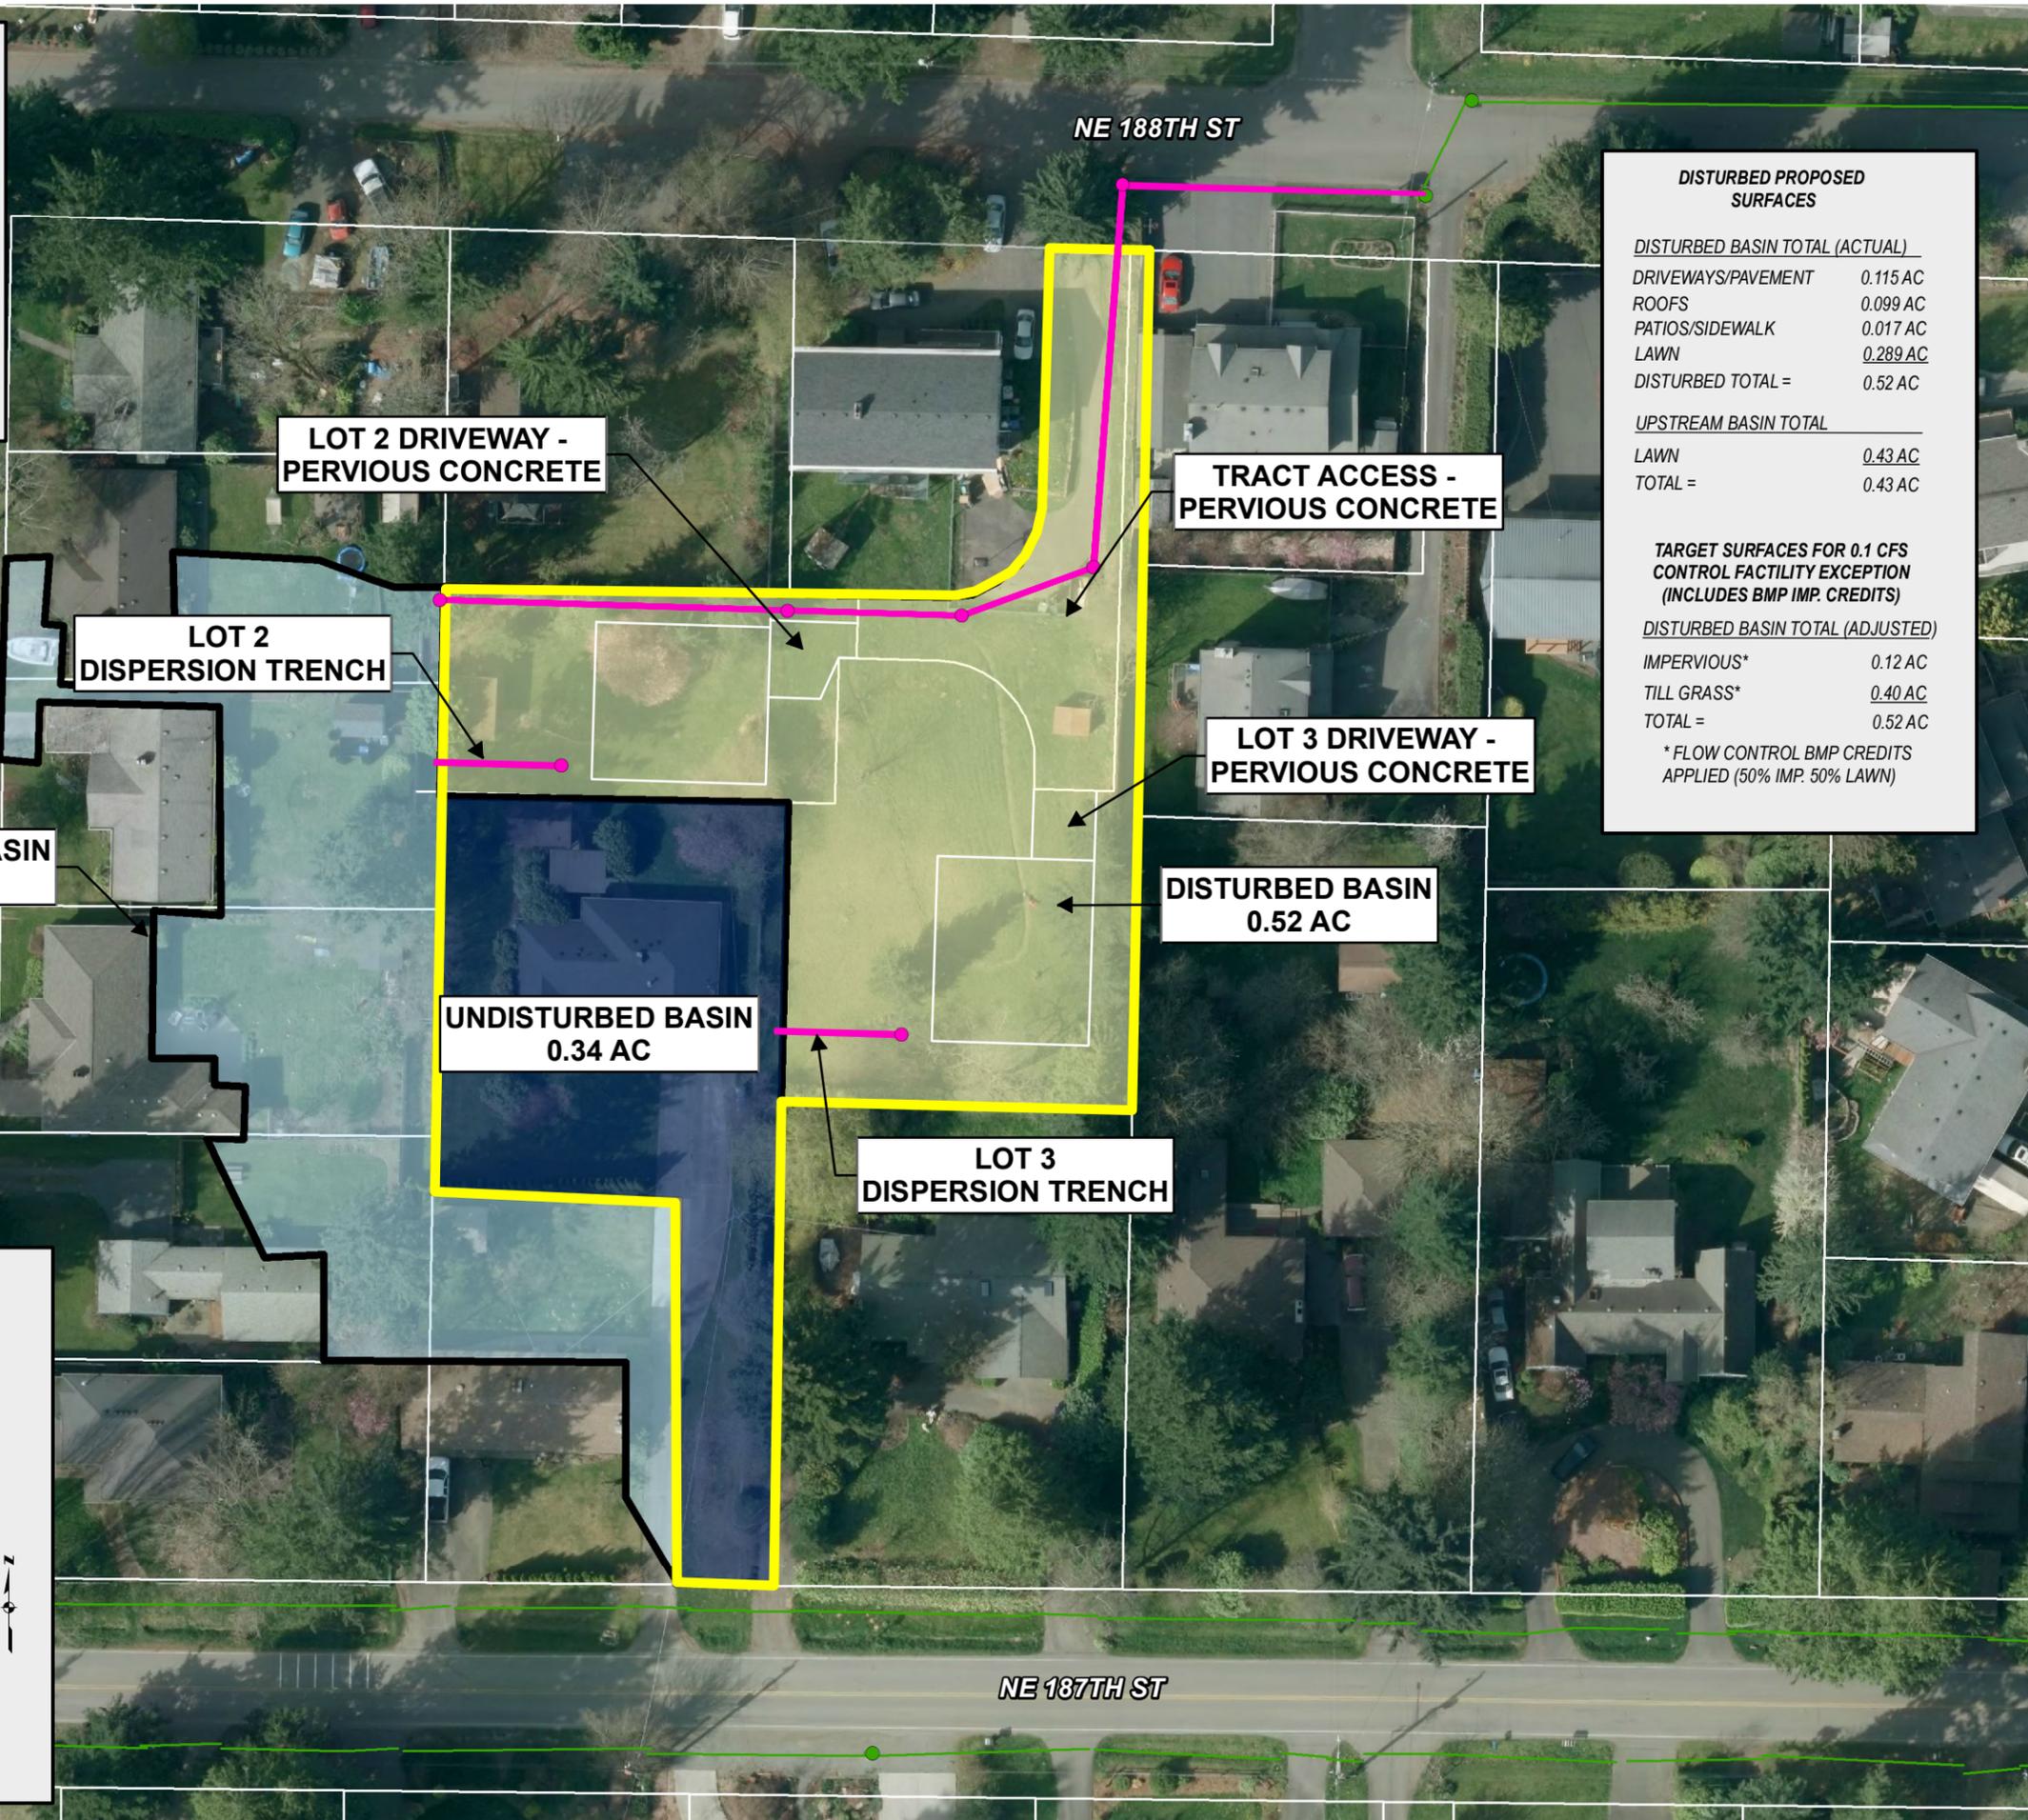
FIGURE:
3.2

DISTURBED PROPOSED SURFACES	
<i>DISTURBED BASIN TOTAL (ACTUAL)</i>	
DRIVEWAYS/PAVEMENT	0.115 AC
ROOFS	0.099 AC
PATIOS/SIDEWALK	0.017 AC
LAWN	0.289 AC
DISTURBED TOTAL =	0.52 AC
<i>UPSTREAM BASIN TOTAL</i>	
LAWN	0.43 AC
TOTAL =	0.43 AC
TARGET SURFACES FOR 0.1 CFS CONTROL FACILITY EXCEPTION (INCLUDES BMP IMP. CREDITS)	
<i>DISTURBED BASIN TOTAL (ADJUSTED)</i>	
IMPERVIOUS*	0.12 AC
TILL GRASS*	0.40 AC
TOTAL =	0.52 AC
* FLOW CONTROL BMP CREDITS APPLIED (50% IMP. 50% LAWN)

Flow control facility is not required per 0.1-cfs exception from the area-specific flow control facility requirement in Section 1.2.3.1, subsection B “Exceptions”. In accordance with Section 1.2.3.1, subsection B “Target Surfaces”, the developed target surfaces assessed in determining the 0.1cfs flow control facility exception have been limited to the following surfaces and modeled in KCRTS as summarized in the table below. See the attached figure 3.2 for a depiction of the developed site basin layout.

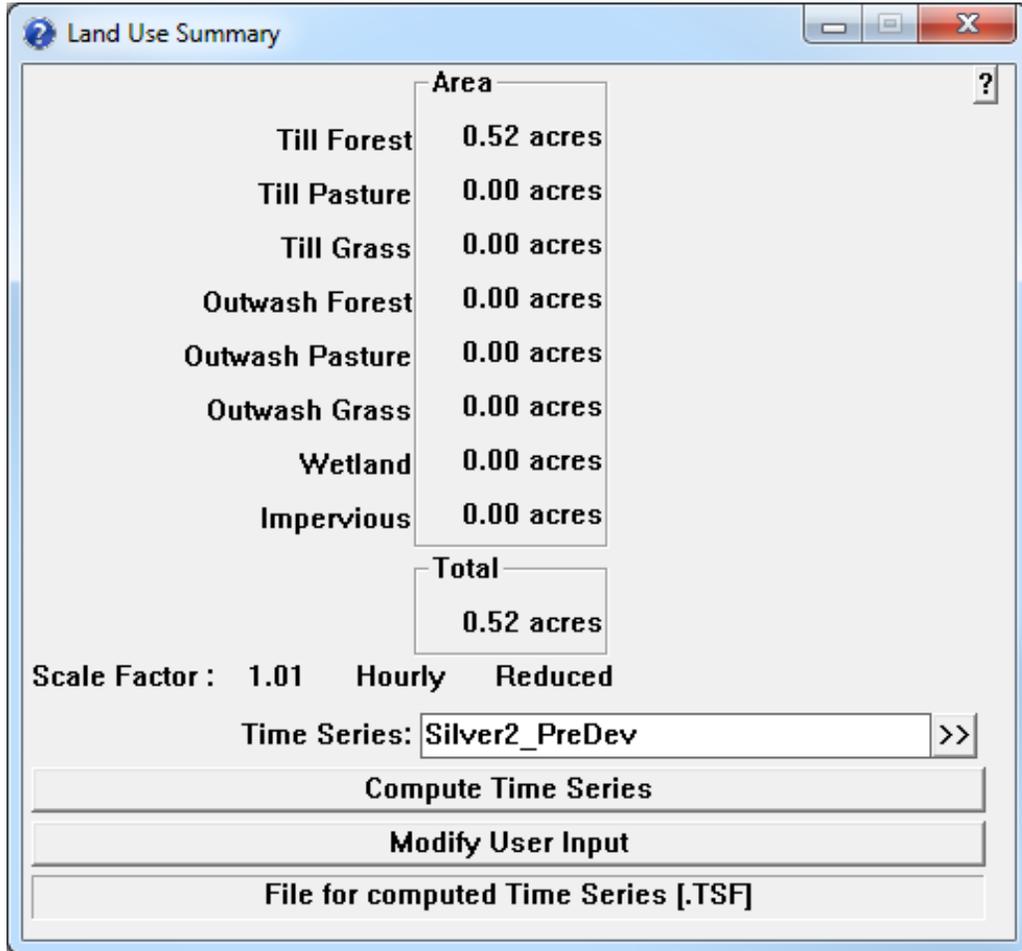
Pre-Developed:

Flow Frequency Analysis

Time Series File:silver2_predev.tsf
 Project Location:Sea-Tac

---Annual Peak Flow Rates---			-----Flow Frequency Analysis-----			
Flow Rate (CFS)	Rank	Time of Peak	- - Peaks (CFS)	- - Rank	Return Period	Prob
0.033	2	2/09/01 18:00	0.043	1	100.00	0.990
0.009	7	1/06/02 3:00	0.033	2	25.00	0.960
0.025	4	2/28/03 3:00	0.025	3	10.00	0.900
0.001	8	3/24/04 19:00	0.025	4	5.00	0.800
0.014	6	1/05/05 8:00	0.021	5	3.00	0.667
0.025	3	1/18/06 20:00	0.014	6	2.00	0.500
0.021	5	11/24/06 4:00	0.009	7	1.30	0.231
0.043	1	1/09/08 9:00	0.001	8	1.10	0.091
Computed Peaks			0.039		50.00	0.980

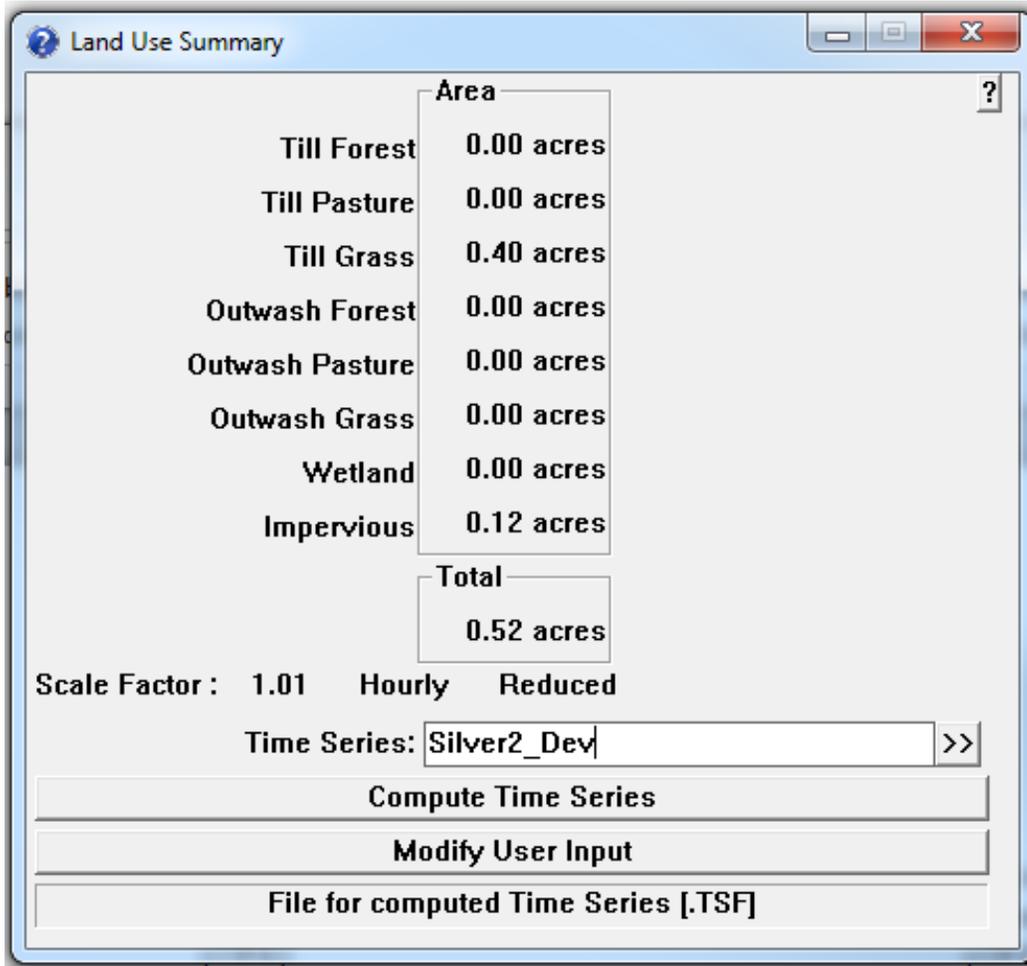
Developed:

Flow Frequency Analysis
 Time Series File:silver2_dev.tsf
 Project Location:Sea-Tac

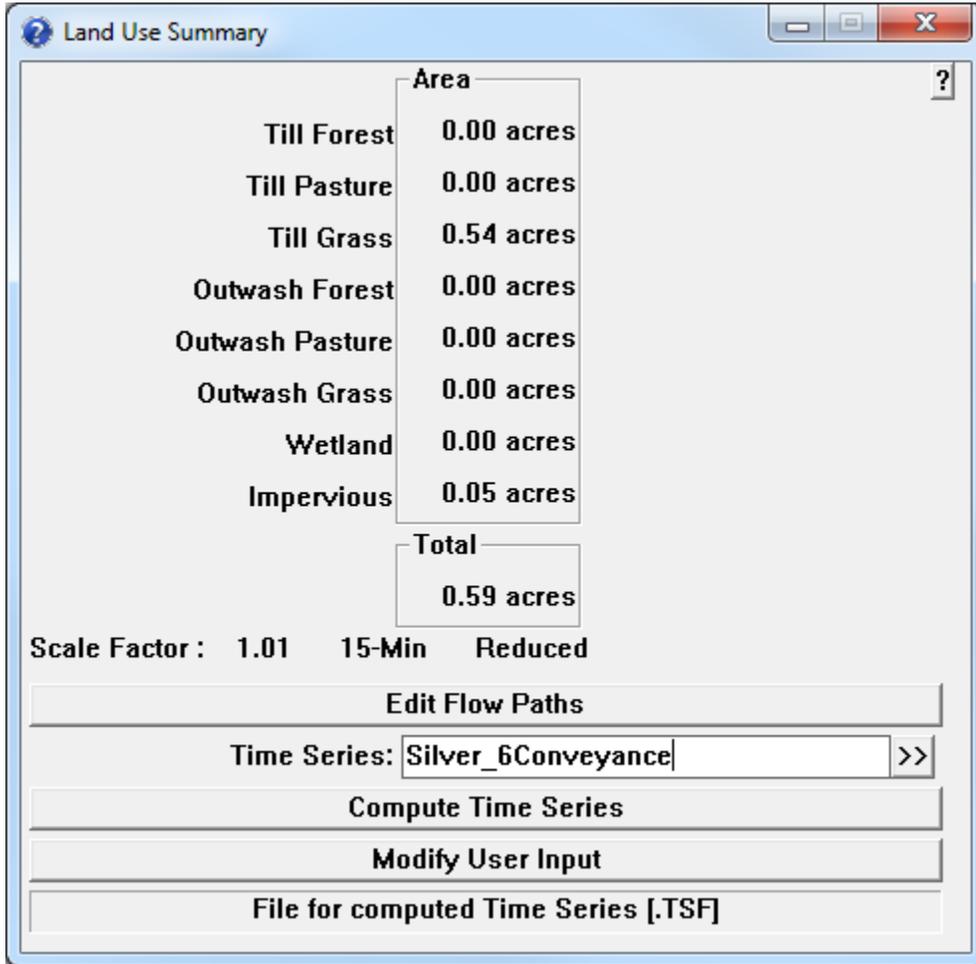
CONVEYANCE - 6" YARD DRAIN PIPE

Flow Frequency Analysis

Time Series File:silver_6conveyance.tsf
 Project Location:Sea-Tac

---Annual Peak Flow Rates---				-----Flow Frequency Analysis-----			
Flow Rate (CFS)	Rank	Time of Peak		Peaks (CFS)	Rank	Return Period	Prob
0.080	4	2/09/01	12:45	0.339	1	100.00	0.990
0.046	7	1/06/02	1:00	0.194	2	25.00	0.960
0.168	3	12/08/02	17:15	0.168	3	10.00	0.900
0.029	8	8/26/04	1:00	0.080	4	5.00	0.800
0.194	2	11/17/04	5:00	0.069	5	3.00	0.667
0.065	6	1/18/06	15:00	0.065	6	2.00	0.500
0.069	5	11/24/06	1:00	0.046	7	1.30	0.231
0.339	1	1/09/08	6:30	0.029	8	1.10	0.091
Computed Peaks				0.290		50.00	0.980

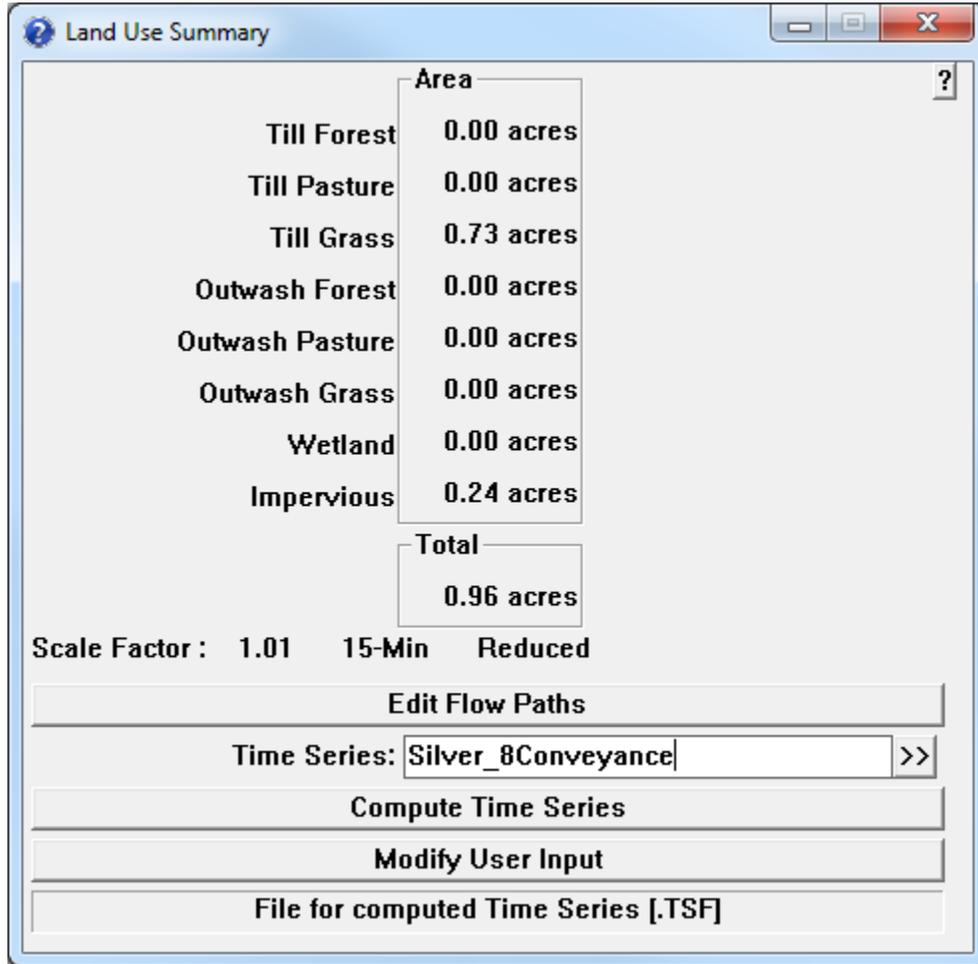
CONVEYANCE - 8" SITE DISCHARGE PIPE

Flow Frequency Analysis
 Time Series File:silver_8conveyance.tsf
 Project Location:Sea-Tac

---Annual Peak Flow Rates---				-----Flow Frequency Analysis-----			
Flow Rate (CFS)	Rank	Time of Peak		Peaks (CFS)	Rank	Return Period	Prob
0.154	6	2/09/01 12:45		0.653	1	100.00	0.990
0.110	7	1/05/02 15:00		0.376	2	25.00	0.960
0.376	2	12/08/02 17:15		0.328	3	10.00	0.900
0.099	8	8/26/04 0:45		0.178	4	5.00	0.800
0.328	3	11/17/04 5:00		0.175	5	3.00	0.667
0.175	5	10/27/05 10:45		0.154	6	2.00	0.500
0.178	4	10/25/06 22:45		0.110	7	1.30	0.231
0.653	1	1/09/08 6:30		0.099	8	1.10	0.091
Computed Peaks				0.561		50.00	0.980

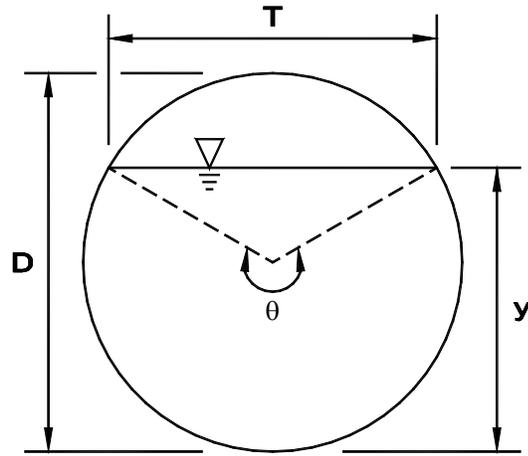
Project Name: Silver Short Plat Project No.: 14-181
Description: Conveyance Calc - 8" Site Discharge Pipe Date: 8/24/2015
Calc. By: DEW

Pipe Diameter (D) = 8 in
Pipe Slope (S) = 0.60 %
Flow Depth (y) = 0.39 ft
Flowrate (Q) = 0.65 cfs
Mannings Coeff. (n) = 0.012
Theta Angle (θ) = 3.48 rad
Wetted Area (A) = 0.21 ft²
Wet. Perimeter (P) = 1.16 ft
Hydraulic Radius (R) = 0.18 ft
Top Width (T) = 0.66 ft
Flow Velocity = 3.09 fps

Theta Angle (θ): If $y \geq r$: $\theta = 2\pi - 2a \cos\left(\frac{y-r}{r}\right)$ where: r = Pipe Radius
If $y \leq r$: $\theta = 2a \cos\left(\frac{r-y}{r}\right)$ where: r = Pipe Radius
