# Preliminary Technical Information Report

## Silver Short Plat City of Lake Forest Park, WA

## *Technical Information Report*

**Job No: 14-181**

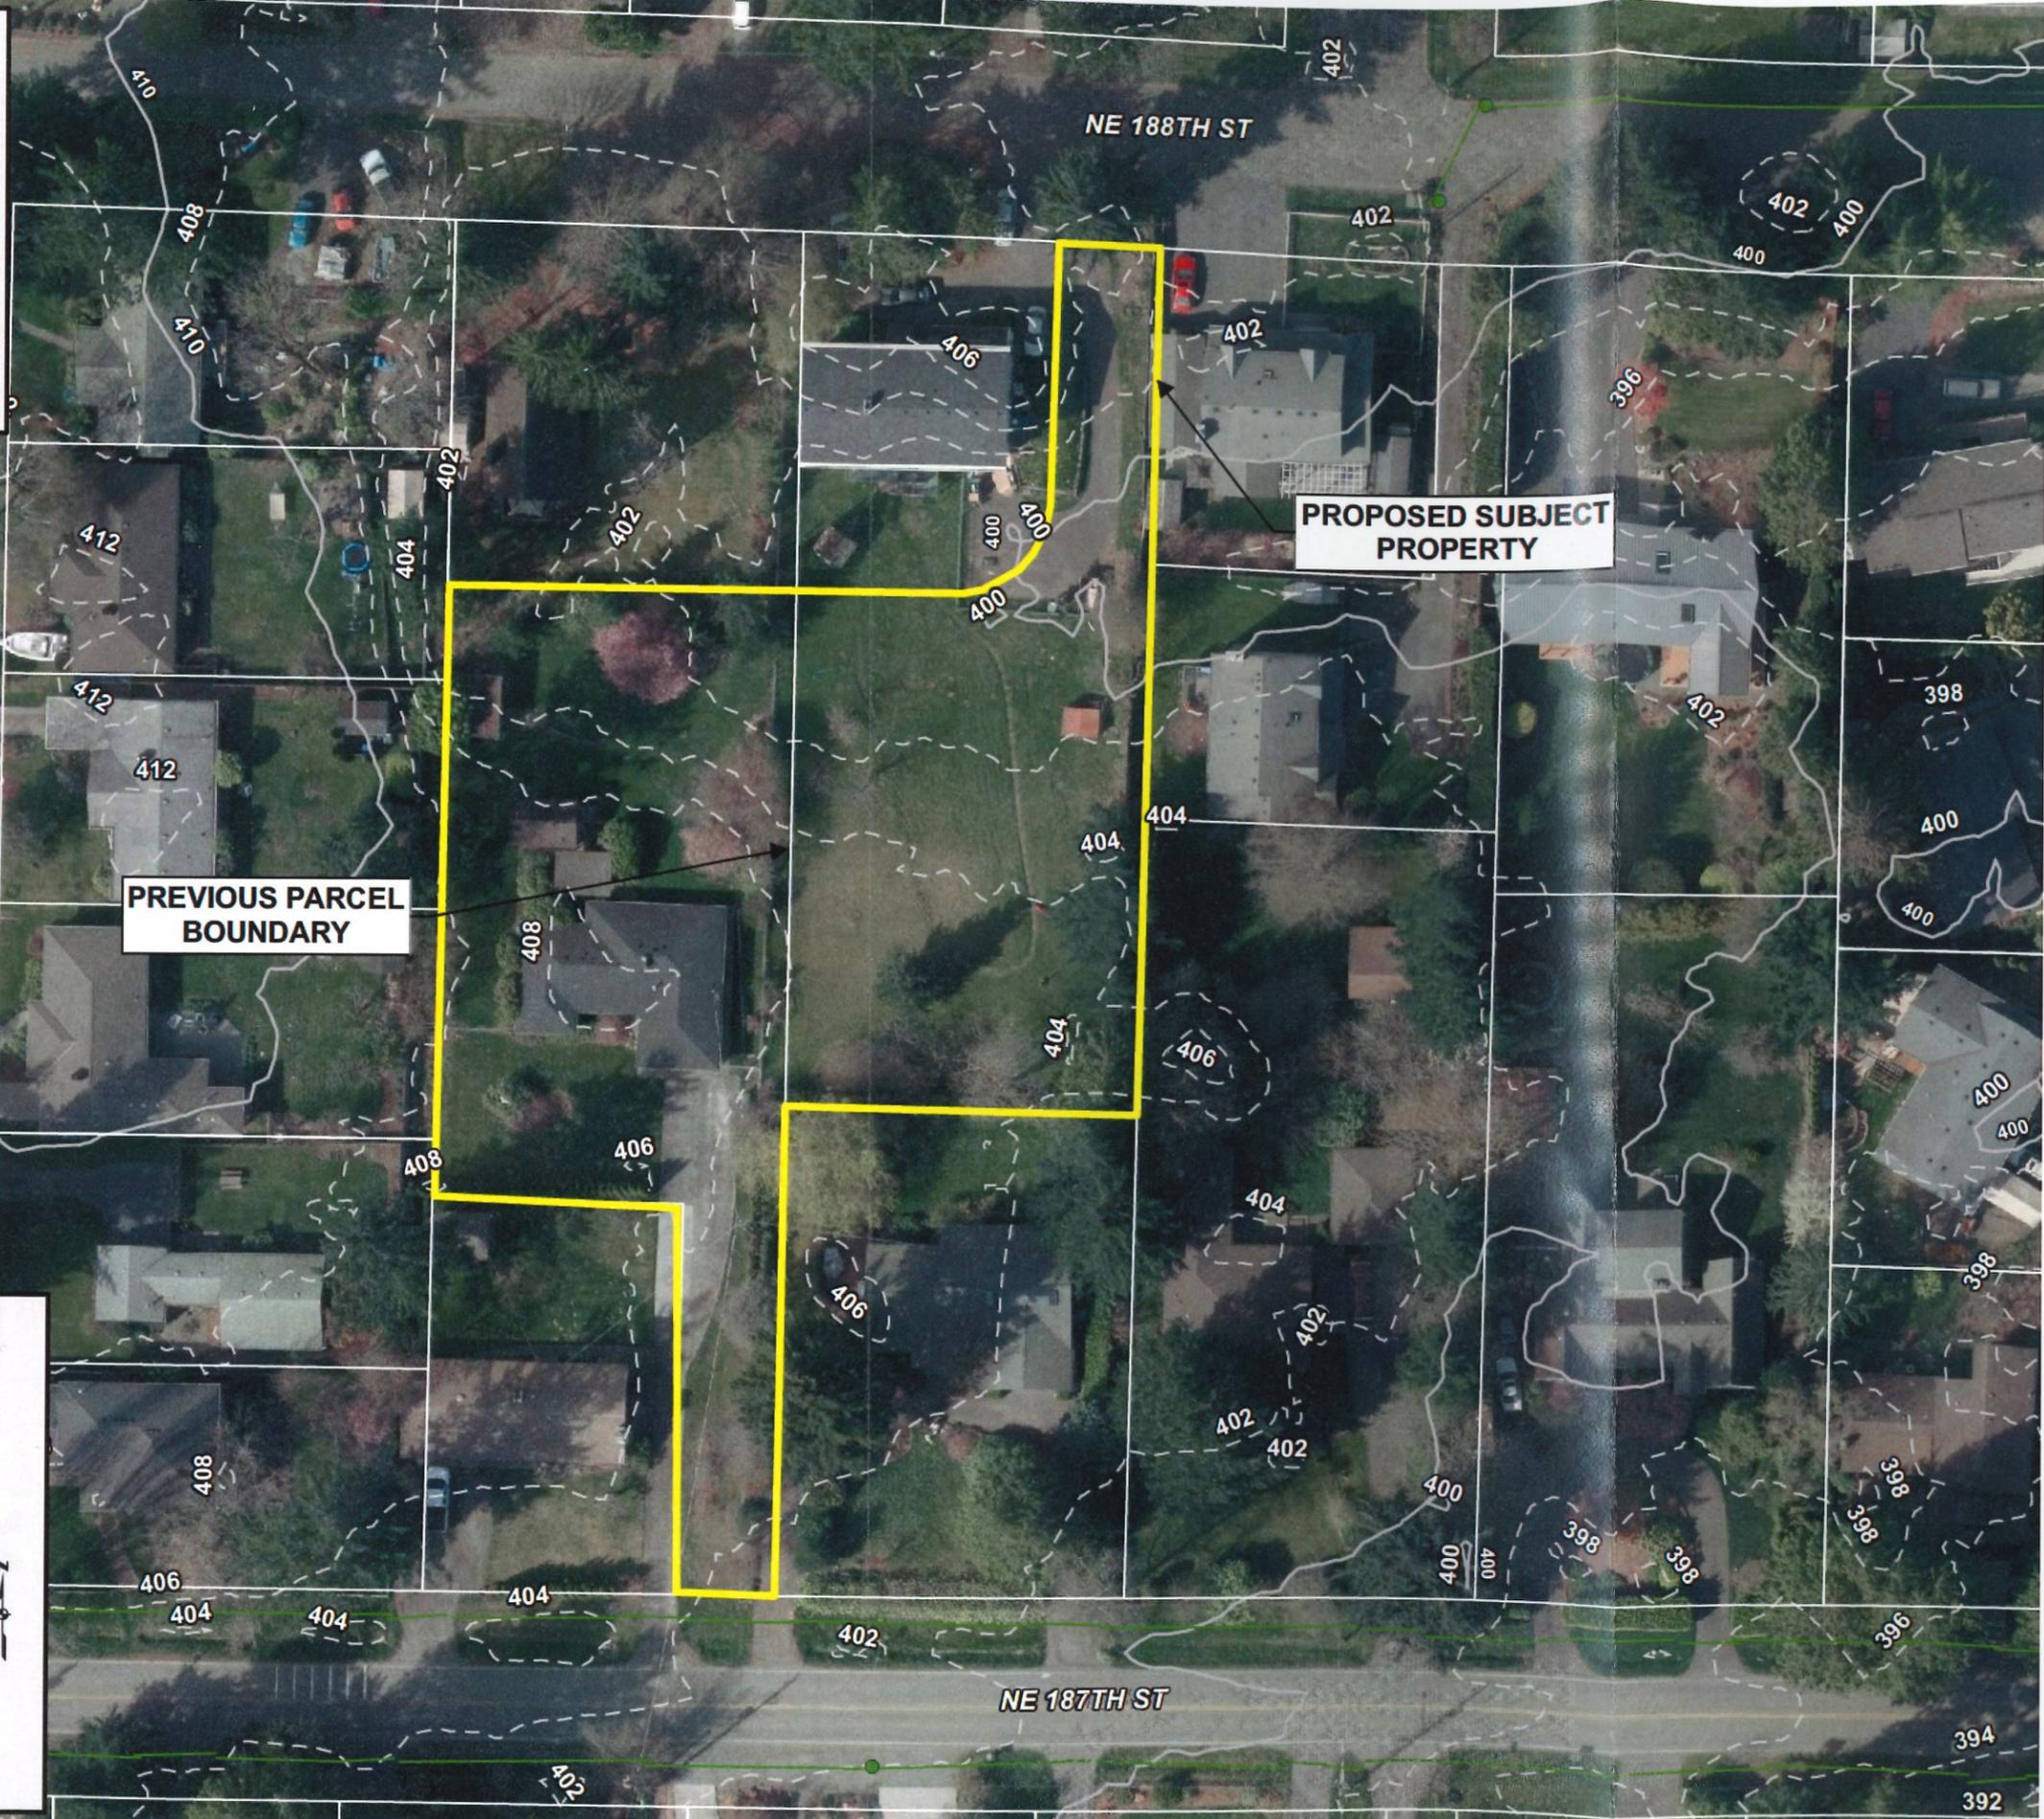
**SILVER SHORT PLAT**  
EXISTING CONDITIONS MAP

- Subject Property
- Existing Storm System
- Existing Catch Basin
- Parcel Boundary
- Watercourse
- Contours (LIDAR)**
- 10 Foot Contour
- 2 Foot Contour

SOURCE INFORMATION	
SOURCE AGENCY	DESCRIPTION
KING COUNTY GIS	PARCEL BOUNDARY, HYDROLOGY
KING COUNTY GIS	CONTOURS GENERATED FROM BARE EARTH LIDAR (KING COUNTY). THIS DATA HAS A STATED VERTICAL ACCURACY OF APPROXIMATELY 1 FOOT.
CITY OF KENMORE GIS	UTILITIES

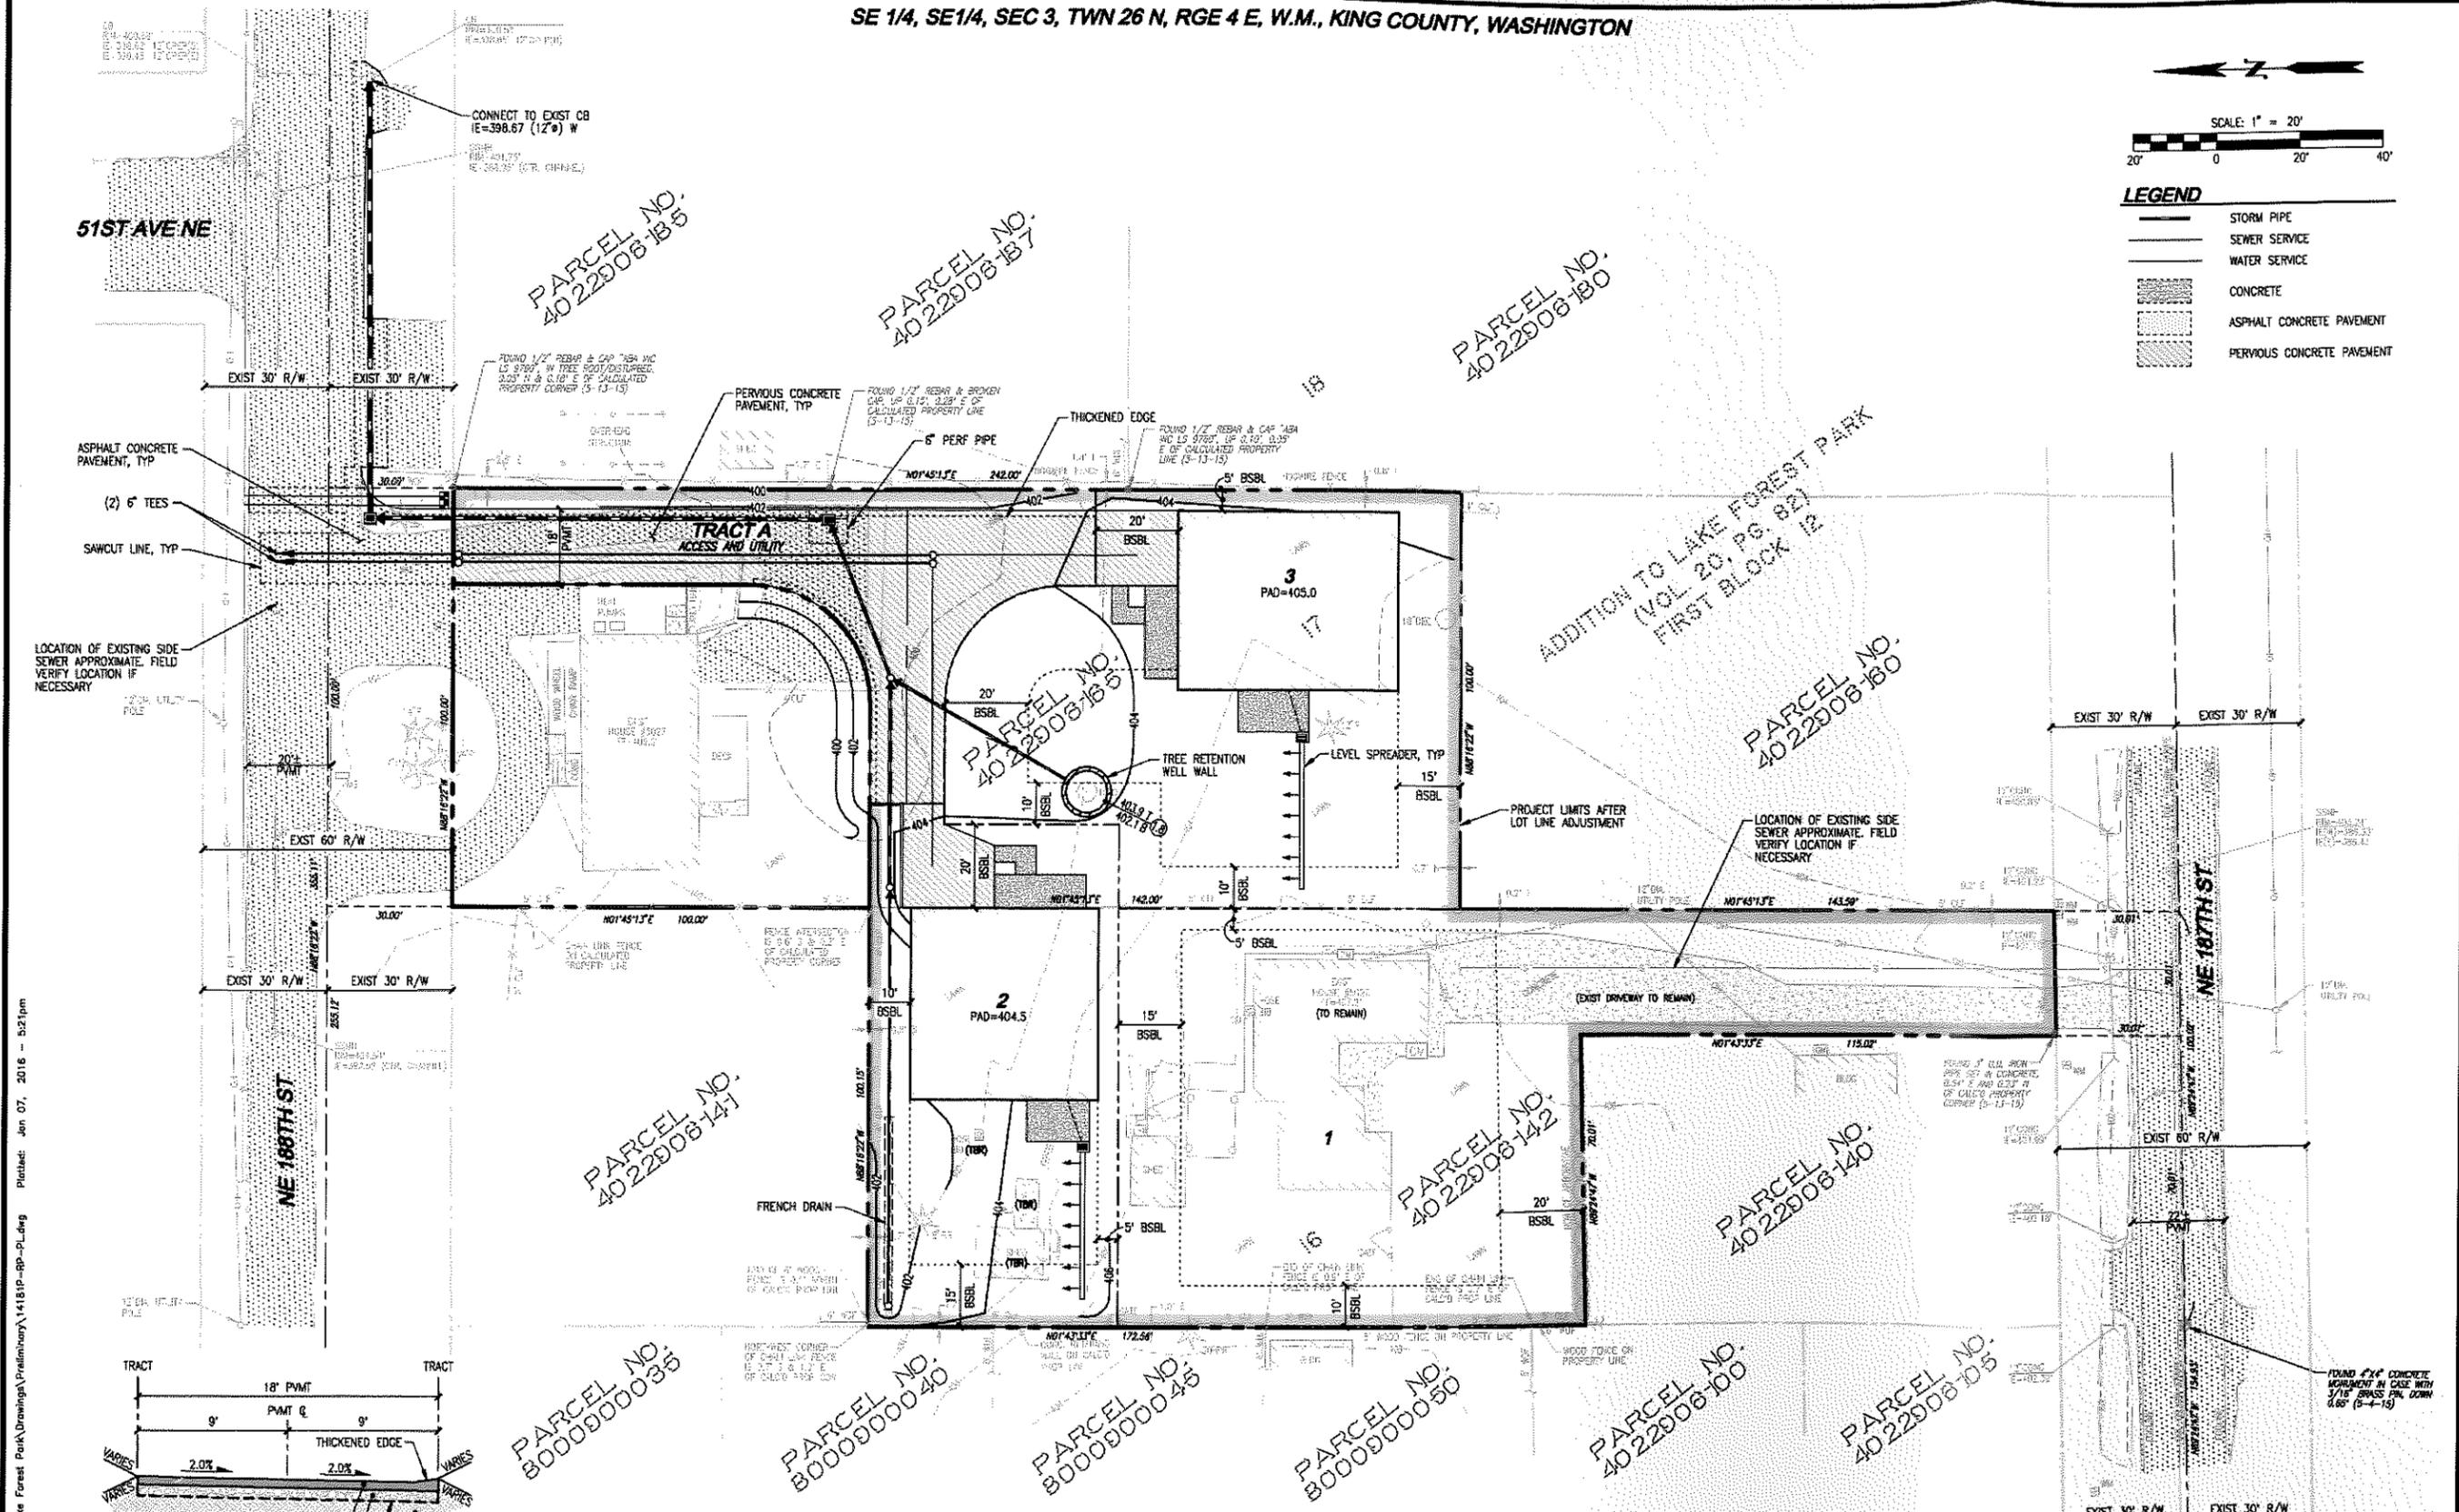
**TRACT A ROAD SECTION**  
SCALE: 1"=5'

6" POROUS/PERVIOUS CONCRETE MEETING ACI 522.1-B SPECIFICATION FOR PERVIOUS CONCRETE

In the developed condition, newly proposed lots (lots 2 and 3) will be accessed from NE 188<sup>th</sup> St. via a private drive access tract (Tract A). Access to lot 1 will remain unaltered; lot 1 will continue access via existing private driveway from NE 187<sup>th</sup> St.

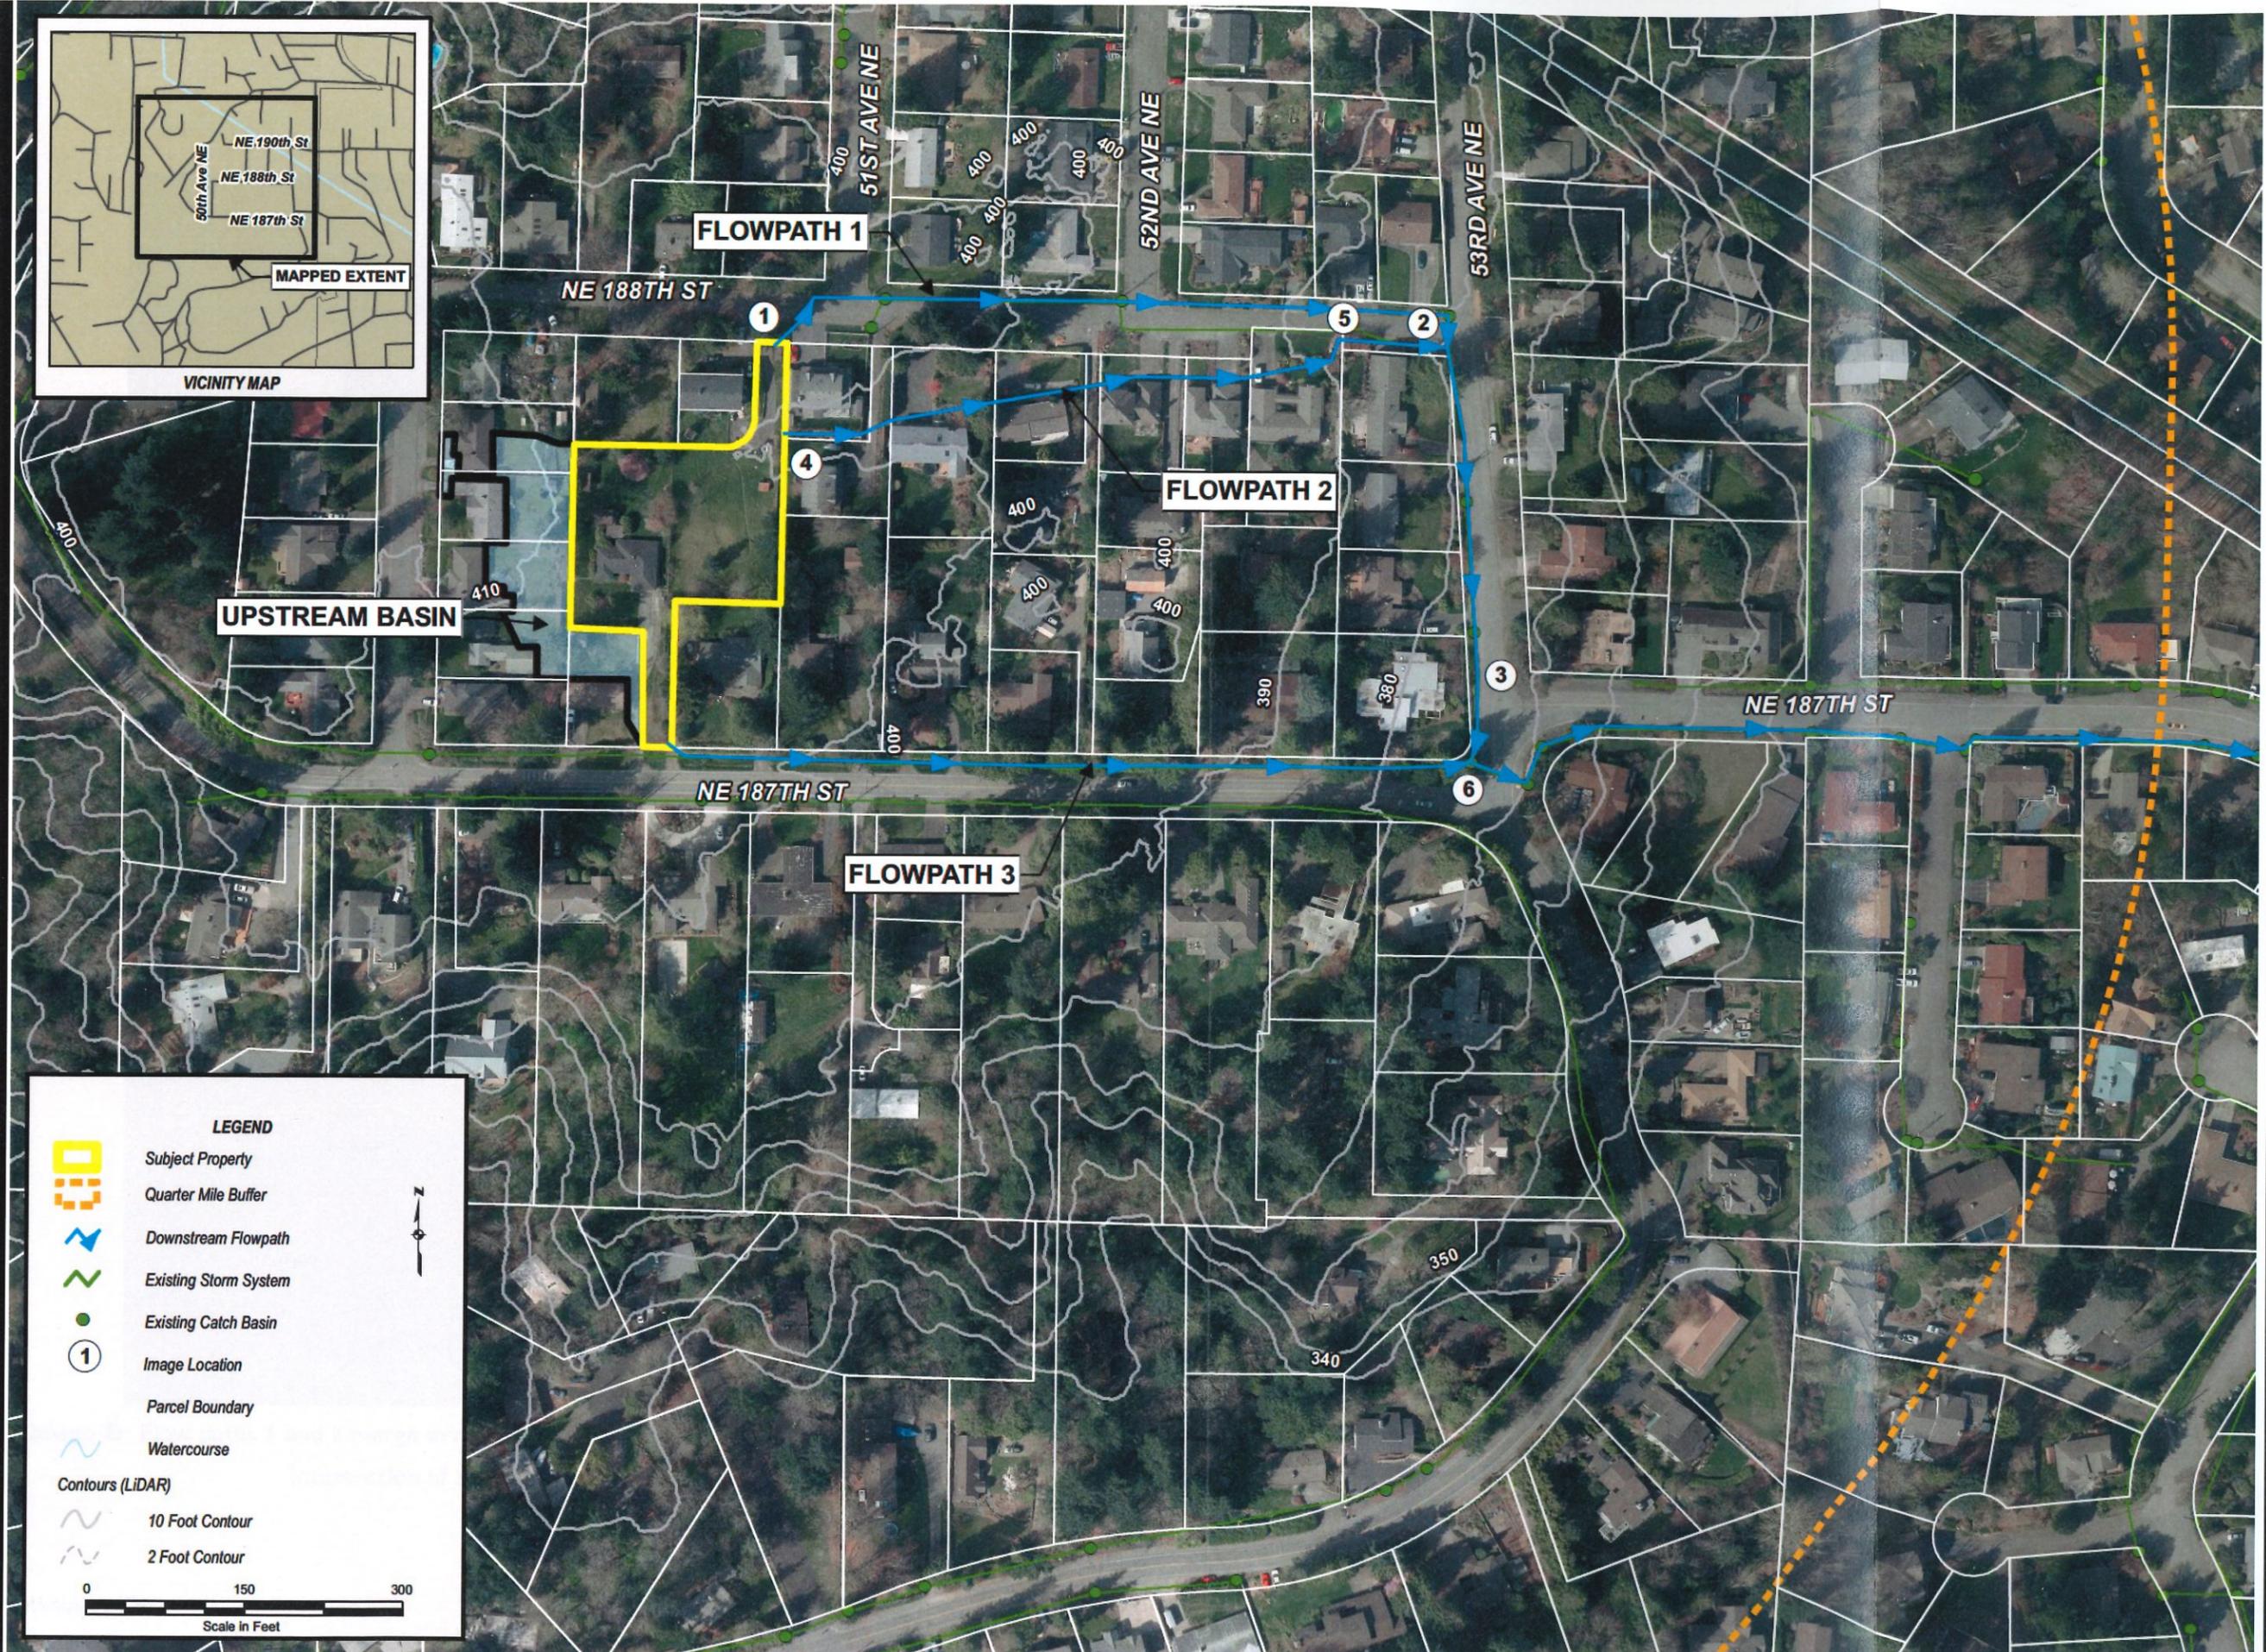
**FIGURE:**  
**5.0**

**UPSTREAM AND DOWNSTREAM ANALYSIS PHOTO RECORD (SEE FIGURE 5.0 FOR  
DOWNSTREAM ANALYSIS MAP)**

SOURCE INFORMATION	
SOURCE AGENCY	DESCRIPTION
KING COUNTY GIS	PARCEL BOUNDARY, HYDROLOGY
KING COUNTY GIS	CONTOURS GENERATED FROM BARE EARTH LIDAR (KING COUNTY)
CITY OF KENMORE GIS	UTILITIES
	THIS DATA HAS A STATED VERTICAL ACCURACY OF APPROXIMATELY 1 FOOT.

King County LiDAR, onsite engineering survey, and 2012 aerial photography were the best topographical references available for the area containing the site. The limits of downstream analysis extended roughly 0.25 miles beyond the subject property (See figure 5.0, Offsite Analysis Map). The project site is tributary to the Cedar River and Lake Washington in respective sequence.

On May 18<sup>th</sup> 2015, upstream and downstream analyses were performed at the site. The weather was mostly sunny and approximately 70°F. The ground was dry, and no overland flow was observed in the downstream flow paths. The following observations were verified during this site visit. Please refer to figure 5.0, Downstream Analysis Map, for reference locations.

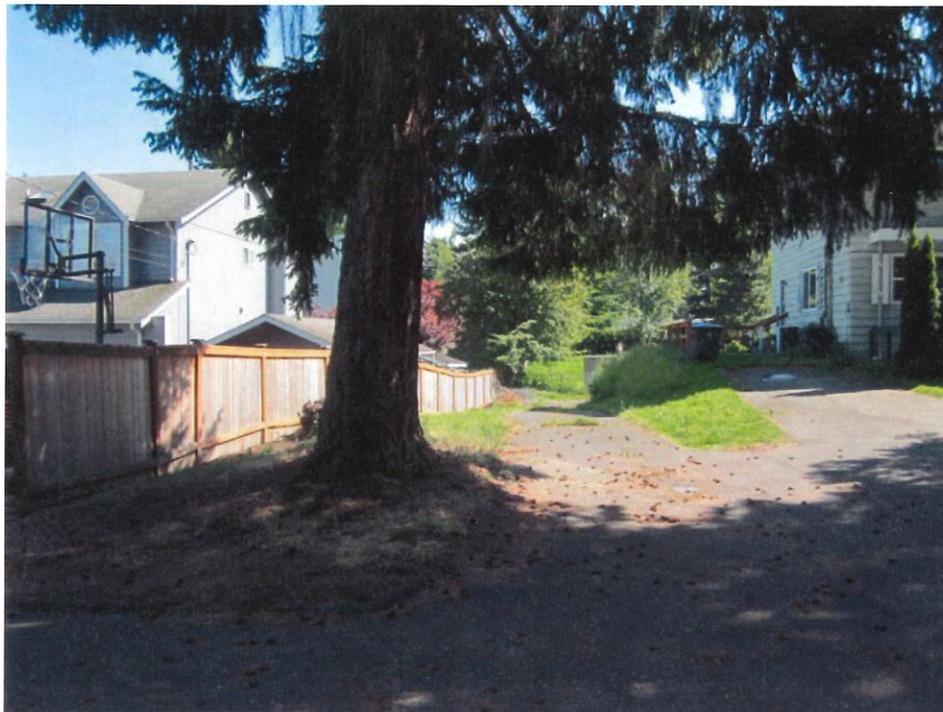
Image ①: Flow path 1 discharges from the northern property line and enters NE188th St. ROW

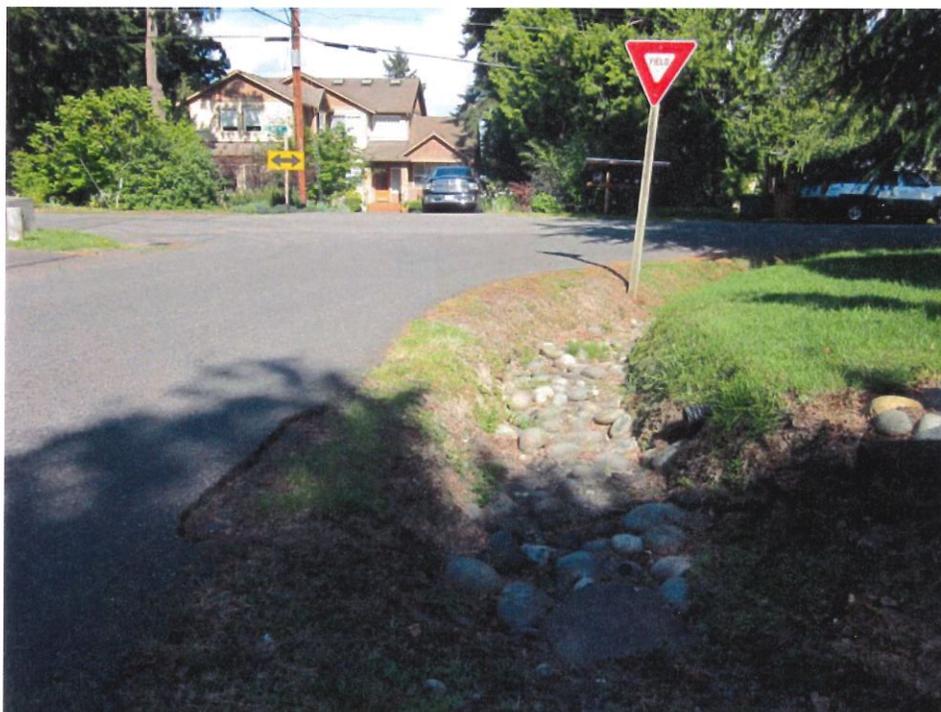
Image ②: Flow paths 1 and 2 merge in roadside ditch located on the southwest corner at intersection of NE188th St. & 53<sup>rd</sup> Ave NE

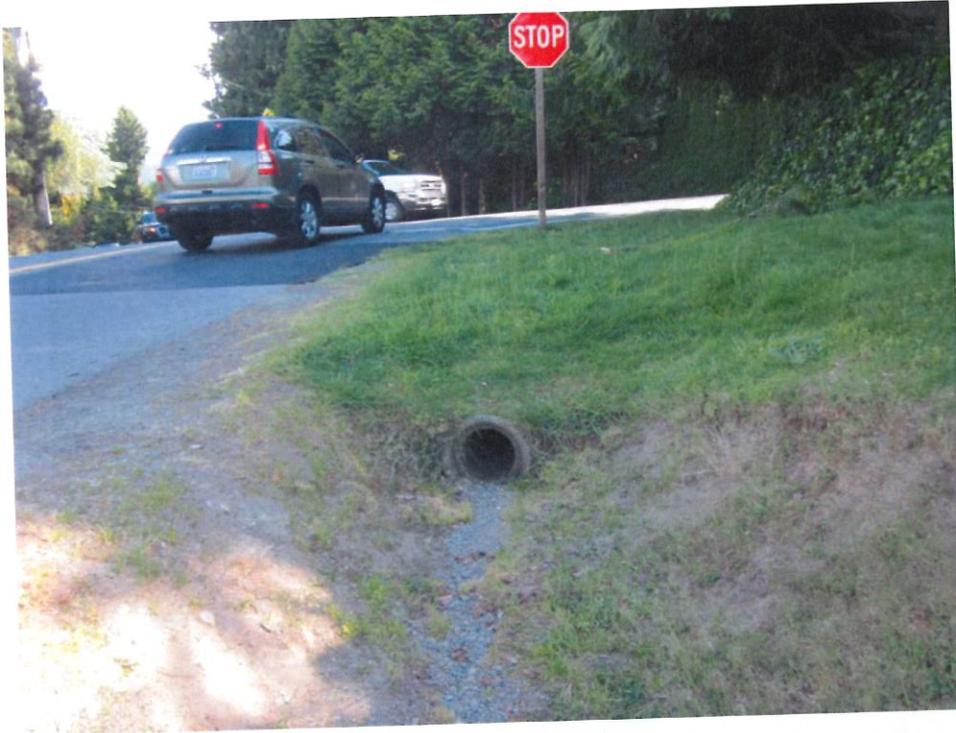
Image ③: Flow paths 1 and 2 flow through a series of roadside ditch and 12" concrete driveway culverts along NE 188<sup>th</sup> St.

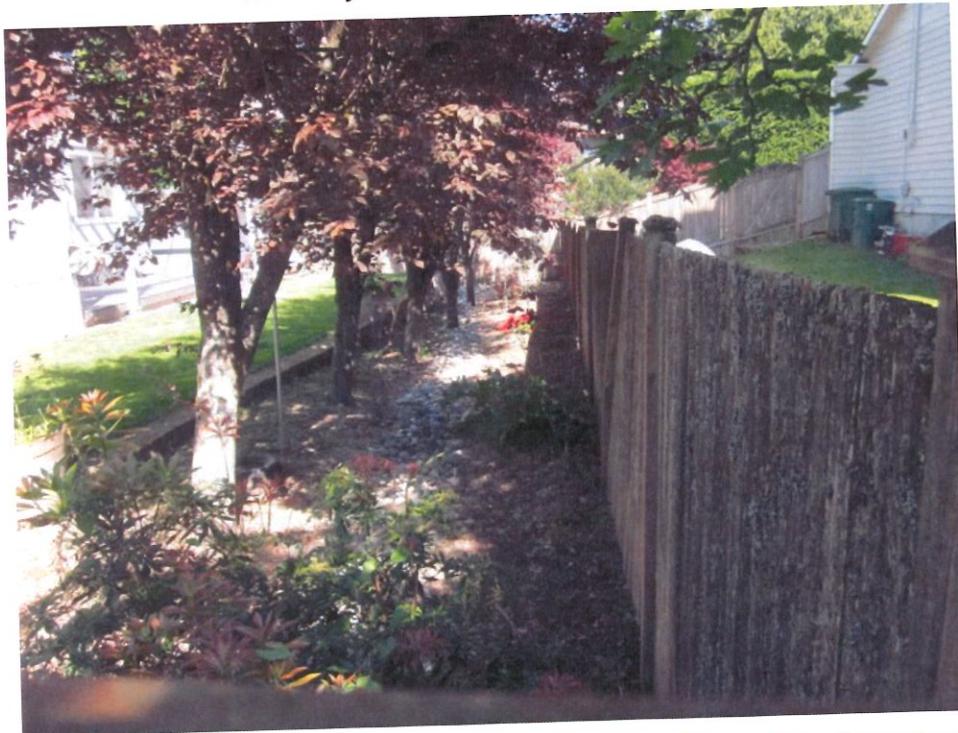
Image ④: Flow path 2 discharges the subject property and is conveyed overland and via underground pipe through adjacent private properties

Flow path 2 is the primary discharge location in the existing condition and is located along the eastern property boundary at a low point on the site. These flows discharge the site④ and are conveyed as surface flow through adjacent parcels through a series of private storm drain pipes, yard drains, and swales. No drainage easement exists for flow path 2 where it exists over private property. These flows eventually outlet from private property and discharge into a public roadside ditch on the south side of NE 188<sup>th</sup> St. just west of intersection NE 188<sup>th</sup> St & 53<sup>rd</sup> Ave NE⑤. At this location flows converge with the flow path 1 and continue on in the same course as described under flow path 1.

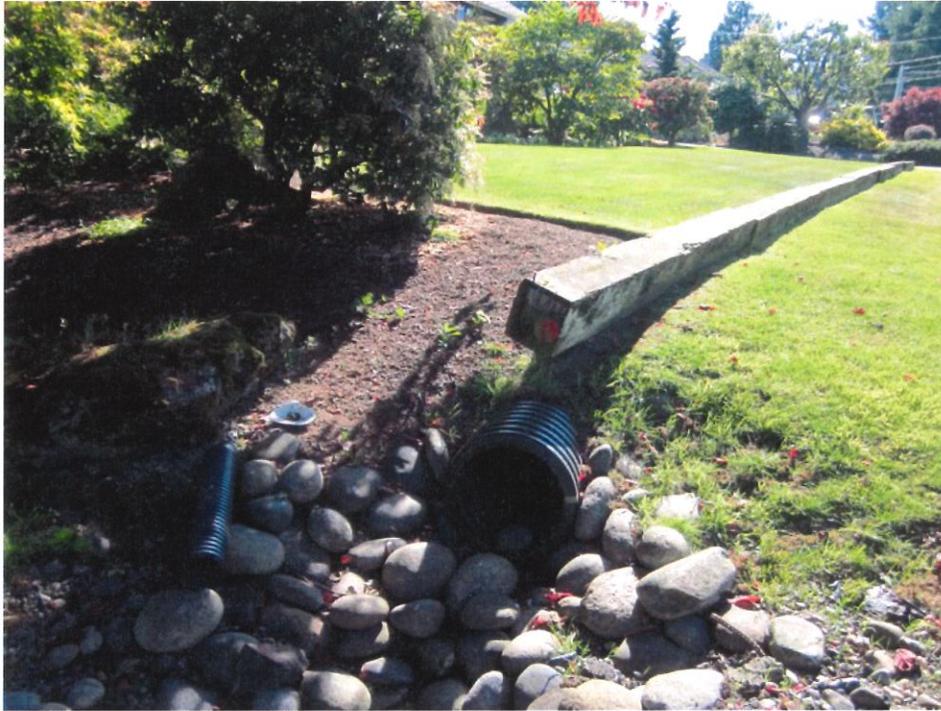
Image ⑤: Flow path 2 outlets from private property and is discharged into NE 188<sup>th</sup> St. ROW roadside ditch

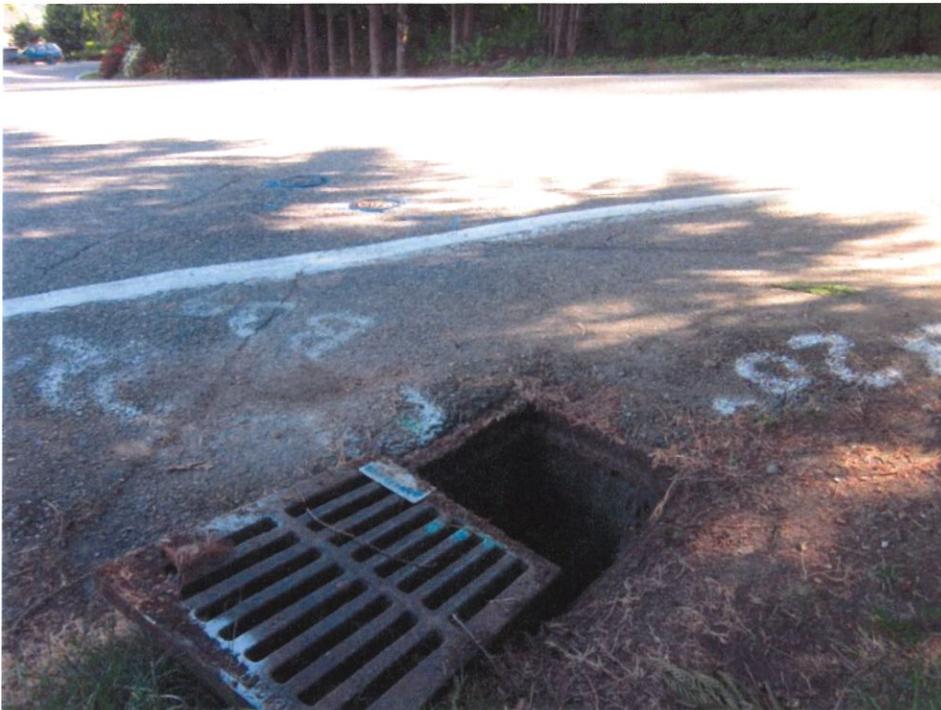
Image ⑥: Flow paths 1 and 2 merge with flow path 3 and are routed to the east along NE 187<sup>th</sup> St.

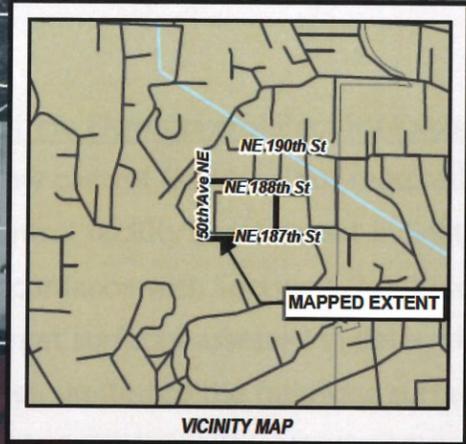
**UPSTREAM BASIN**  
0.45 AC

**EXISTING ONSITE BASIN = 0.86 AC**

<b>Predeveloped and Developed Upstream Basin</b>	<b>Area</b>
Till Grass	0.43 acres
<b>Total</b>	<b>0.43 acres</b>

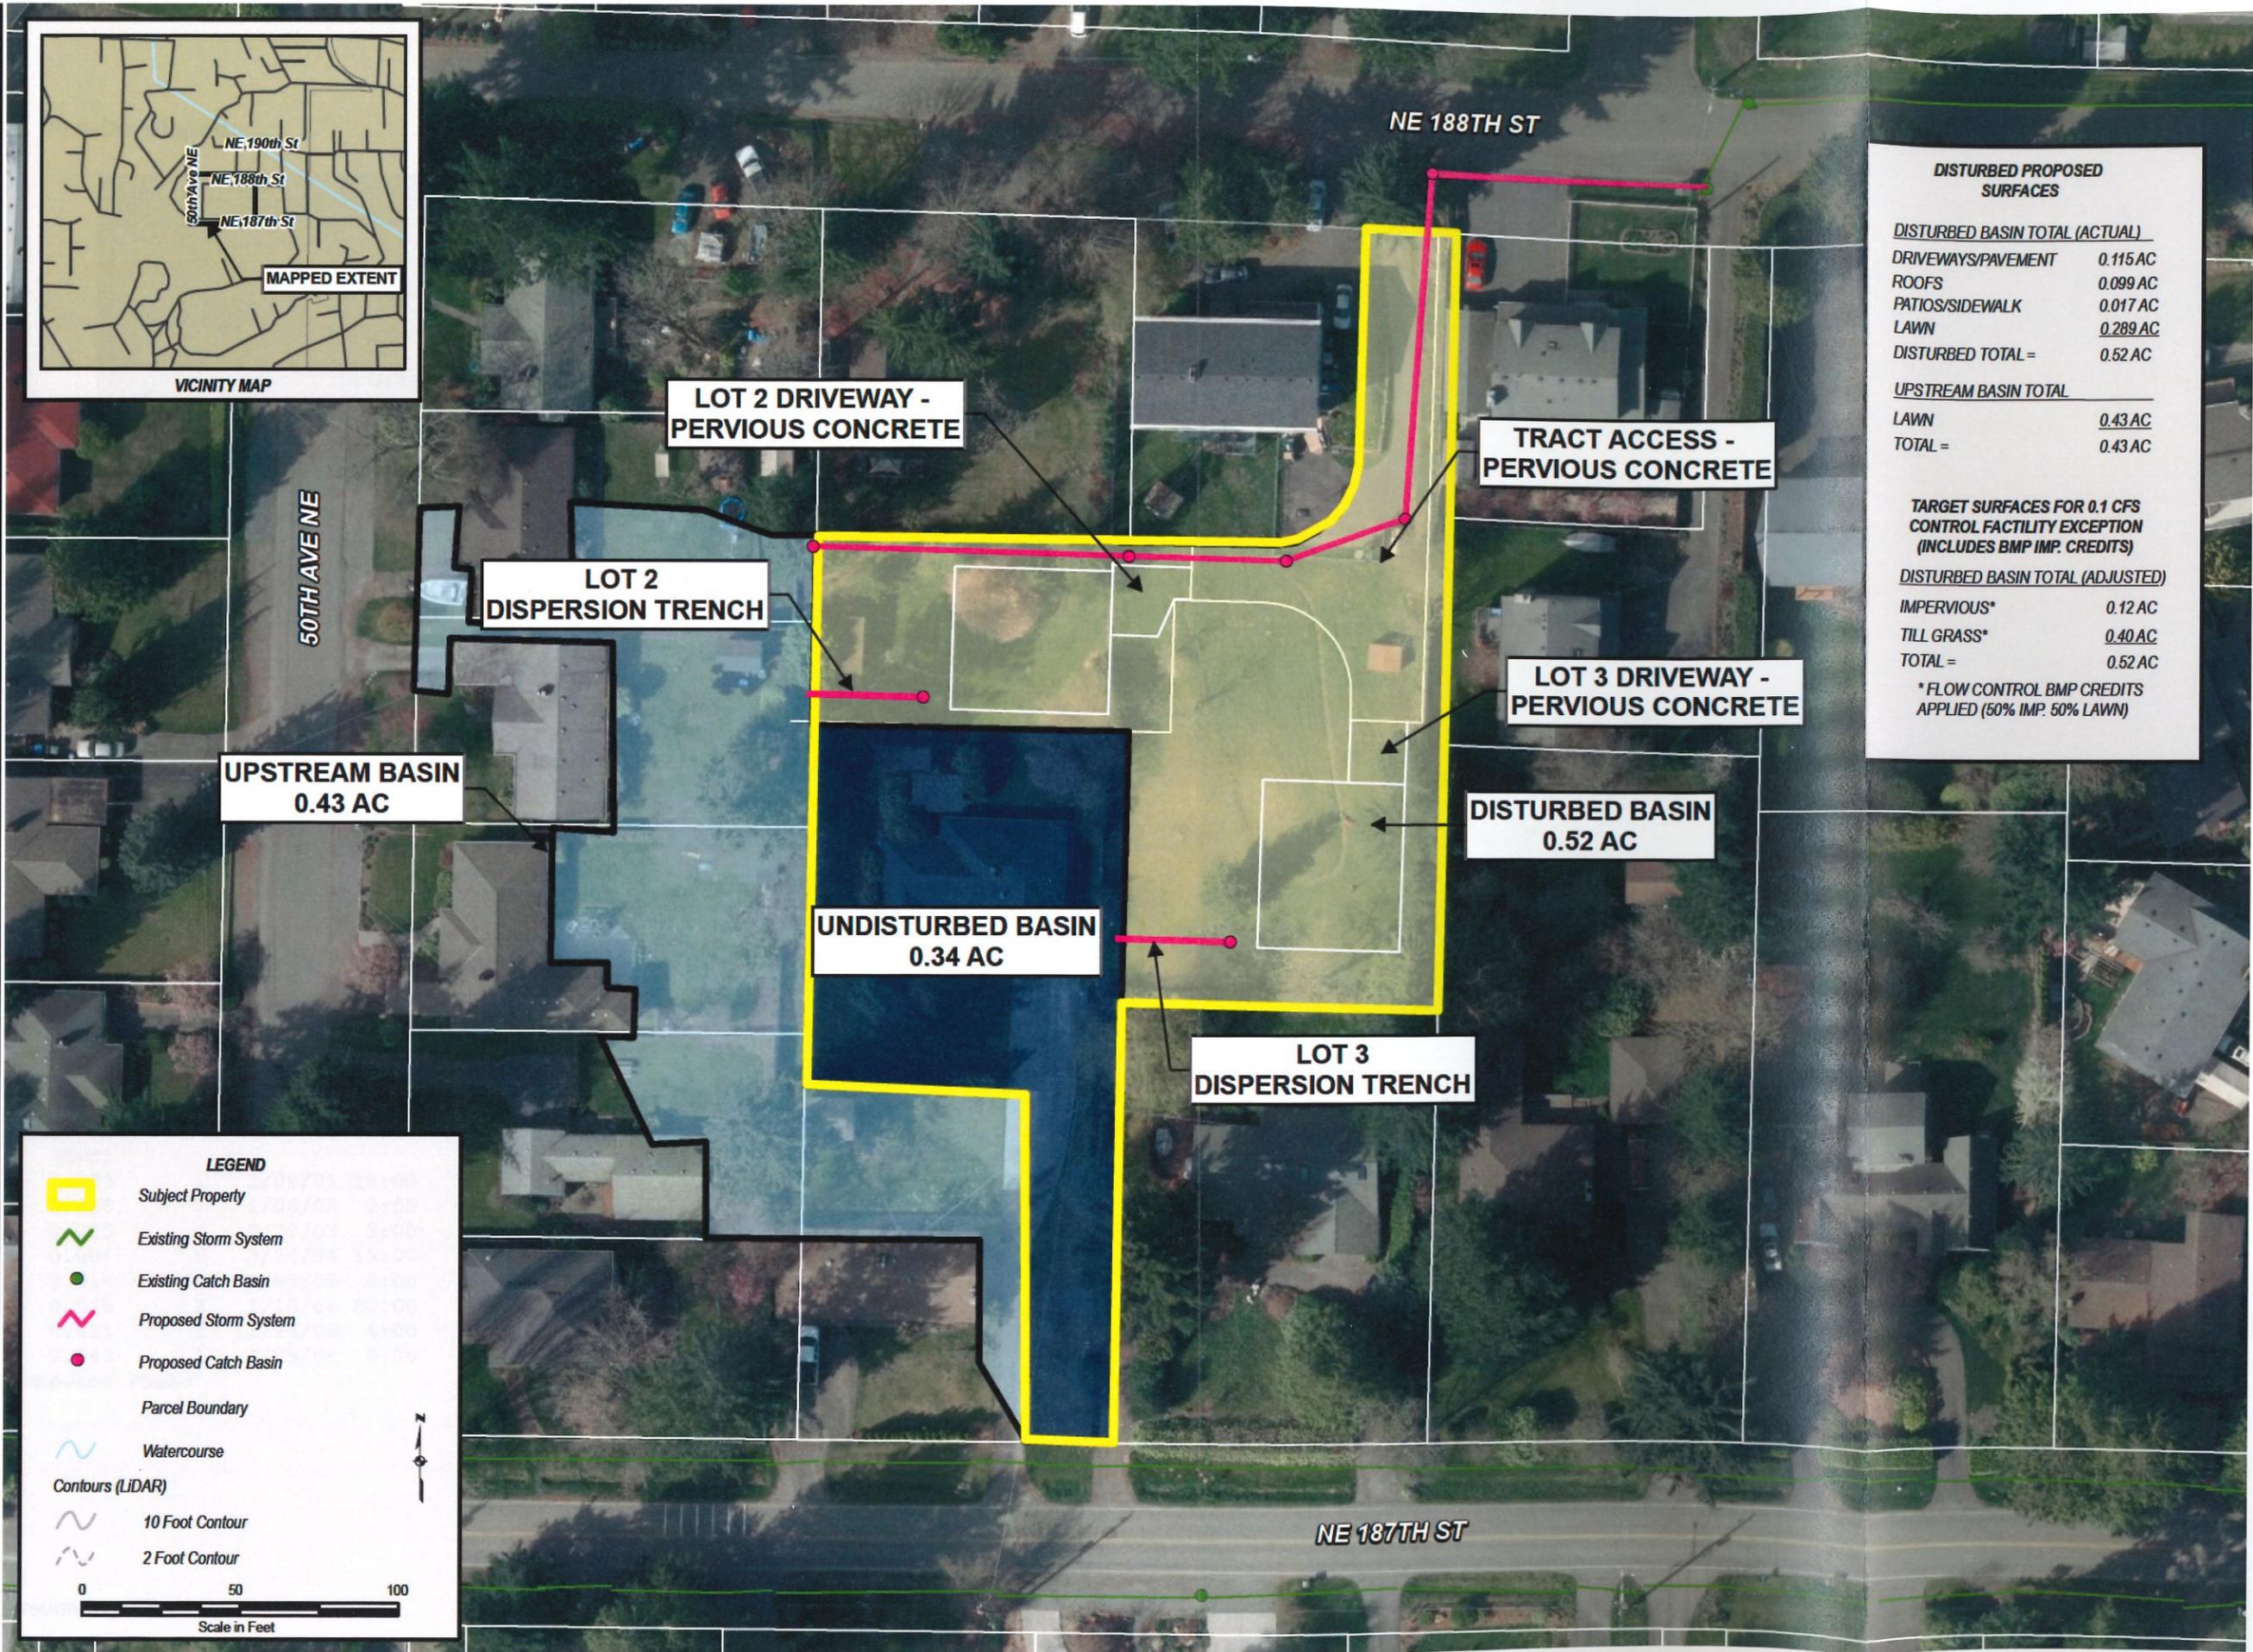
DISTURBED PROPOSED SURFACES	
<u>DISTURBED BASIN TOTAL (ACTUAL)</u>	
DRIVEWAYS/PAVEMENT	0.115 AC
ROOFS	0.099 AC
PATIOS/SIDEWALK	0.017 AC
LAWN	0.289 AC
<b>DISTURBED TOTAL =</b>	<b>0.52 AC</b>
<u>UPSTREAM BASIN TOTAL</u>	
LAWN	0.43 AC
<b>TOTAL =</b>	<b>0.43 AC</b>
TARGET SURFACES FOR 0.1 CFS CONTROL FACILITY EXCEPTION (INCLUDES BMP IMP. CREDITS)	
<u>DISTURBED BASIN TOTAL (ADJUSTED)</u>	
IMPERVIOUS*	0.12 AC
TILL GRASS*	0.40 AC
<b>TOTAL =</b>	<b>0.52 AC</b>
* FLOW CONTROL BMP CREDITS APPLIED (50% IMP. 50% LAWN)

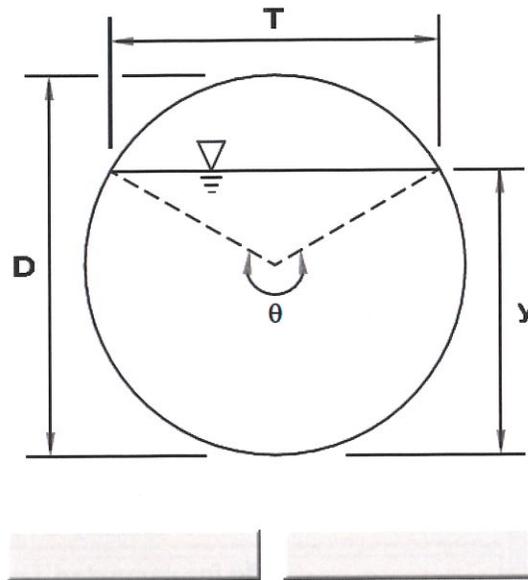
Pipe Diameter (D) = 6 in  
Pipe Slope (S) = 1.00 %  
Flow Depth (y) = 0.27 ft  
Flowrate (Q) = 0.34 cfs  
Mannings Coeff. (n) = 0.012  
Theta Angle ( $\theta$ ) = 3.27 rad  
Wetted Area (A) = 0.11 ft<sup>2</sup>  
Wet. Perimeter (P) = 0.82 ft  
Hydraulic Radius (R) = 0.13 ft  
Top Width (T) = 0.50 ft  
Flow Velocity = 3.19 fps

Theta Angle ( $\theta$ ): If  $y \geq r$ :  $\theta = 2\pi - 2a \cos\left(\frac{y-r}{r}\right)$  where: r = Pipe Radius

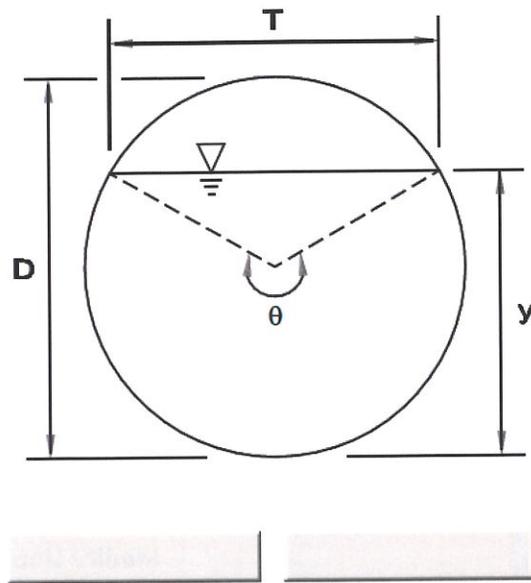
Pipe Diameter (D) = 8 in  
 Pipe Slope (S) = 0.60 %  
 Flow Depth (y) = 0.39 ft  
 Flowrate (Q) = 0.65 cfs  
 Mannings Coeff. (n) = 0.012  
 Theta Angle ( $\theta$ ) = 3.48 rad  
 Wetted Area (A) = 0.21 ft<sup>2</sup>  
 Wet. Perimeter (P) = 1.16 ft  
 Hydraulic Radius (R) = 0.18 ft  
 Top Width (T) = 0.66 ft  
 Flow Velocity = 3.09 fps

Theta Angle ( $\theta$ ):  
 If  $y \geq r$ :  $\theta = 2\pi - 2a \cos\left(\frac{y-r}{r}\right)$  where: r = Pipe Radius  
 If  $y \leq r$ :  $\theta = 2a \cos\left(\frac{r-y}{r}\right)$  where: r = Pipe Radius
