INSPECTOR'S DAILY REPORT

City of Lake Forest Park - Staunton Cove Short Plat

Subject: Storm Drainage Construction

Location: 40th Place NE, south of the NE 186th Street intersection

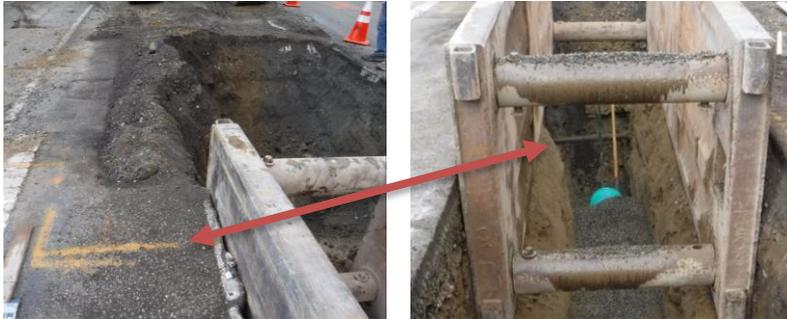
- (1) The existing gas line (painted in yellow) crossed south of CB-4. The approved location of CB-4 was moved 2 feet to the east (right, in the picture) to avoid the jog on the existing gas line, as depicted by the paint line.
- (2) CB-4, 12-inch-diameter ribbed PVC pipe and bedding material.

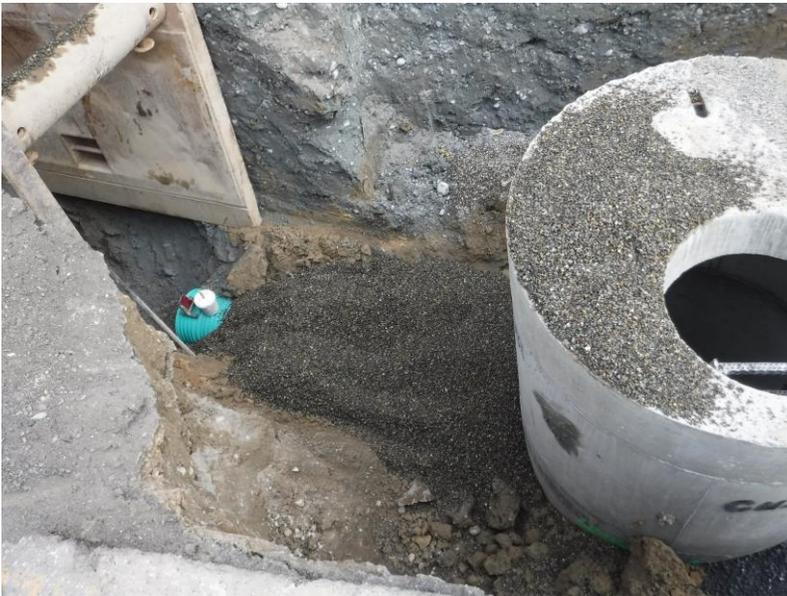
(2)

The storm drainage pipes used were 12-inch diameter ribbed PVC pipes as per the approved materials submittal. These pipes comply with the City-adopted Design Manual.

Pea gravel was used as pipe bedding material and structure base material; crushed rock was used as trench backfill material. Both the bedding and trench backfill materials used today were compliant with the 2009 King County Washington Surface Water Design Manual (Design Manual) as adopted by the City of Lake Forest Park. Proper depth and cover within the pipe zone were also per the Design Manual.
